STAR ONLINE PUBLICATION

Case Number: S2223000043

Symptom/Vehicle Issue: Rear Seat Back Trim Cover Loose J-Clip Retainer

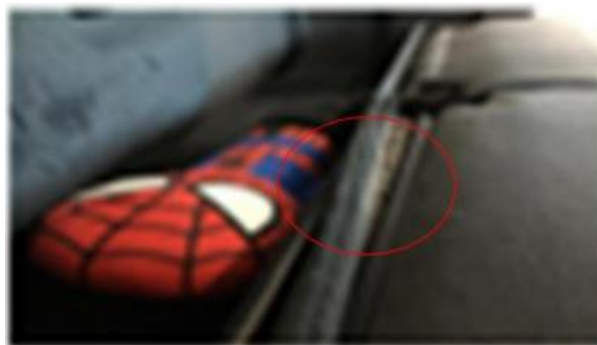
Customer Complaint/Technician Observation: Mega Cab rear seat trim cover appears loose or partially coming loose.

Fig 1
Disengaged J clip example with rear seat folded

Discussion: Inspect the J channel of the rear seat back trim cover. Replace the trim cover if the J clip is broken, cracked or damaged. During normal customer operation the cover J channel will become exposed and could be disengaged by loading and unloading of items from the back seat. This damage could cause the trim cover to become loose and the J channel damaged. Ensure the J channel is fully installed using a trim stick (fig 2).

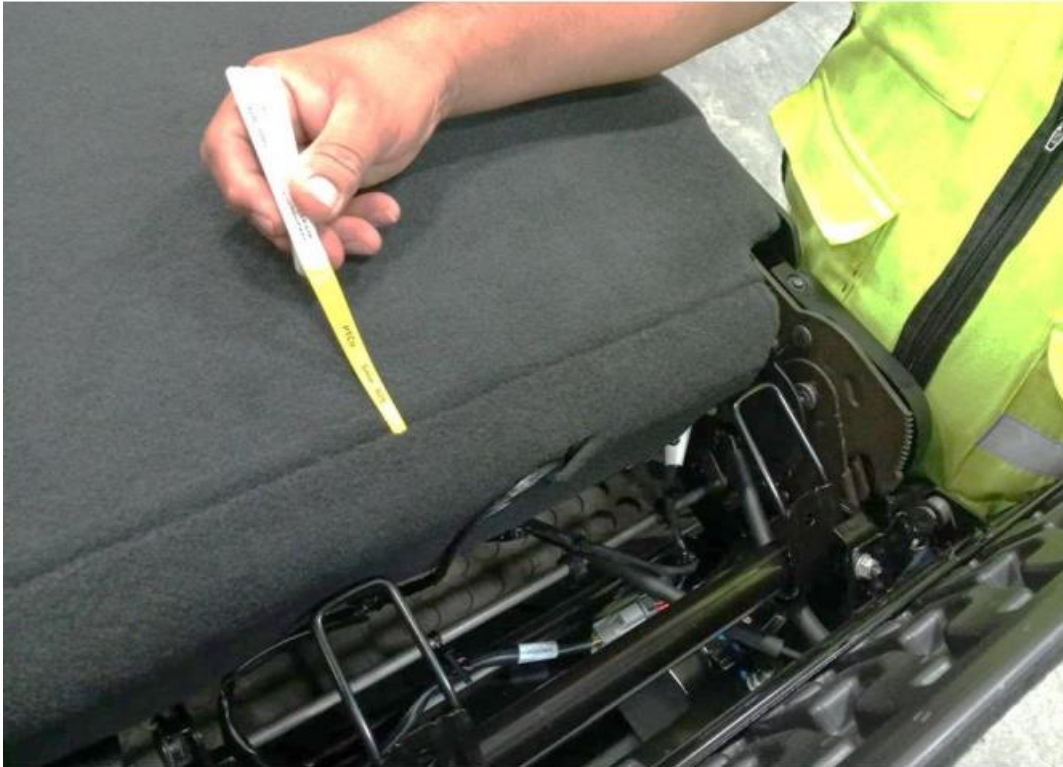
Fig 2
Trim stick used to seat the J channel retainer.
