STAR ONLINE PUBLICATION

Case Number: S1523000016 Rev A

Symptom/Vehicle Issue: A Rattle Or Creak Noise Is Heard From The Dual Pane Sunroof Area.

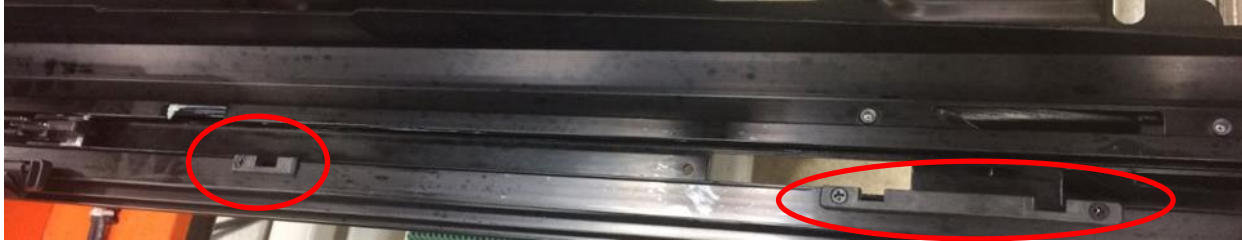
Fig1. Apply white lithium lubricant to the areas shown on frame. 1 side shown- apply to both sides.

Frame lubrication: See figure 1 below. Apply white lithium grease to the 4 areas indicated. If the concern can still be duplicated while driving over un-even or bumpy surfaces continue to Repair Procedure #3 Seal replacement. If the concern is no longer present return the vehicle to the customer.

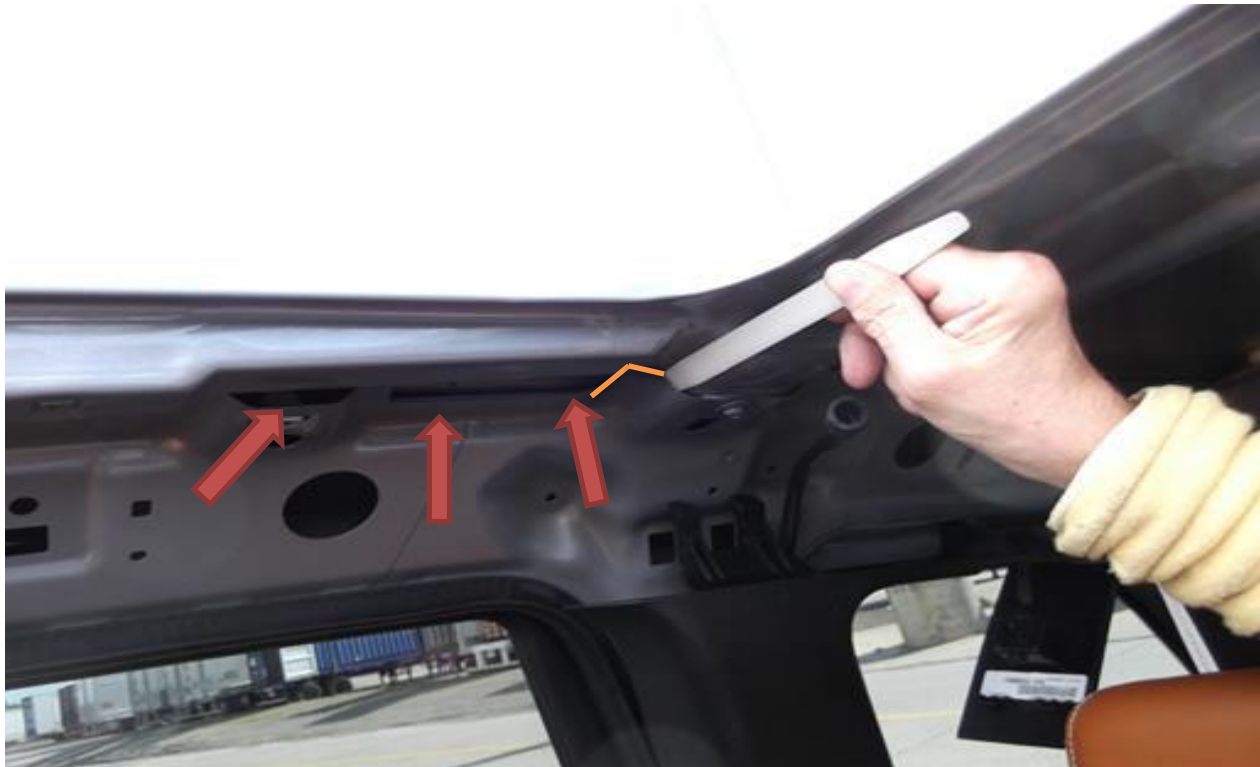
Fig 2. Body Side Aperture, C-Pillar Area. Concept shown. KL similar

1. If the noise can be duplicated from the roof area at the A/B/C pillar, remove the headliner to inspect the panel seam as shown in (Fig. 2). Refer to Service Library: Service Info> 23 - Body> Interior> HEADLINER> Removal.

2. If a trim stick or equivalent can be inserted into the sheet metal joint area shown and the metal can be easily flexed apart, a panel adhesive such as LORD Fusor 112B slow cure can be injected into the horizontal seam area to bond the surfaces, not the vertical seam where the trim stick is inserted (Fig. 1). Use a fiber or trim stick to open the joint to allow the adhesive to be injected. It will be necessary to remove the sunroof module for access to the seam to inject the adhesive. Refer to Service Library under: Service Info> 23 - Body> Sunroof, Dual Pane> Removal.

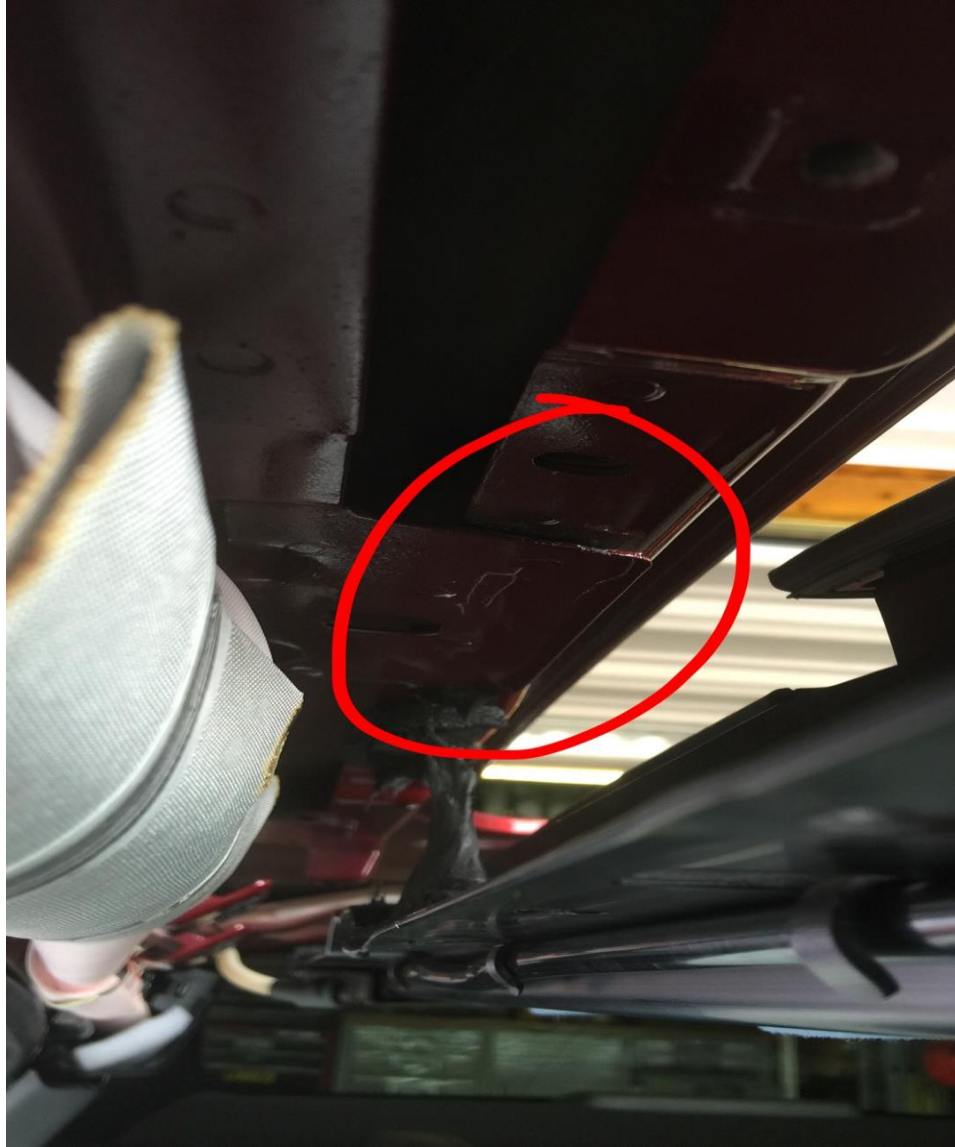
Fig 3. Body Side Aperture, B-Pillar Area

3. Once adhesive is inserted, remove fiber or trim stick. Using clamps or locking pliers clamp the area down as shown (Fig. 3&4). Follow adhesive manufacturer's instructions for cure time.

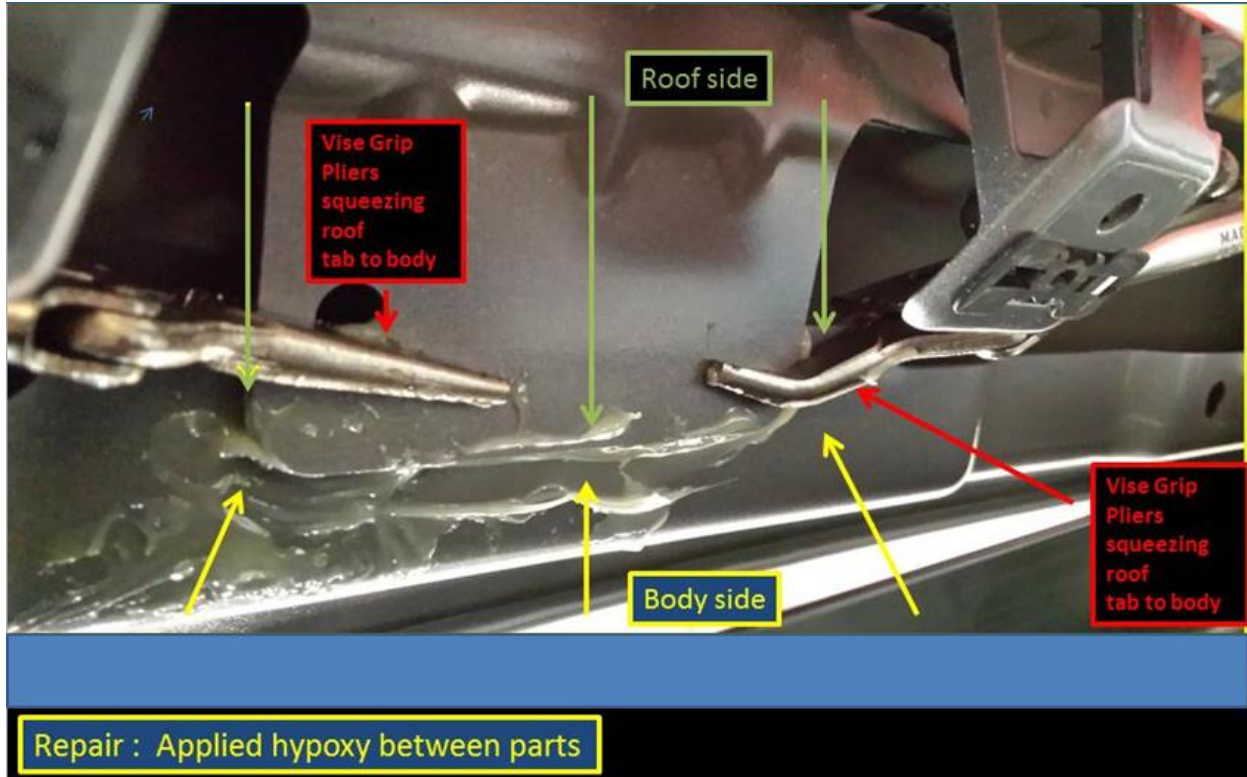
Fig 4. Locking pliers (or clamps) applied to panels. UF shown, KL similar.
