STAR ONLINE PUBLICATION

Case Number: S2223000023 Rev A

Symptom/Vehicle Issue: Headrest Does Not Fold Or Does Not Lock In Up Position.

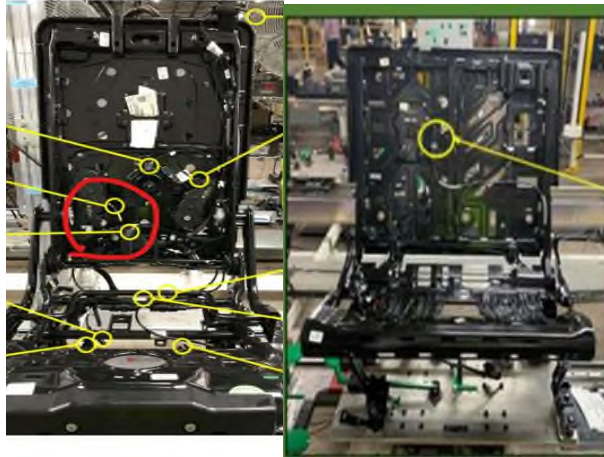
Connectors for headrest circuits
Second row red circle(left). Third row (right)

Procedure 1 Electrical Verify the seat connectors are fully connected for the inoperative headrest. Inspect pin fits. Perform continuity checks. To access the seat back mounted connectors, refer to Service Library.

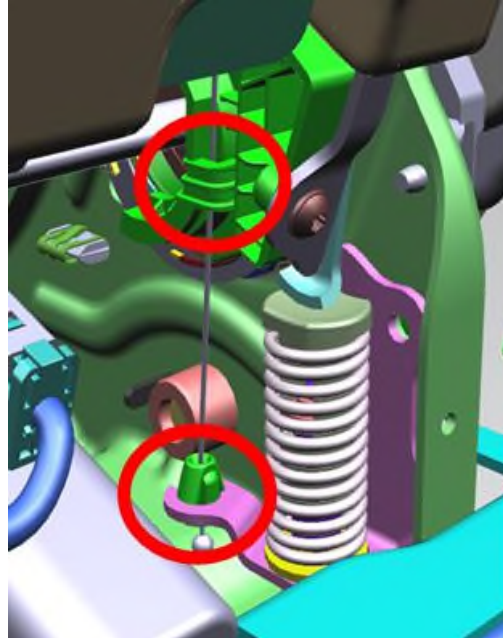
At the bottom corner of the seat the head rest release cable attaches to the cam. Check to see that the cable is snapped in place as shown. If yes, continue to next step. If no, attach and check headrest operation.

Headrest cable attachment at seat base

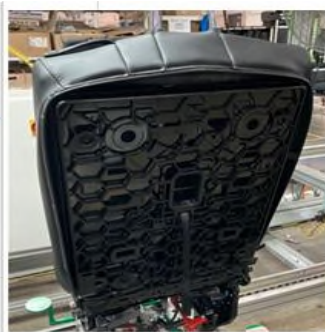
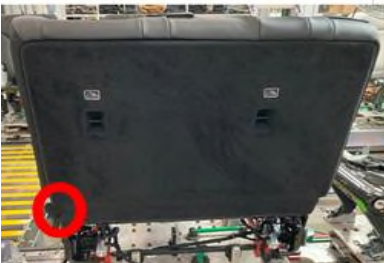
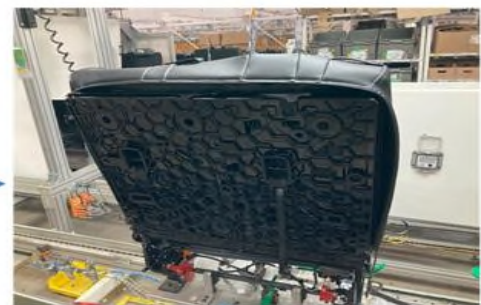
Detach the carpet from the seat back. Release the seat back carpet starting at the lower bottom corner shown below.

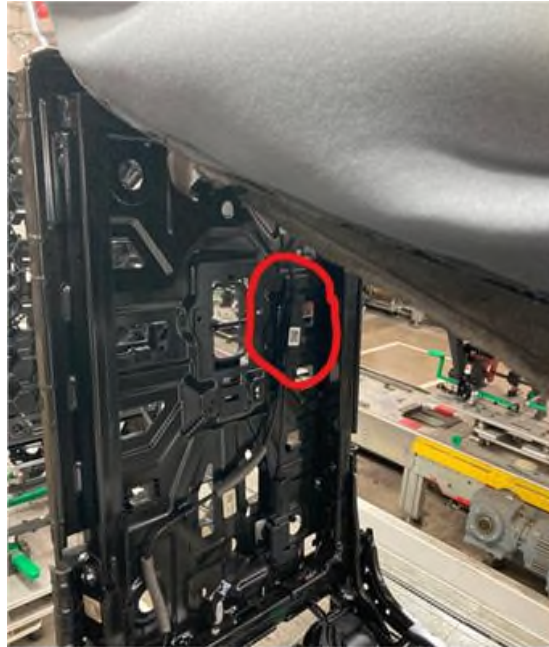
Carefully pull the seat back and cushion forward to reveal the headrest cables.

Circled- headrest cable junction block

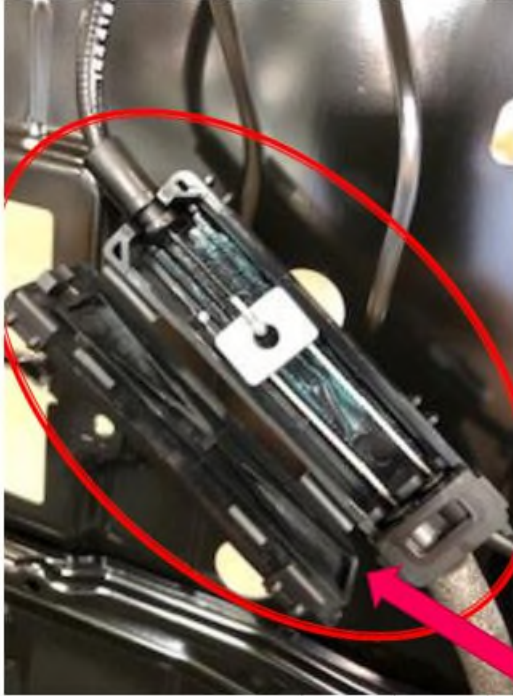
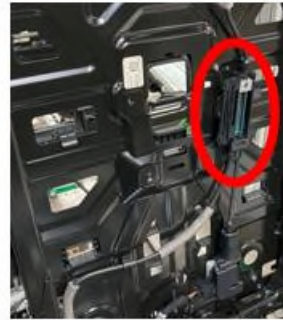
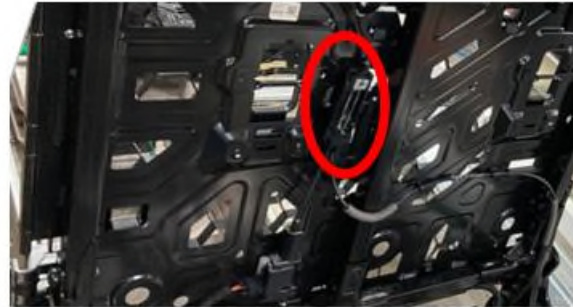
Inspect cable attachments in junction block. Reattach cables as required.

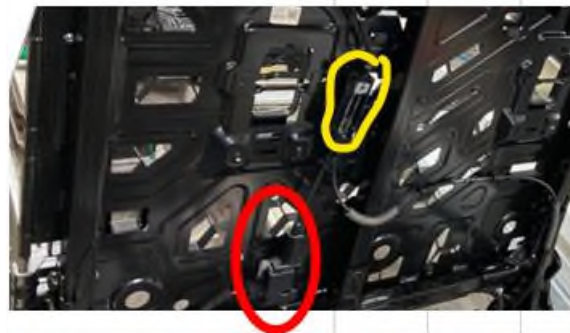
Below the junction block is the actuator. Take the actuator cable cover off by sliding it off. Inspect the cable attachment.

Junction block in yellow circle. Actuator circled in red.

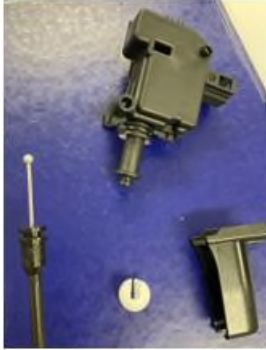
Inspect the cable attachment and reattach cable if it is found loose.

Reassemble seat in reverse order. Test operation by actuating the electric and mechanical release. For additional information refer to 23 - Body / Seats, Second Row / HEADREST, Second Row / Removal and Installation
