NUMBER: 02-006-22

GROUP: 02 - Front Suspension

Noise in Front Over Bumps

2021- 2022 (B1) Jeep Renegade

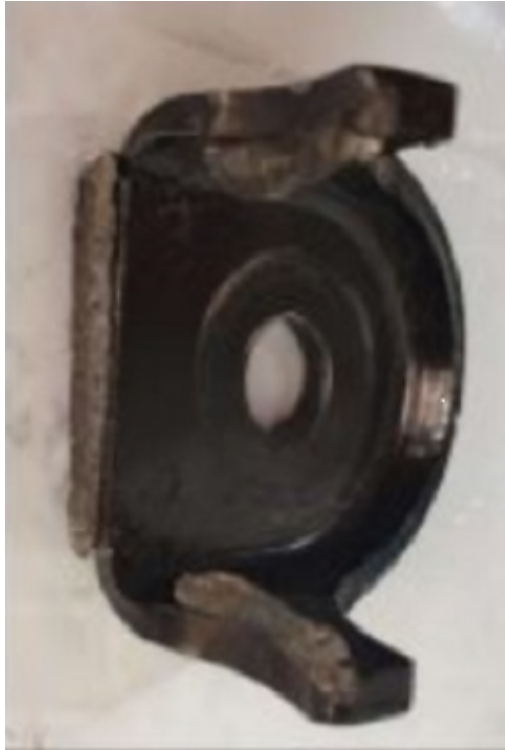
NOTE: The right front strut could have a damaged sway bar tab. (Fig. 1) ,(Fig. 2)

Fig. 1
Sway Bar Ear Broken

1. Raise the vehicle in the air. Refer to the detailed service procedures available in DealerCONNECT>Service Library under: Service Info 04 - Vehicle Quick Reference / Hoisting / Standard Procedure.
2. Replace the right front strut. Refer to the detailed service procedures available in DealerCONNECT>Service Library under: 02 - Front Suspension / Front / shock absorber, Suspension / Removal and Installation.

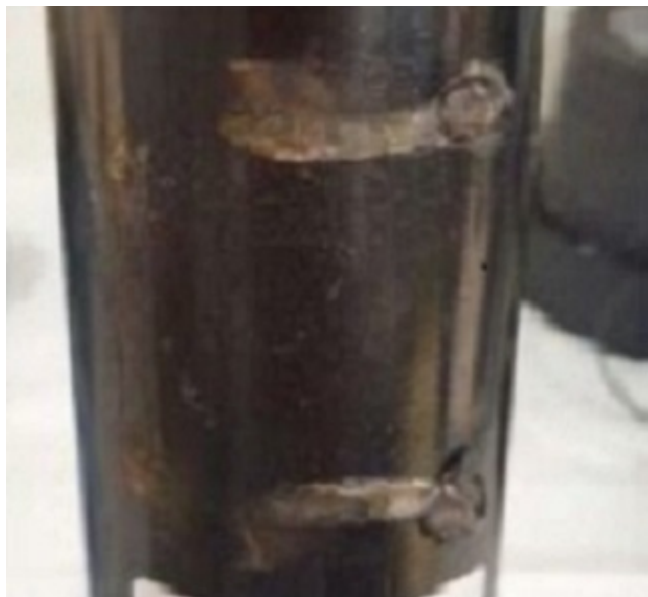
Fig. 2
Strut With Sway Bar Ear Broken
