Technical Service Bulletin

91 Poor hands-free call quality, speech dialogue system function impaired, DTCs B120313 - B120813

91 22 07 2067267/1 June 13, 2022.

Model(s)	Year	VIN Range	Vehicle-Specific Equipment
TT Roadster	2016 – 2023	All	Not Applicable
A5 Cabriolet, and S5 Cabriolet	2018 – 2023

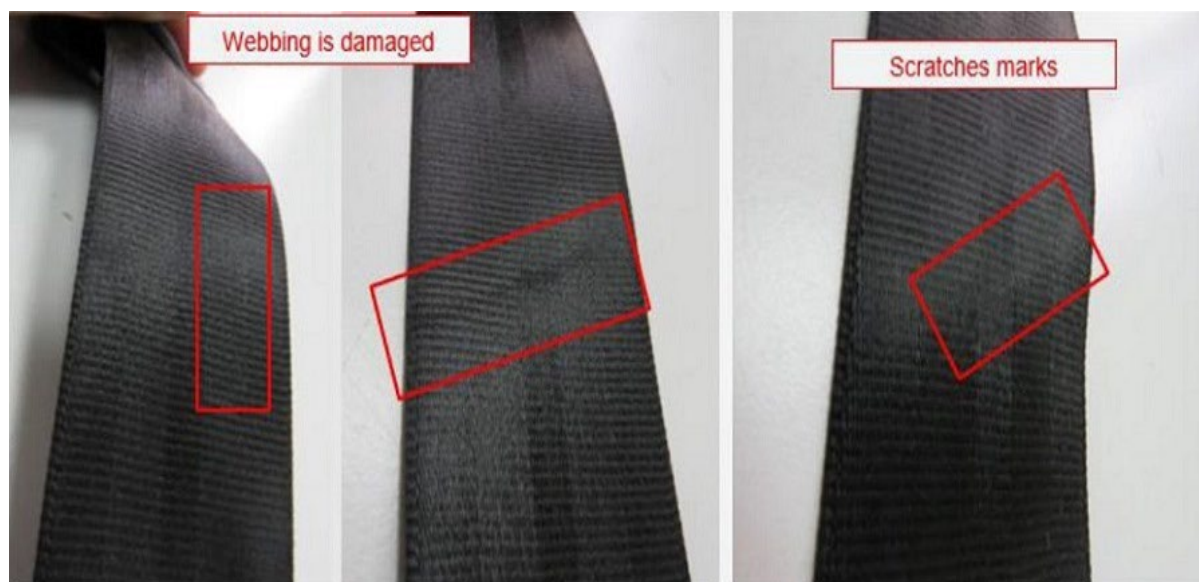
1. Lines running down or across (A5/S5 Cabriolet, TT Roadster)

If there are visible lines running down or across the seat belt (Figure 1), it can be assumed that the seat belt was trapped in the front door.

Figure 1. Marks indicating that the seat belt was trapped in the front door

The seat belt must be replaced to restore proper function.

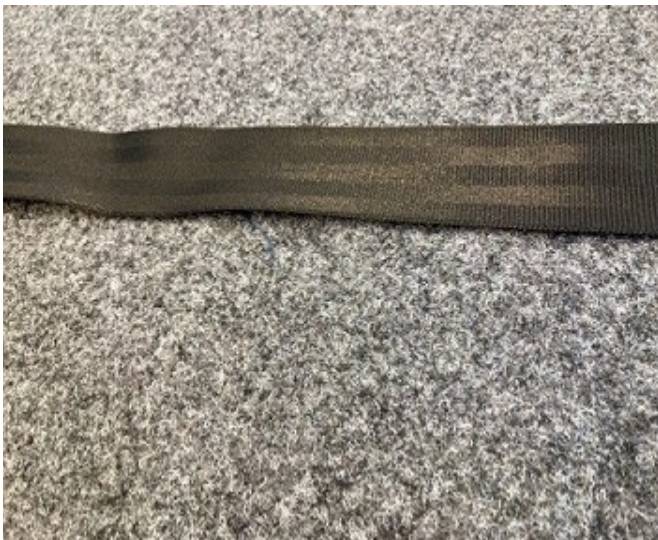
2. Waviness (A5/S5 Cabriolet only)

If the seat belt is wavy (Figure 2), it can be assumed that the seat belt was misused by a rear passenger by pulling on it while exiting the vehicle (Figure 3).

Figure 2. *Waviness indicates that the seat belt was pulled on when exiting the rear of the vehicle*

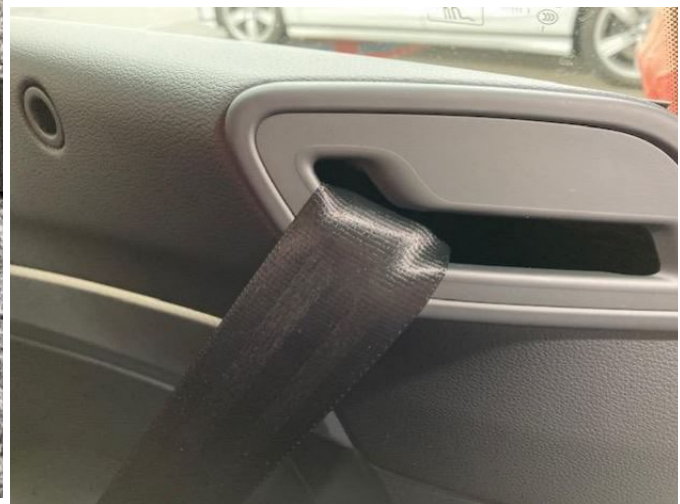
- Trapping the seat belt in the door.
- Rear passengers pulling on the seat belt when exiting the vehicle.

Figure 3. *Pulling on the seat belt when exiting the vehicle can damage the seat belt/microphones.*
