**Document ID:** IK1600145

**Title: Front Cab Mount Bushings/Insulators on MV, HV, DuraStar® WorkStar® Vehicles Used in Severe Vocations. (TSI-11-16-03)**

**Applies To: Model: MV, HV, DuraStar, WorkStar**

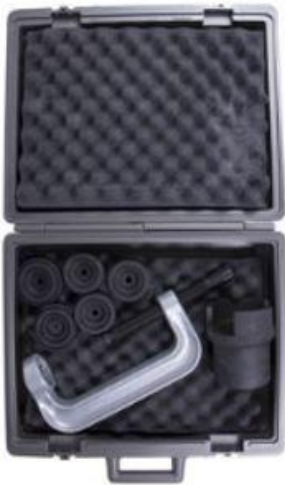
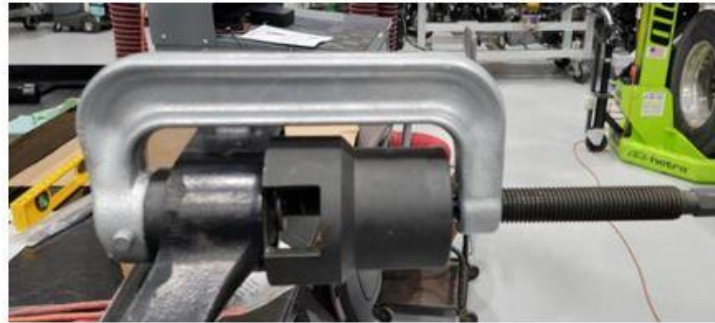
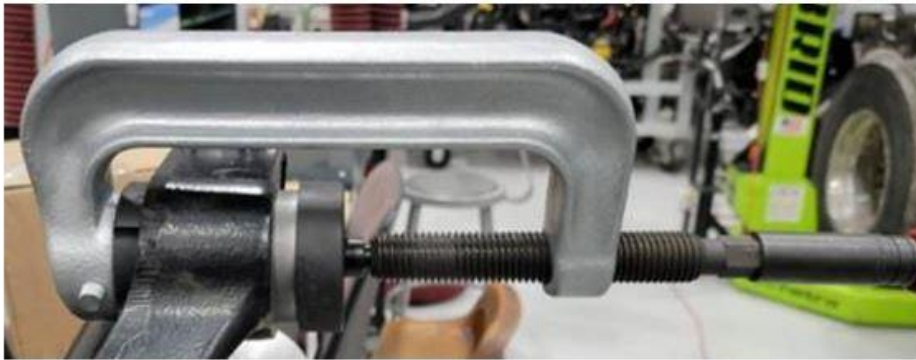
Navistar's Front Cab Mnt Bushing Press P/N: ZTSE4928

## PRESS, CAB MOUNT BUSHING

**Product Number:** ZTSE4928

Used to remove and/or install cab-mounting bushings.

Note: There is a special Tool available to remove and install the isolator bushings; In some cases this can be done without removing the front mount casting from the vehicle.
