## Automated Manual Transmission ( AMT ) I-Shift / mDRIVE - Ribbon Harness Replacement - Speed Sensor Bolts, Possible Fault Codes P1058 - 21 Or MID 130 PID 161 FMI 1

### AMT Ribbon Harness Replacement-Speed sensor bolts

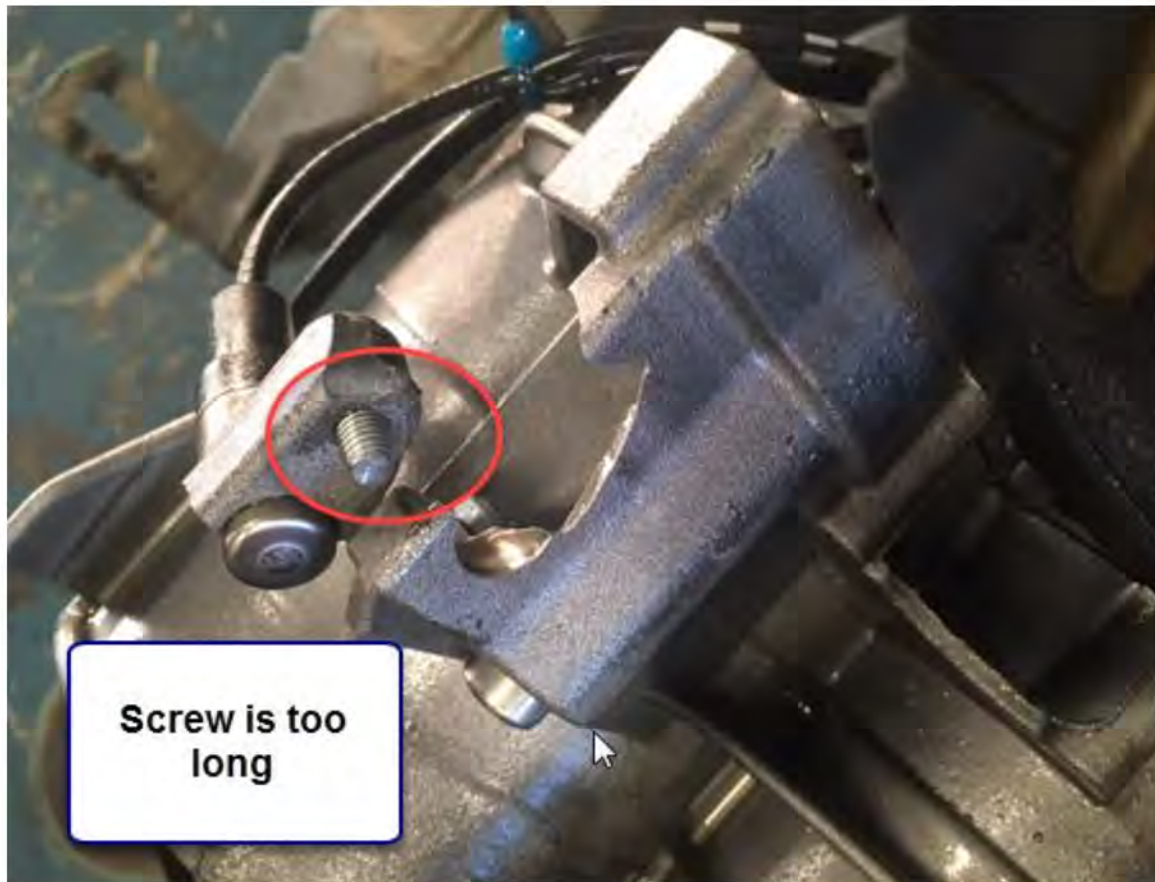
When replacing the internal ribbon harness in the AMT gearbox the proper length screws are critical for mounting the countershaft speed sensor. Too long of a bolt will cause the bolt to interfere with the gear on the main shaft and damage will occur.

The screw should not extend past the end of the main shaft or countershaft speed sensor.

If there are new mounting bolts supplied in the kit carefully check that they are not too long or use the original mounting screws to mount the countershaft speed and main shaft speed sensors.

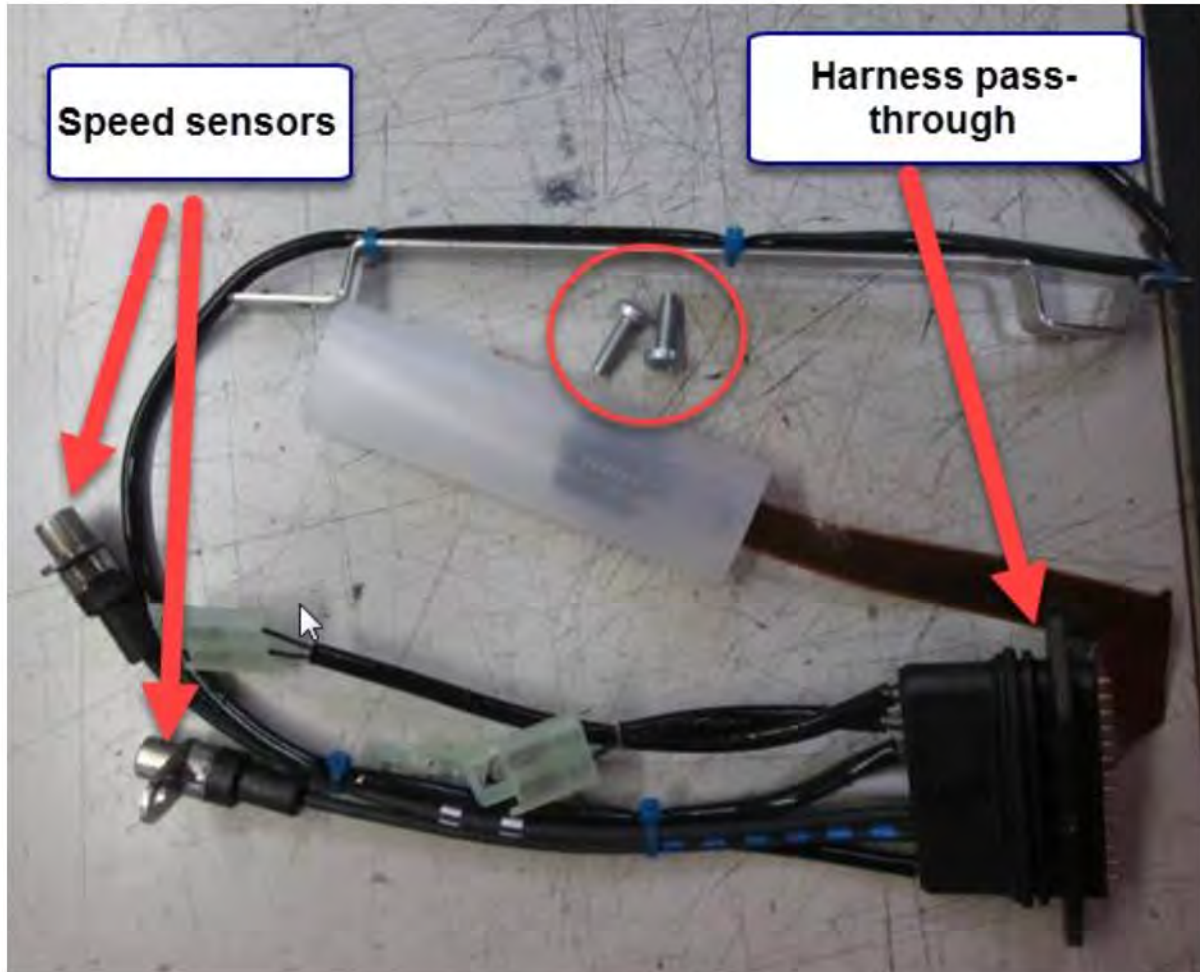
The screws that are shown (circled) in the picture below are supplied with the harness kit. These screws ARE NOT for mounting the speed sensors. Use these screws as replacements for the two form-screws that are removed from the harness pass-through. These screws will form their own threads in the housing as they are installed.
