Technical Service Bulletin

CENTER DISPLAY SURFACE PEELING AND/OR MAP SCROLLS WITHOUT OPERATION (GHOST TOUCH)

Bulletin No.: 09-003/22

2017-2020 CX-5 vehicles with VINs lower than JM3KF*****869655 (produced before August 25, 2020)

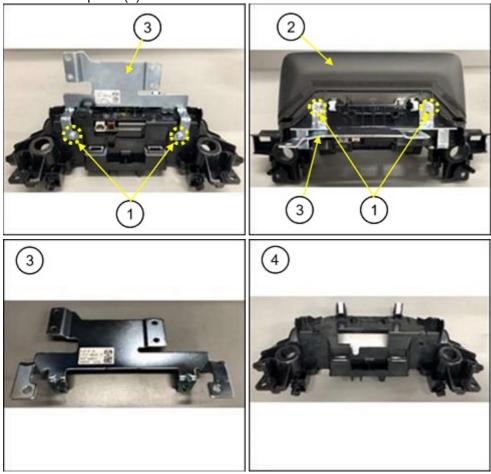
6. Remove the 4 four screws (1) that assemble the center display (2) and the bracket (3), then separate the bracket (3) and the cover panel (4).

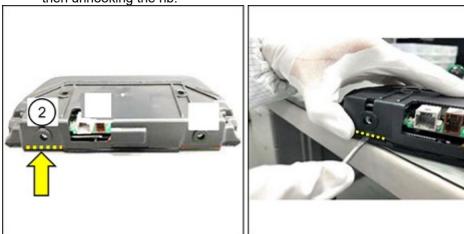
b. Unhook rib (2) by inserting the tip of a flathead screwdriver in the gap (2) between the lens and the rear cover, then unhooking the rib.
