## Volvo Chassis - Equipped with An Automated Manual Transmission (AMT, iShift) - SNV 19-002 - AMT Oil Filter Housing Corrosion

**Bulletin:** SNV19-002

### AMT oil filter housing corrosion

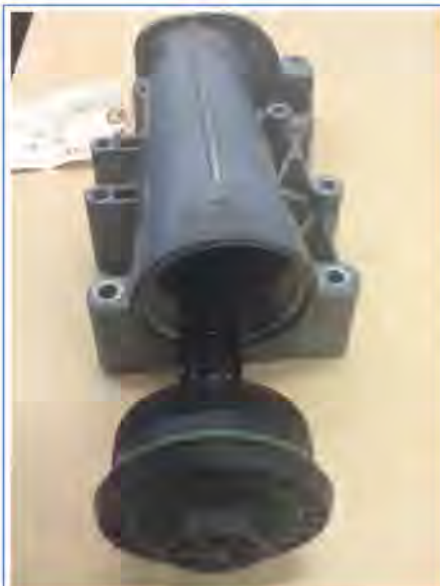
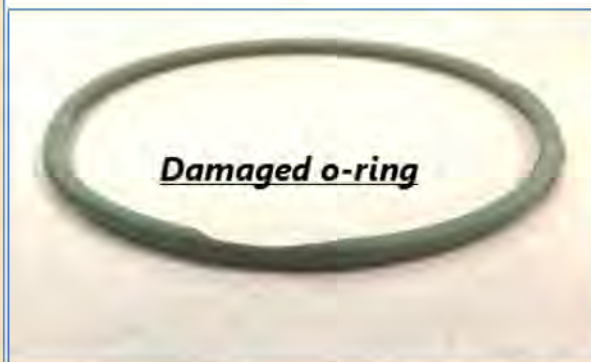
The AMT gearbox oil filter housing has been found to develop debris buildup or corrosion on the filter cover flange.

Failure to inspect and properly clean this area during a filter change can lead to a sealing ring failure during installation of the cap that may not be found during the oil change. The subsequent oil leak can lead to catastrophic gearbox failure due to loss of oil if not detected and corrected.

If you detect corrosion on the location shown above do not attempt to clean or reuse this housing. The corrosion is harder than the aluminum. This housing must be replaced.

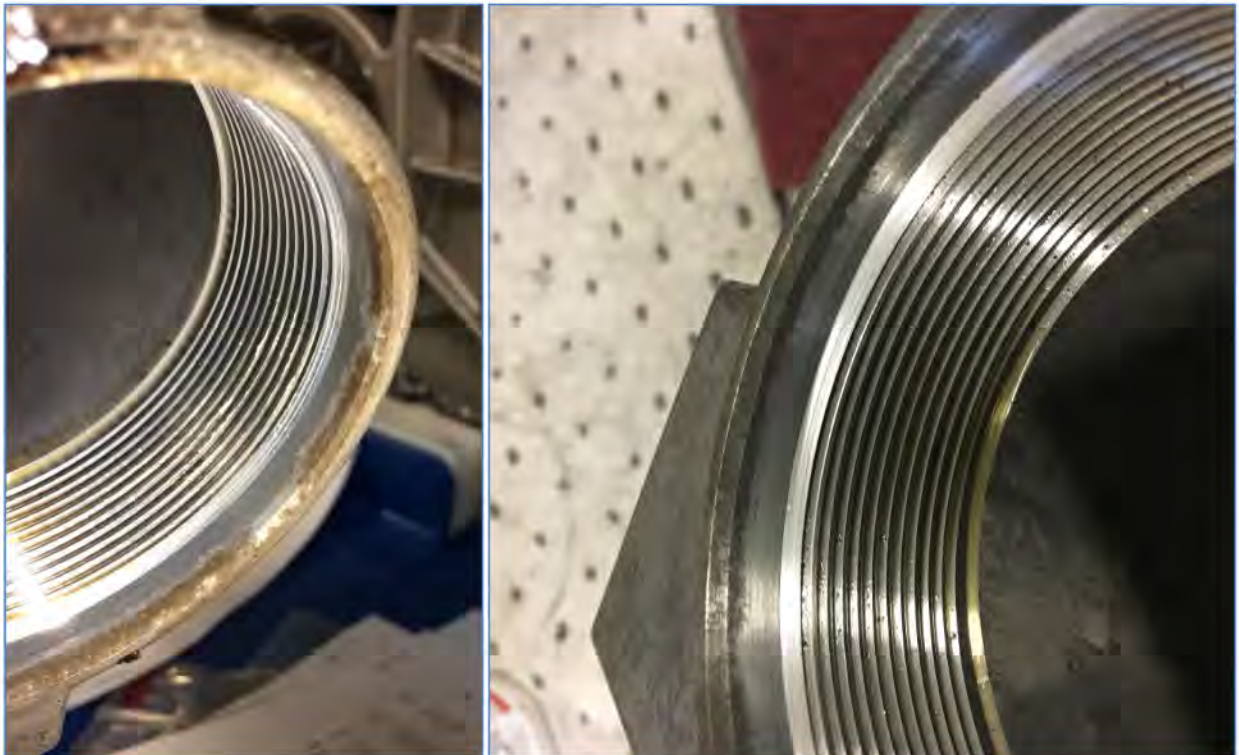
Filter housings that show normal dirt build up (left image) can be cleaned with a Scotchbrite pad or equal. Some residual staining of the aluminum housing (right image) may still be present after cleaning. Clean the threads and sealing surfaces before reassembly. Apply a small amount of silicone grease that meets the specification below on the o-ring, filter housing sealing area and the cap flange below the o-ring prior to assembly to help seal out moisture and dirt. There must be enough grease present to allow squeeze-out under the flange so the dirt and moisture is sealed out of the area of concern. Clean the filter cap of any excess grease squeeze-out after assembly to prevent giving false impression of a leak.

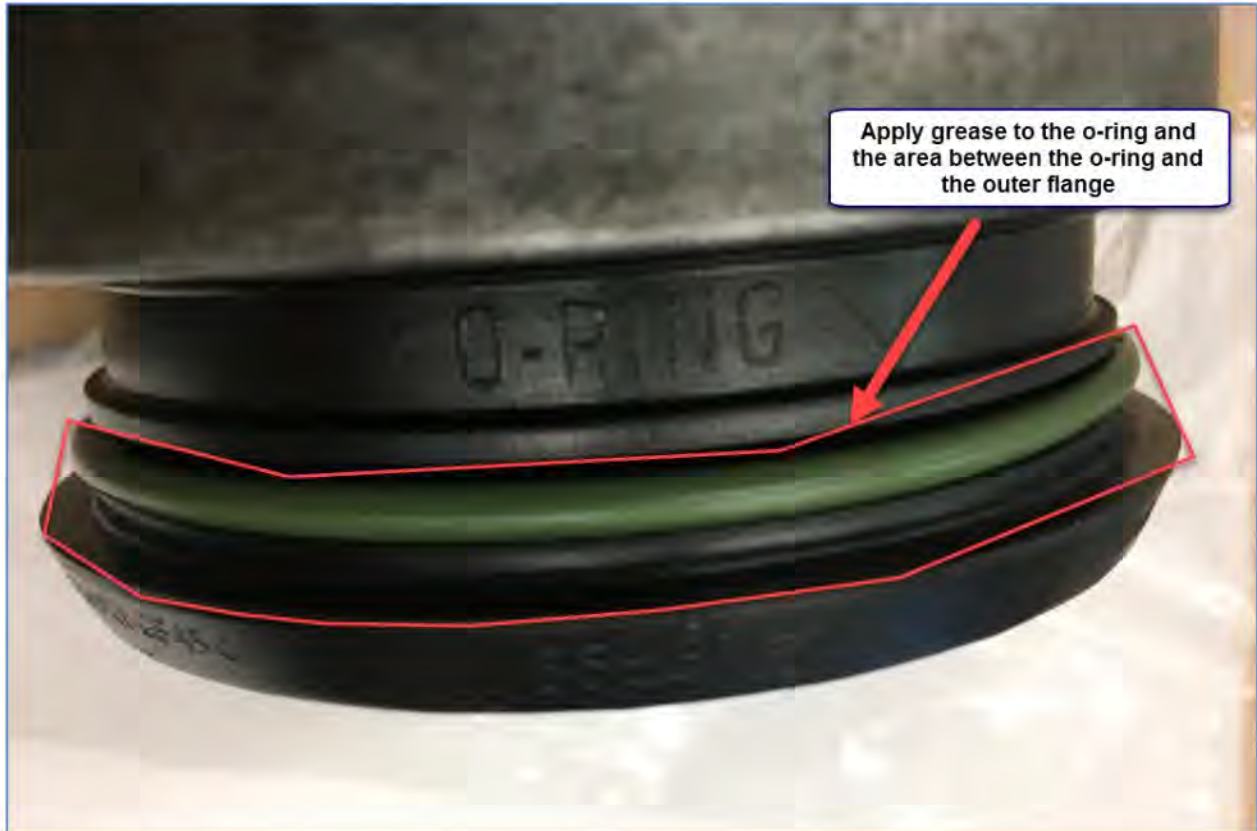
Silicone grease

Base	Silicone
Consistency	NLGI 2
Thickener	Lithium soap
Temperature range	-70°C to +160°C

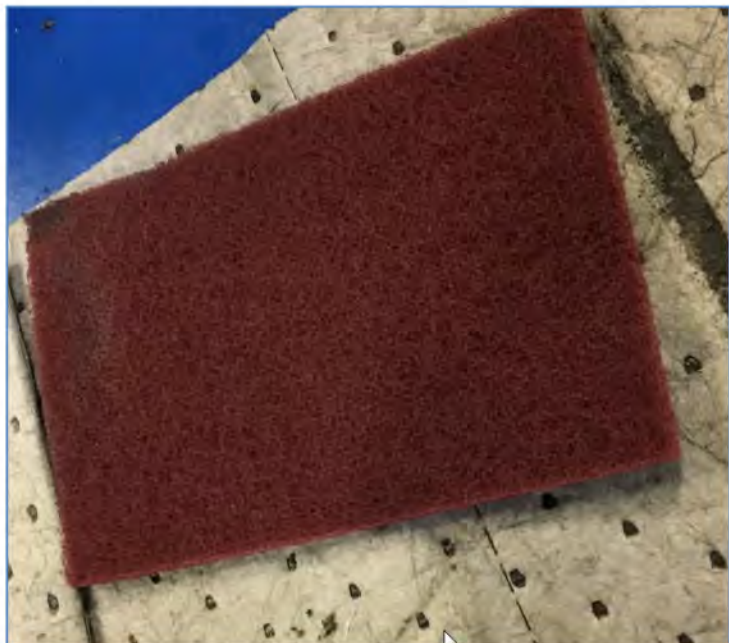
Approved cleaning pad red or green Scotchbrite pad or equal.
