Generator Baggage Door Ventilation

Bulletin Type:	SRP	
Bulletin #(s):	22-061	
Job Code(s):	If affected unit has warranty	
Flat Rate(s):	remaining, submit your claim following the normal process

Publication Date:	July 2022
Make(s):	Jayco & Entegra Coach
Model(s):	Alante and Vision with 4K Generator
Model Year(s):	2021-2022

Incident:	4K Generator drawing engine heat from below and shutting down
Affected Units:	Certain 2021-2022 Jayco Alante & Certain 2021-2022 Entegra Coach Vision
Parts List:	(8) RIVET,.19X01.00 AL BLK W/RBR SEAL (Jayco Part #0308359) (1) BOOT,4KY GEN AIR INTAKE INR+OTR ADJ (Jayco Part #2016837) (1) Generator Door (Contact Jayco Customer Service Parts Department) (1) Graphic (Contact Jayco Customer Service Parts Department)
Misc. Tools & Supplies:	Drill with 3/16" Drill Bit Rivet Gun Measuring Tape

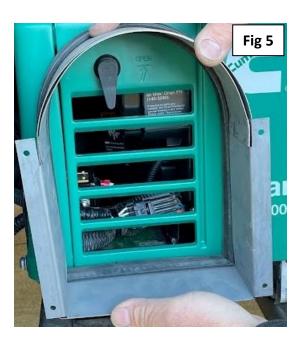
- 1. Install the new generator door with 2 to 3 screws into each side. Please test door to see if closes completely.
- 2. Continue with opening the generator door and holding the air intake up to the generator as shown in Figure 5.
- 3. The correct location would have the gasket seal touching the generator and surrounding the generator intake. Verify the gasket seal touches the generator.
 - A. NOTE: The outer flange of the air intake can adjust outwards if needed.
- 4. Drill (4) 3/16" mounting holes through interior metal of the generator door. (Figure 4 marked with orange arrow)
 - A. NOTE: Drill bit must not go through exterior skin.

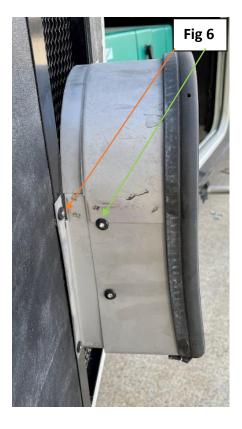
5. With rivet gun, secure the air intake to the back of the baggage door at (4) locations (Figure 6 marked with green arrow).

6. Close door and verify that the rubber gasket touches the generator and the door can still close (Fig. 7). Complete the installation of the generator door by installating the handle and graphic. Contact Jayco Customer Service Parts Department for the
