2018-2022 Odyssey: Sliding Door Power Window Reverses During Auto-Up Operation

AFFECTED VEHICLES

Year	Model	Trim	VIN Range
2018–22	Odyssey	ALL except LX	ALL

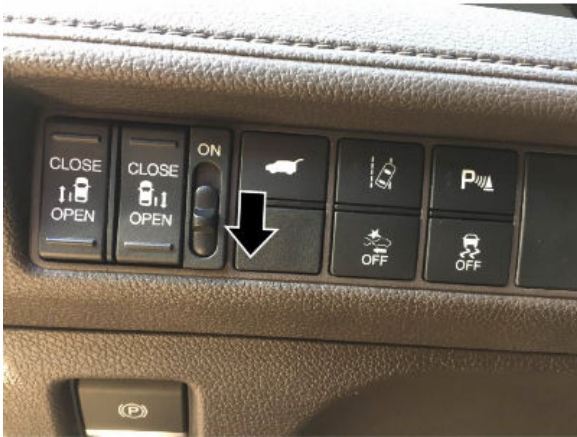
1. Slide the switch down to turn OFF the power sliding door.

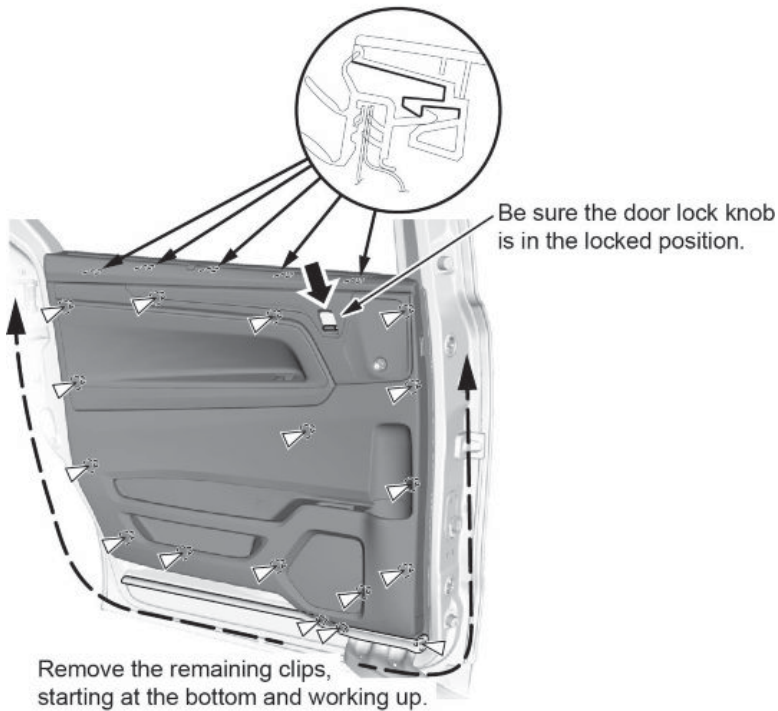
5. Start at the bottom edge of the door panel, and remove the remaining clips with a commercially available trim pad remover.

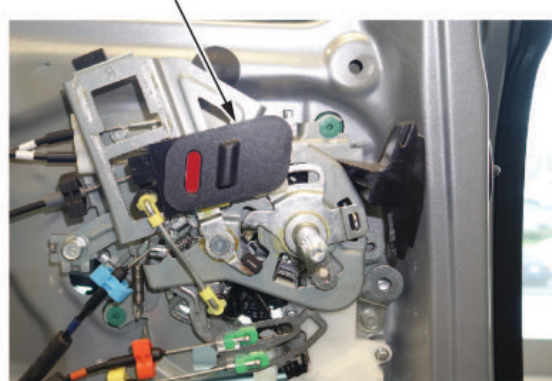
Door lock knob is disengaged.

8. Make sure the door lock knob properly engages the bracket. If it is disengaged, disconnect the rod from the slider, reinstall the slider, then connect the rod.

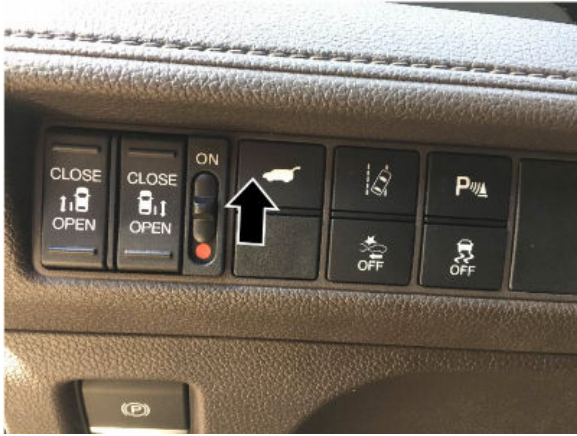
11. Slide the switch up to turn ON the power sliding doors.
