June 28, 2022

Version 2

Driver's and Front Passenger's Seat-Back Clicks or Pops

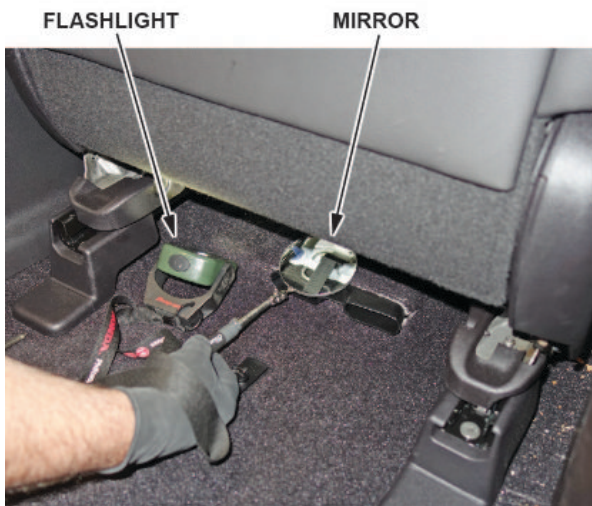
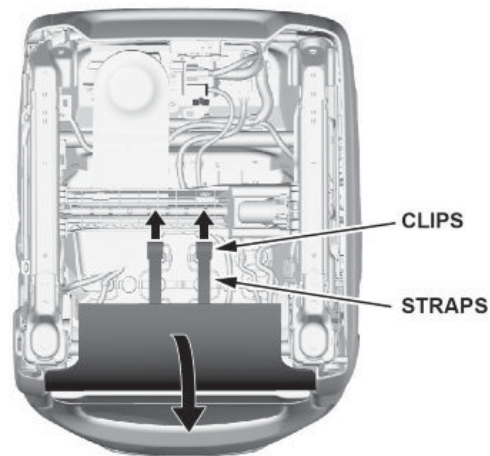
1. Move the seat all the way forward and to its full height position. This will give you more room to work.
2. Use a mirror and flashlight to locate the two straps attached under the seat. Then, unclip the straps.

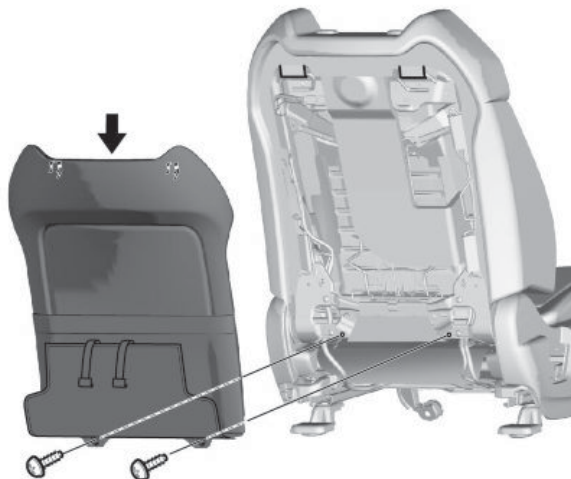
3. Remove the two screws, then pull down the back panel.

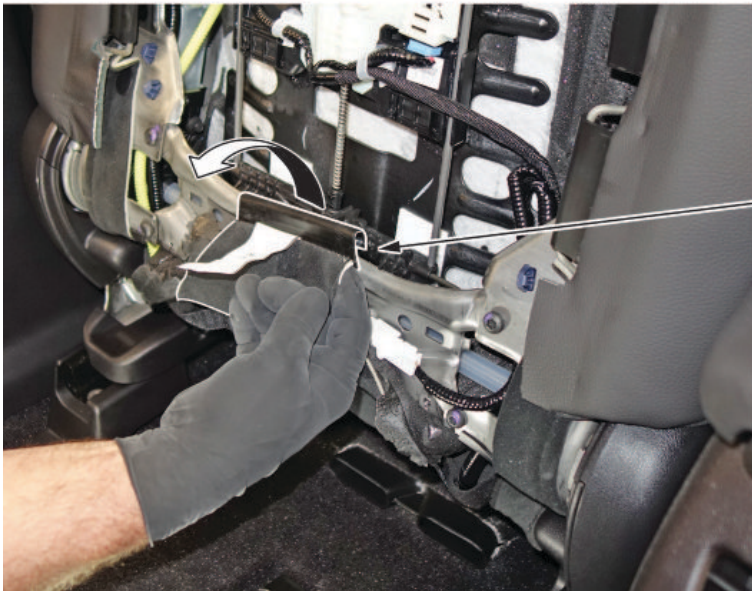
BLACK PLASTIC
SEAT COVER CLIP

4. Remove the black plastic seat cover clip to expose the lumbar contact area of the seat frame.

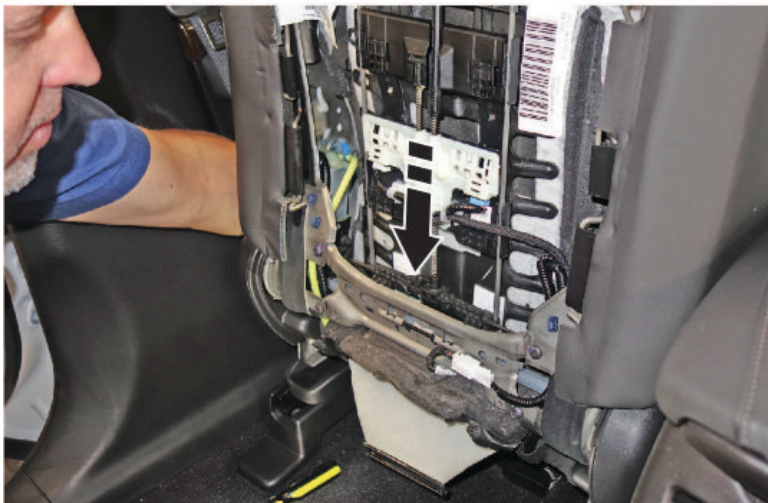
5. Using the power seat adjustment switch, move the lumbar support to its fully retracted, flattened position. Then, lower the lumbar support all the way to gain easier access to the area shown below.

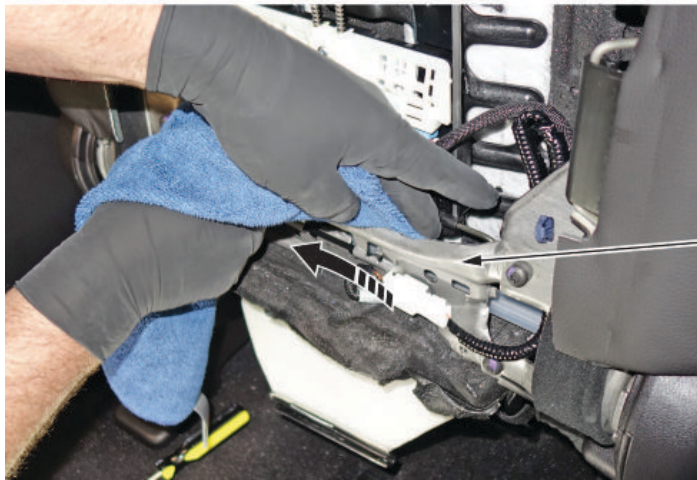
The plastic lumbar adjustment mechanism contacts the metal seat frame.

6. With a clean cloth, wipe down the area where the plastic lumbar support contacts the seat frame.

METAL SEAT FRAME
Clean the inside surface.

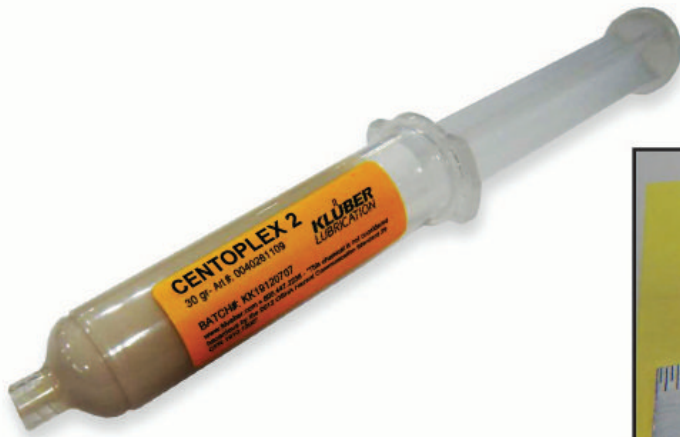
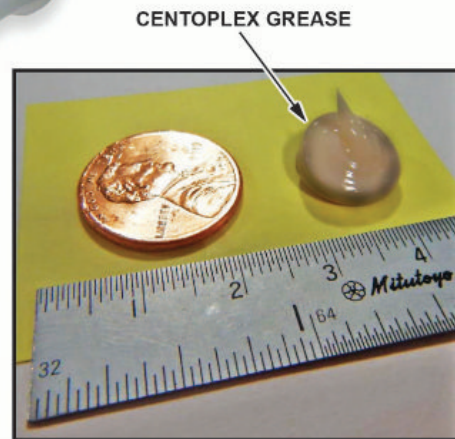
7. Measure out two penny-size dabs of Centoplex grease onto a clean piece of cardboard or paper.

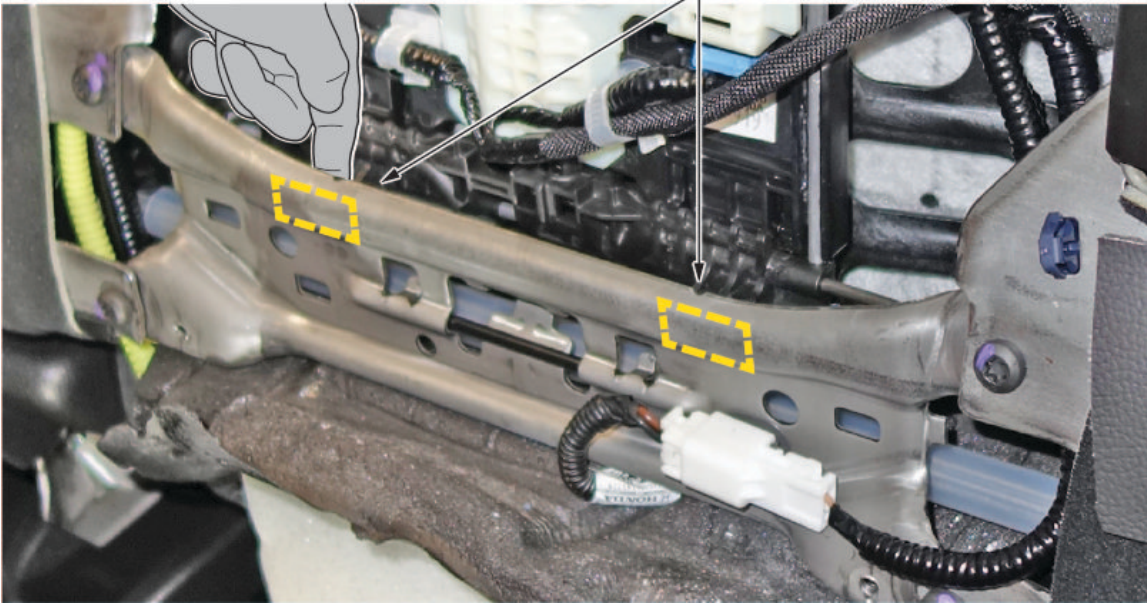
8. While wearing gloves, apply each dab with your finger to the locations shown. Be sure to spread the grease evenly over the frame.

Apply grease to two locations on the inside of the frame.

Apply Kluber Centoplex 2 grease where the plastic lumbar adjustment mechanism contacts the metal seat frame.

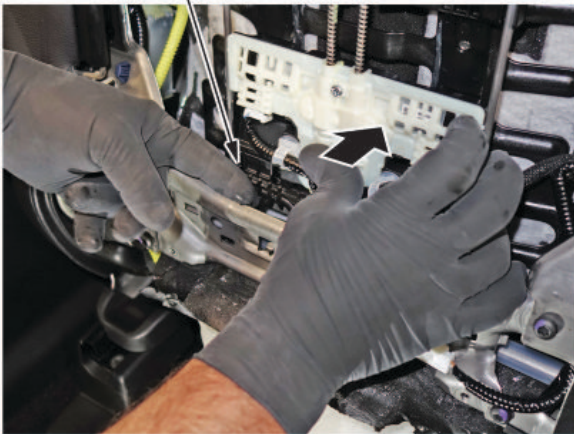
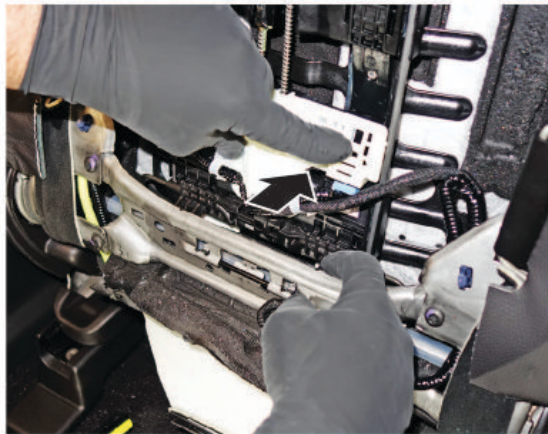
Apply the grease with a gloved finger.

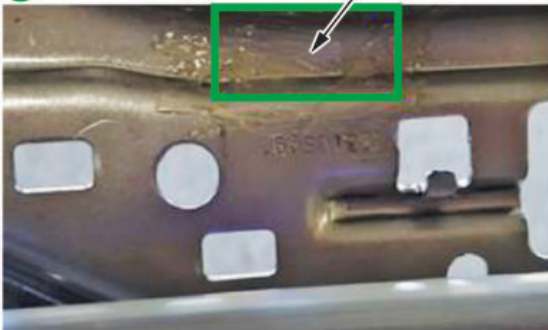
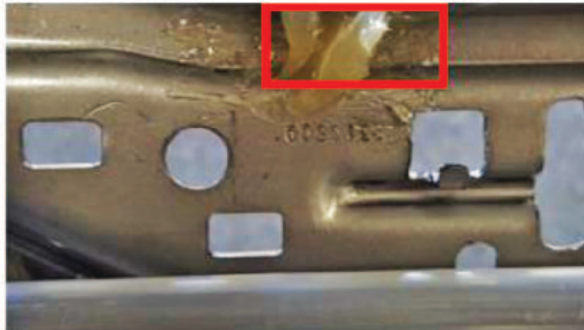
GOOD

Spread the grease evenly.

NO GOOD
