# INSTRUCTION TO SERVICE

ITS: 60401		06/20/2022
<b>SECTION:</b>	526 Seating	
<b>WRITTEN BY:</b>	Kalman Takacs	
<b>SUBJECT:</b>	Tighten hardware / Replace rivets on upper deck cantilever seats if required	
<b>ISSUE:</b>	Cantilever seats on upper deck may move	
<b>SUMMARY:</b>	Repair seat securement per this ITS.

# ITS60401

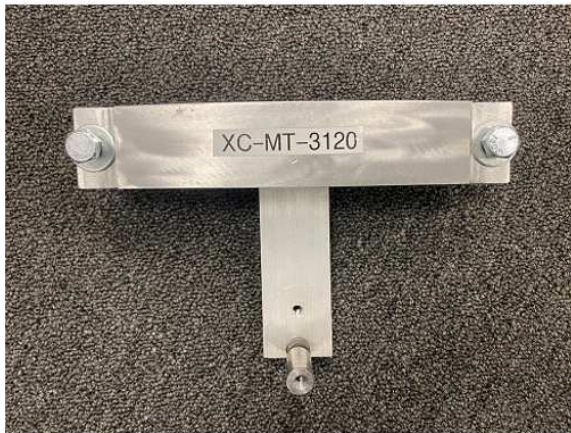
**Figure 1: Bracket to attach force gauge**

1. Turn the main battery disconnect switch to the “OFF” position.
2. On the cantilever mounted seats located at the upper deck, check the seats for tightness according to the followings:
  - a. Attach the bracket # XC-MT-3120 to the bottom seat frame. Refer to Figures 1 and 2 below.

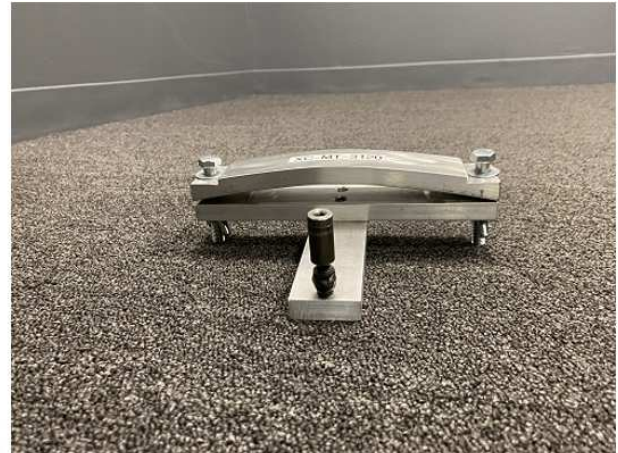
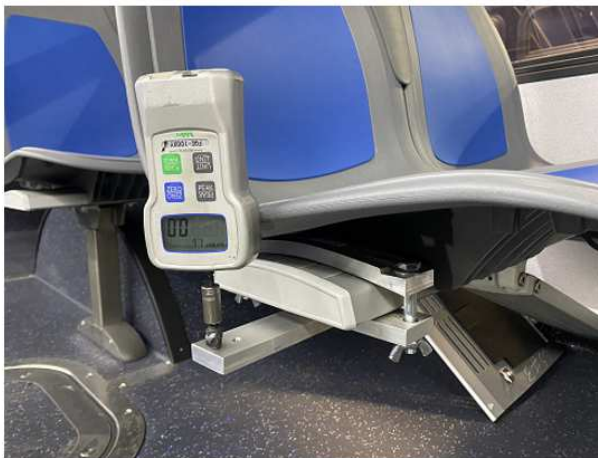
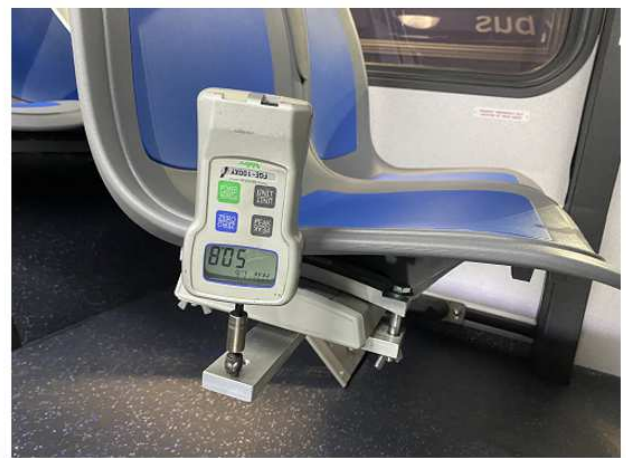
**Figure 2: Force gauge is attached**

- b. Attach force gauge to the end of the bracket. Refer to Figure 2.

- c. Push down the gauge until it shows 50 lbs. Then pull up gauge until it shows 50 lbs. Refer to Figure 2.

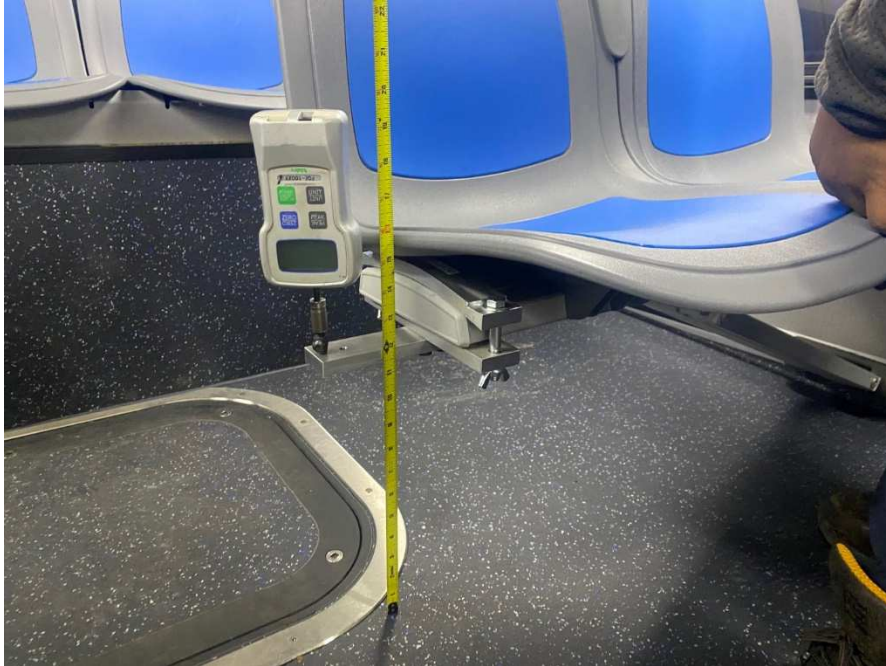
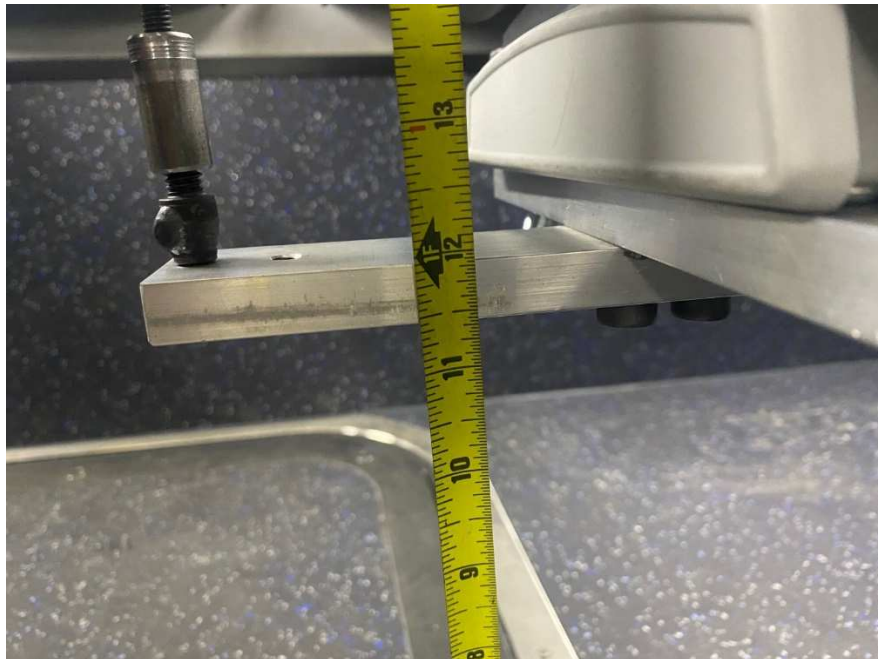
**Figure 3: Measure movement (if any)**

- d. Less than  $\frac{3}{8}$ " of movement at the aisle end allowed at 50 lbs. push and 50 lbs. pull force. Use a helper to measure the movement with a tape measure. Refer to Figure 3.

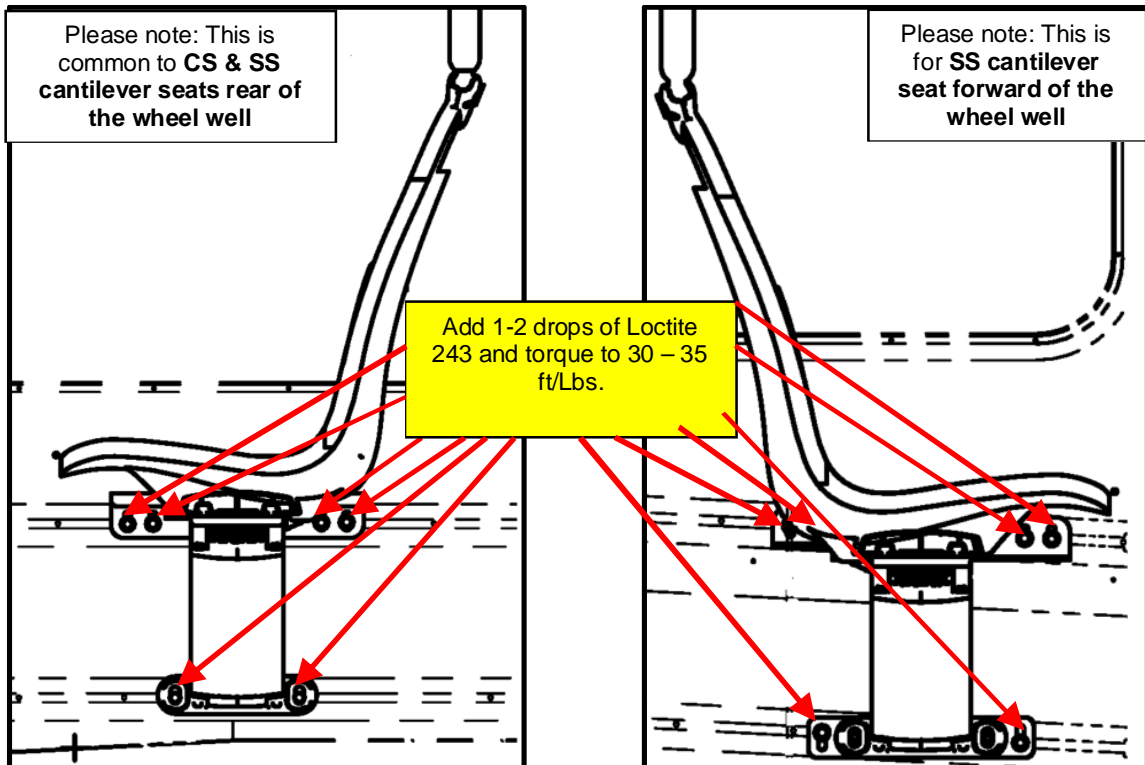
Figure 4: Check Mounting Hardware & Torque to Spec if Required

- a. Check the mounting hardware of the seat and make sure it is tight and torqued to spec. Locations of the hardware to check with torque specs are shown in Figure 4 and 5. If the hardware is not torqued to spec, add 1-2 drops of Loctite 243 (NF PN **081034**) and torque hardware to spec and check the seat for tightness again.

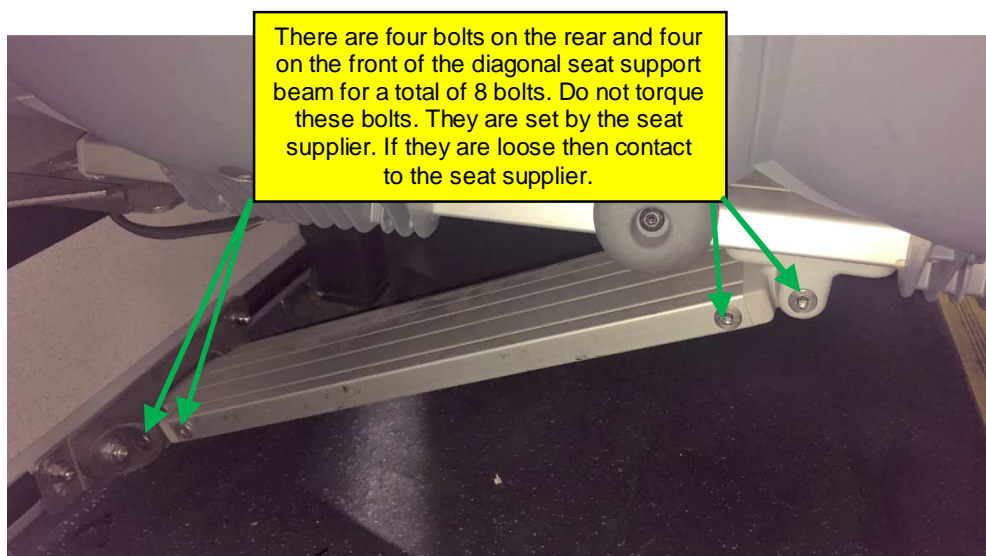
Figure 5: Diagonal support beam joint-bolts

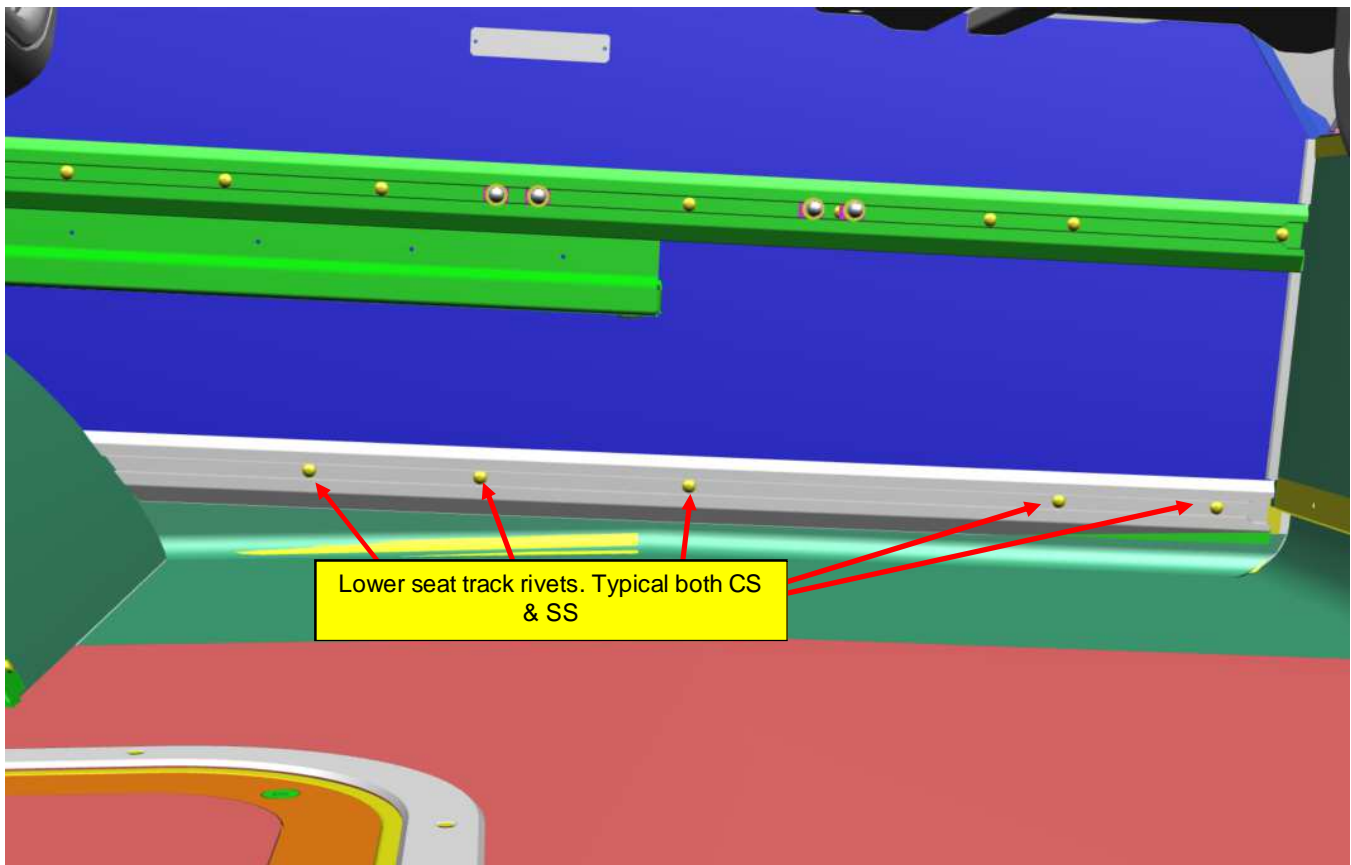
**Figure 6: Lower Seat Track Rivets (Typical CS & SS – Seat Removed from Picture for Clarity)**

7. If seat is still moving more than 3/8" then inspect the lower seat track for tightness. This seat track should have no excessive movement between itself and the wall. A slight flexing is normal when a helper is pulling the aisle end of the seat upward. This pull up load doesn't happen in service; the load (the weight of the seat and passengers on seats) is pushing the seat track against the side wall structure. If the lower seat track is noticeably loose, inspect rivets for tightness. Refer to Figure 6 for affected rivets and to Figure 7 for example issues need to verify on rivets.

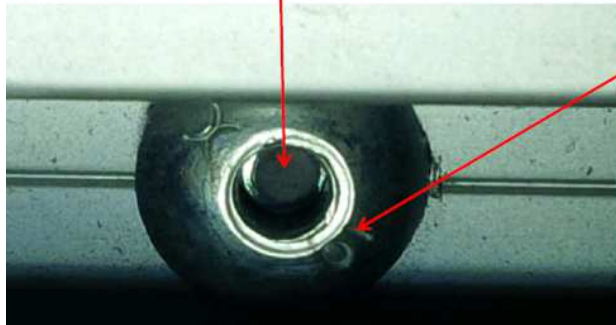
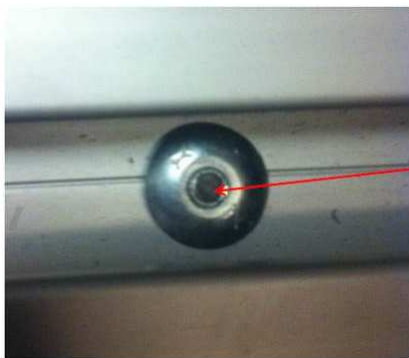
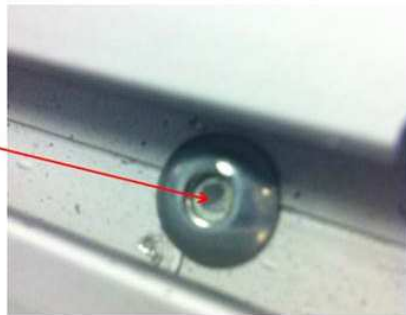
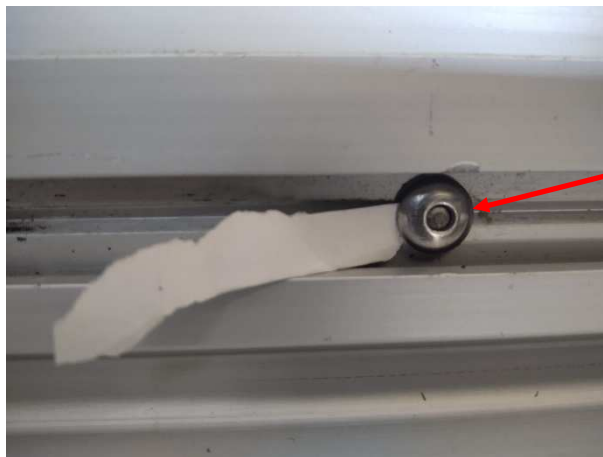
Mandrel is pushed in- incorrect

Head of rivet marked with X10 - correct

Correctly installed rivet, the mandrel is flush with the top of the rivet.

Incorrect rivet that may be present, This is a monobolt, it has no markings on the head, and should not be present on any buses.

Gap between the seat track and the head of the rivet (rivet is loose)

**Figure 7: Rivet inspection**

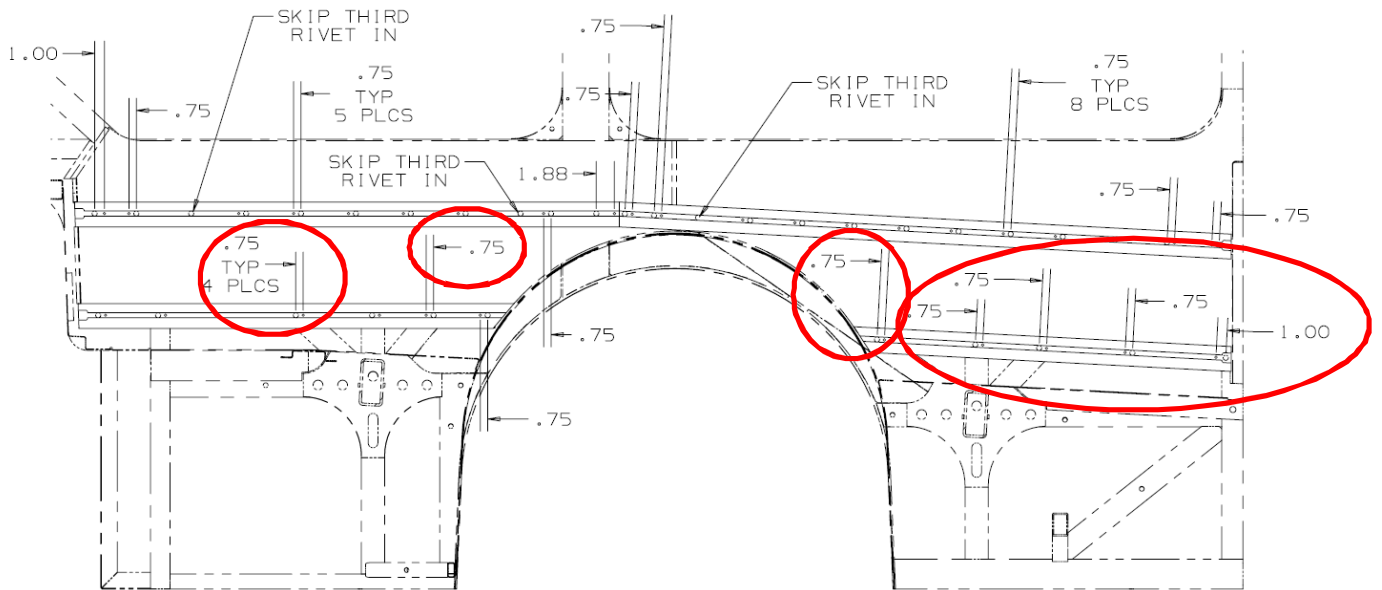
**Figure 8: Installing additional rivets (as many as required) to the street side seat track**

- 8. If lower seat track is loose then drill new hole by using a 17/64" DIA size drill bit ¾" or 1" from any existing nonconforming rivets according to the drawings below.

**Note:** do not remove seats to add rivets to the lower seat track. The weight of the seat is helping to push the lower seat track against the side wall structure.

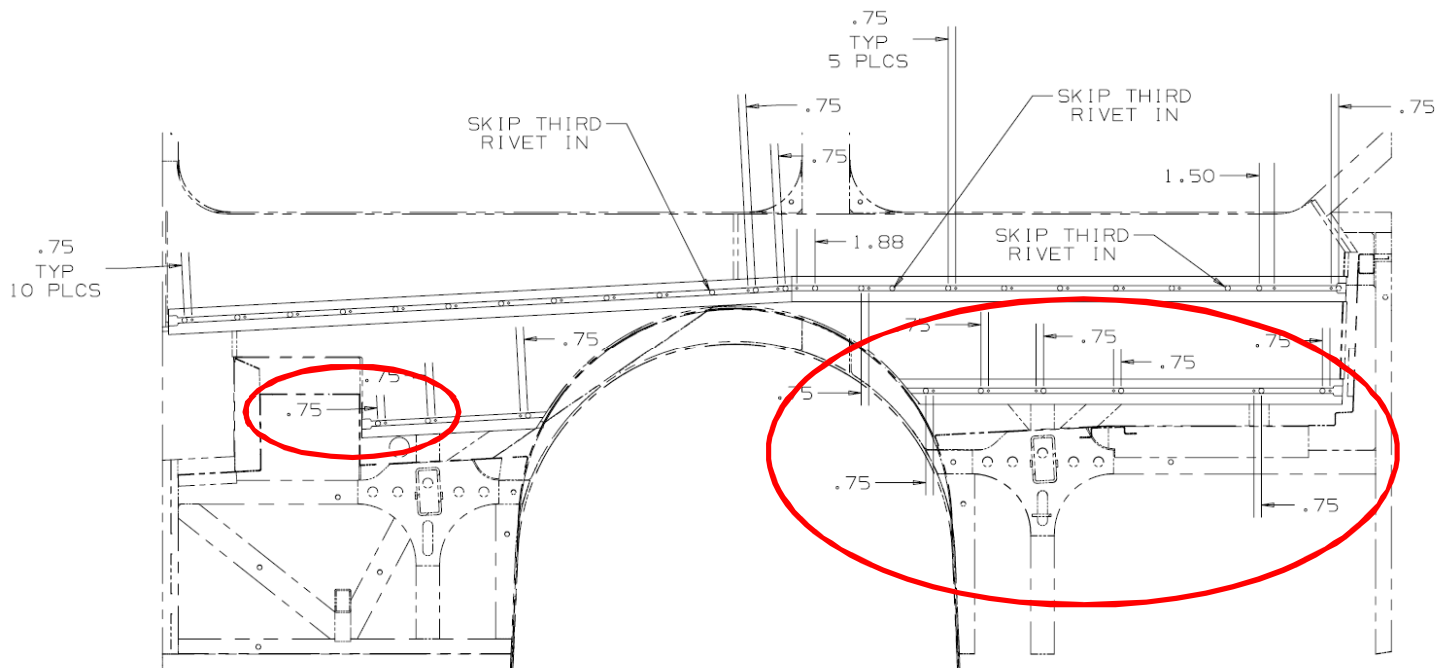
**Figure 9: Installing additional rivets (as many as required) to the curb side seat track**

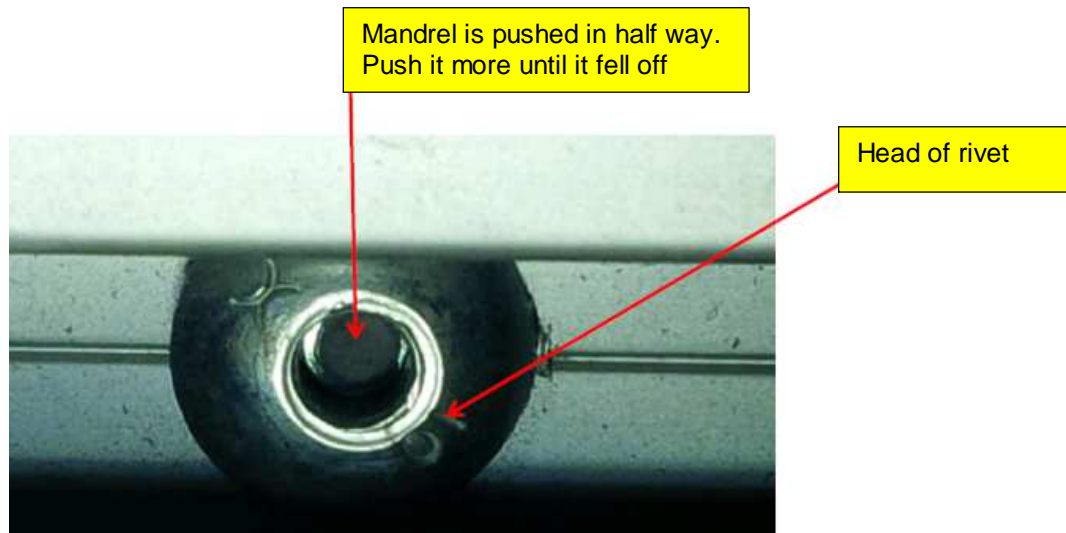
**Figure 10: Rivet mandrel**

11. If the lower seat track has to be removed for any reasons, then remove seats and carefully drill out the rivets in the lower seat track according to the followings:
12. Use a pointy center-punch and hit the center of the mandrel out of the rivet. Refer to Figures 10 and 11.

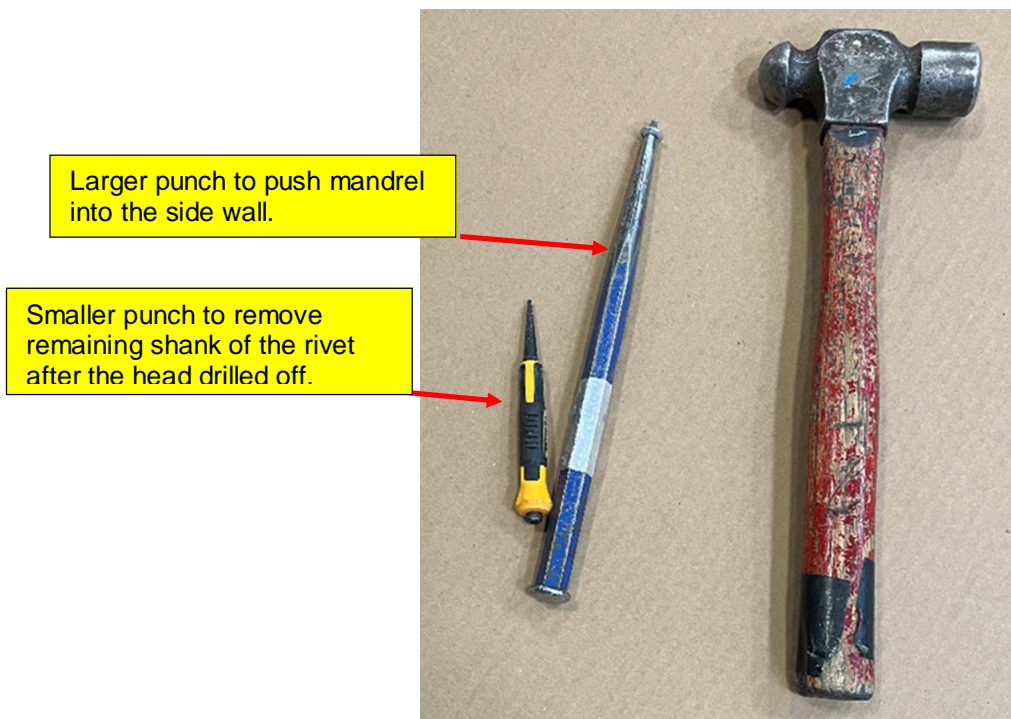
**Figure 11: Tools to remove rivets (drill bit is not shown)**

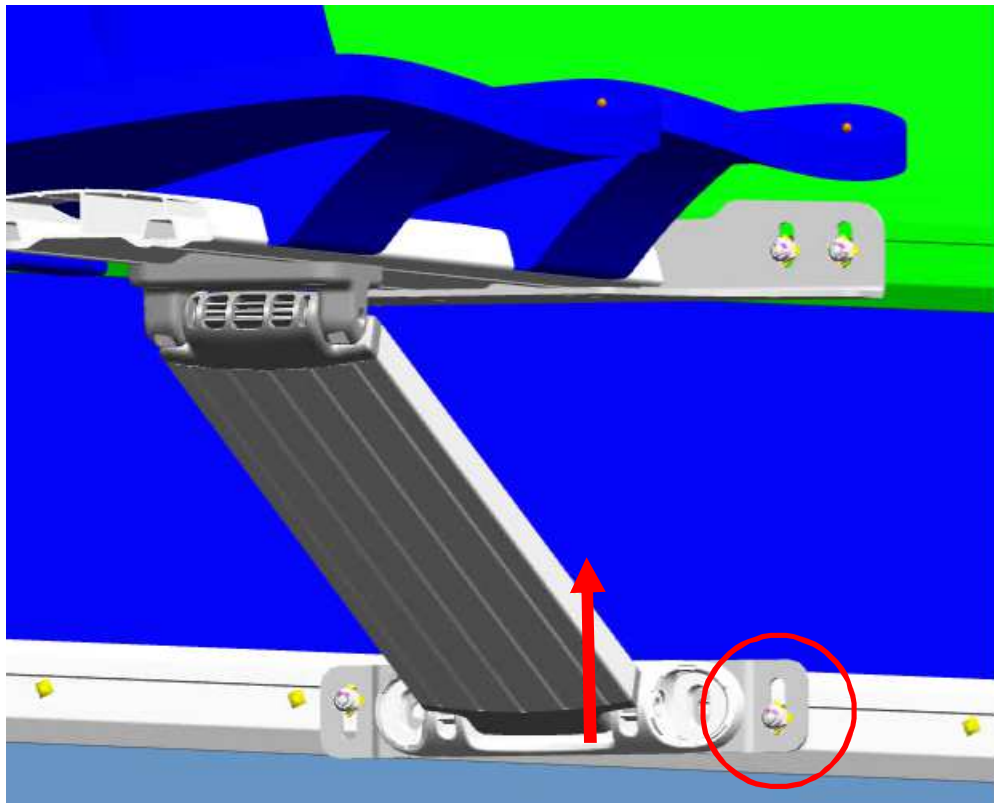
**Figure 12: Push diagonal support beam all the way up**

16. Reinstall seats and torque mounting hardware per Figure 4. Ensure the diagonal support is pushed all the way up per engineering drawing. Refer to Figure 12 below.
