Service Bulletin

Bulletin No.: 22-NA-131

Subject: Accessory Lighted Sill Plate Does Not Illuminate or Intermittently Illuminates

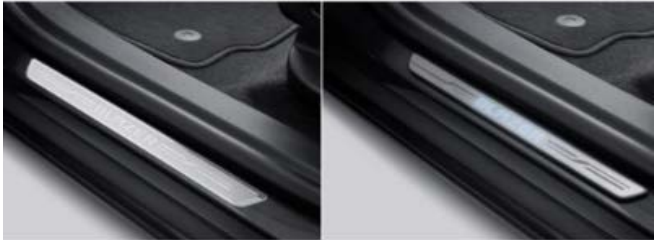
</div> <p style="text-align: right; font-size: small;">6100224</p> <p>The customer may experience an Accessory Battery Powered Illuminated Sill Plate that does not illuminate or intermittently illuminates.</p>
Cause	This design is very sensitive to door fit and interference of magnetic current could cause the Accessory Lighted Sill Plate not to illuminate and parts have been discontinued.
Correction	<p>Confirm vehicle LPO/RPO S0M/VST and inspect to confirm the sill plates do not illuminate.</p> <p>No Repairs need to be performed.</p> <p>Reimburse the Customer the cost of the Illuminated Sill Plates, as per the table below, and leave the parts in place.</p>
