TECHNICAL SERVICE BULLETIN

2021-2022 Bronco - Soft Top Roof – Excessive Wind Noise, Loose Cover, And/Or Difficulty Latching

22-2296

Ford 2021-2022 Bronco

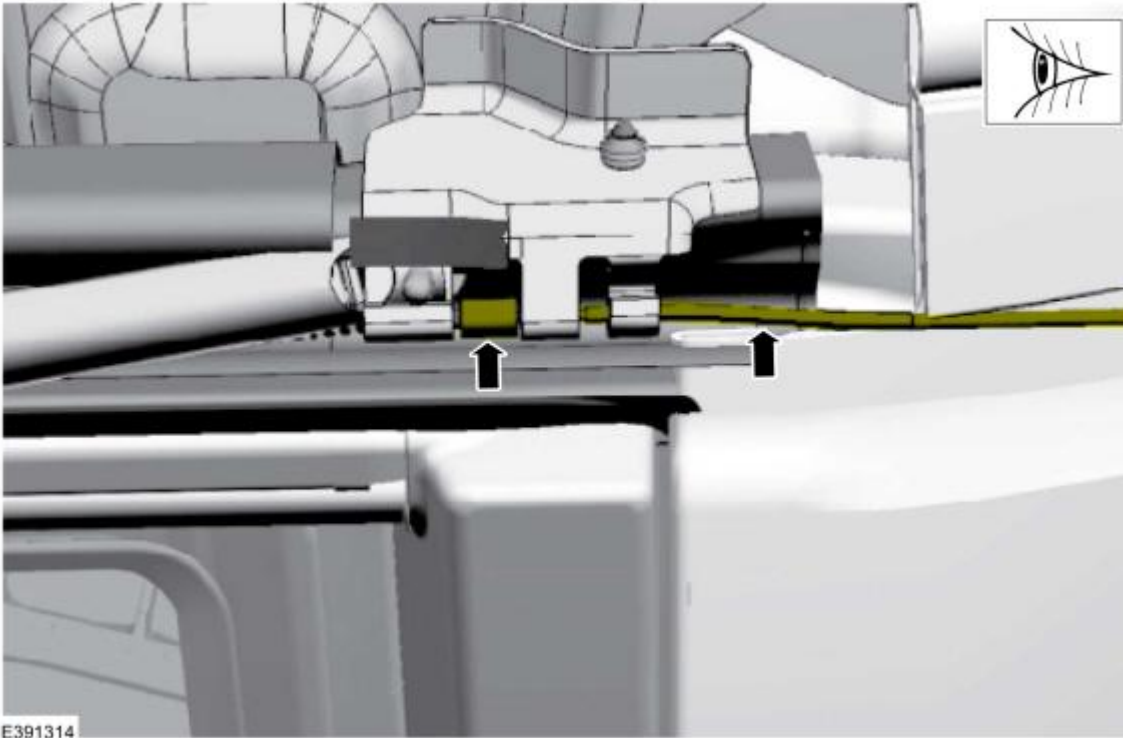
Figure 6 - Left side shown, right side similar

(2). Inspect the rear tension cable lobe position inside the bracket. The tension cable lobe should be secured in the most vehicle-forward position. The tension cable should not be loose or easily removable. Adjust or repair as necessary. (Figure 6)

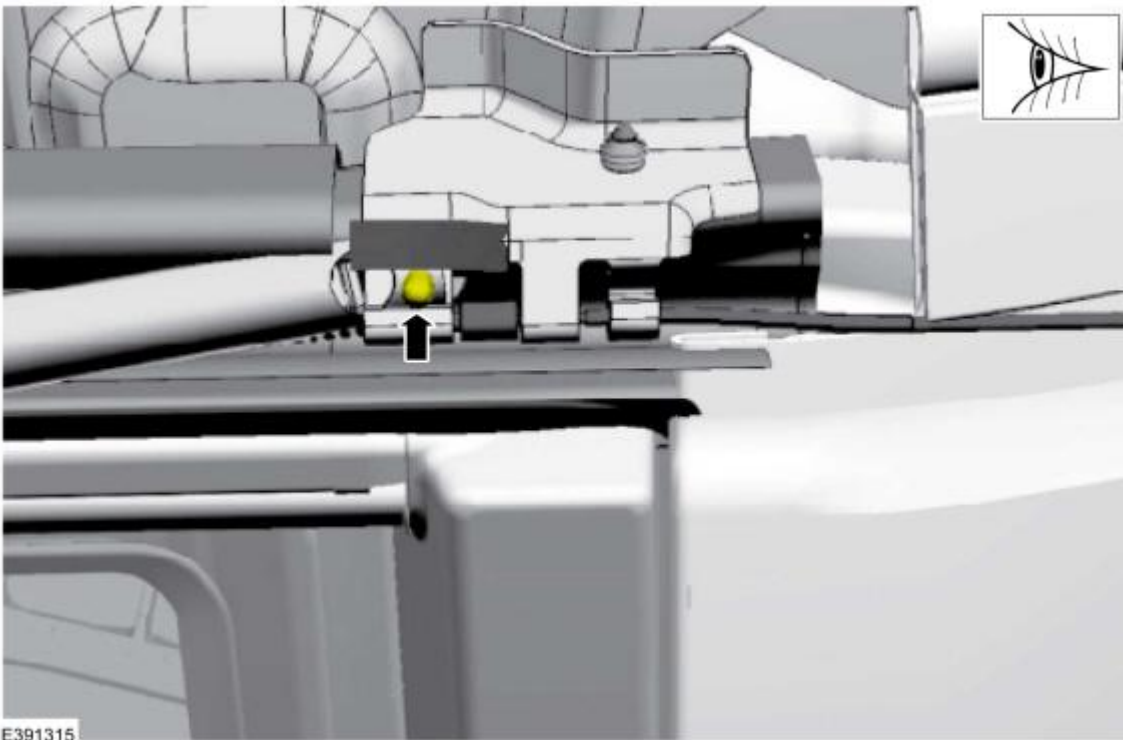
Figure 7 - Left side shown, right side similar

(3). Inspect the rear tension cable spring for proper attachment to the bracket. Adjust or repair as necessary. (Figure 7)

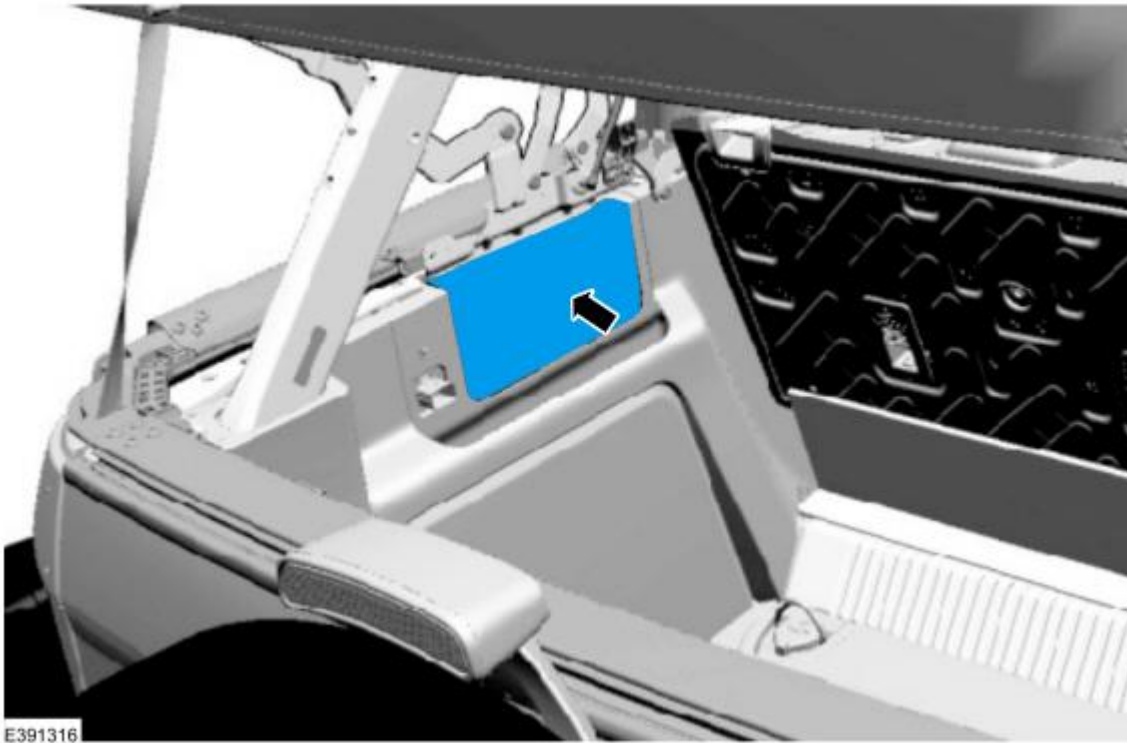
Figure 8 - Left side shown, right side similar

(2). Remove both access covers to gain access to the 6 bolts (3 on each side) that secure the soft top frame to the body. (Figure 8)

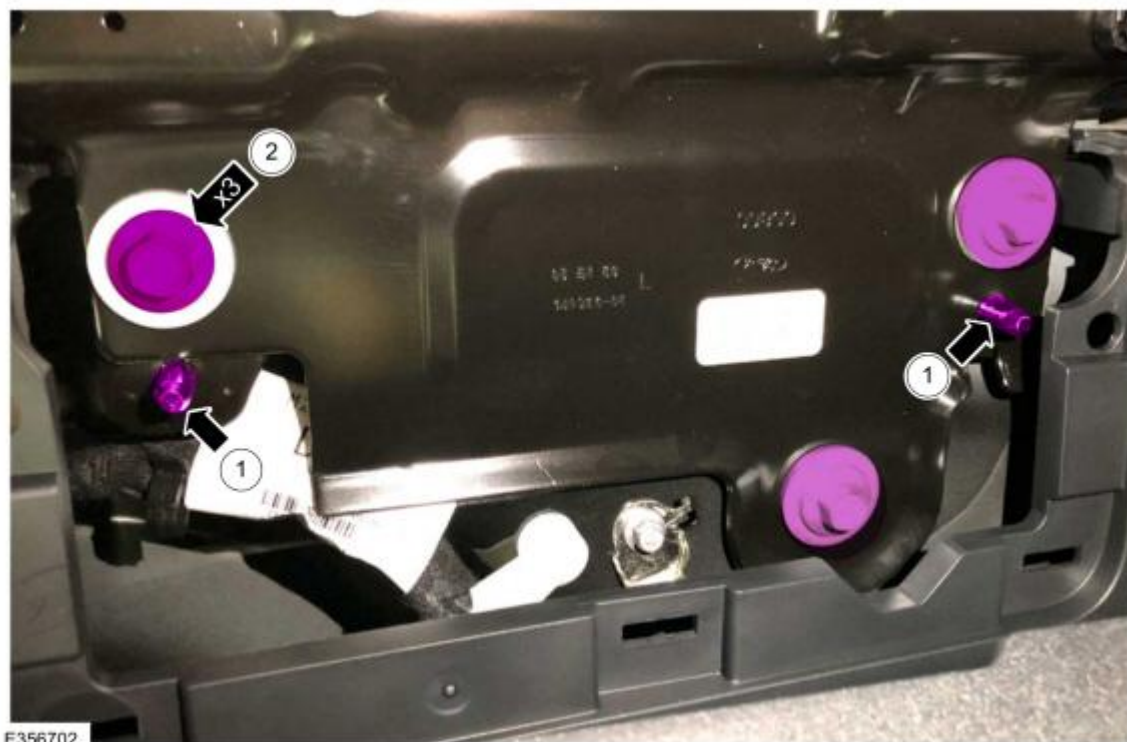
Figure 9 - Left side shown, right side similar

(3). Loosen all 6 soft top assembly mounting bolts (3 on each side) just enough to allow the soft top assembly to shift. (Figure 9, Callout 2)

(4). Starting on the left side, pull the soft top frame down so that it is contacting both dowels on the body (Figure 9, Callout 1) then tighten all 3 soft top assembly bolts to 106 lb.in (12 Nm) (Figure 9, Callout 2). Repeat this step on the right side. Before proceeding, make sure both sides of the soft top frame are contacting the dowels. Repeat this Step as needed to make further adjustments.

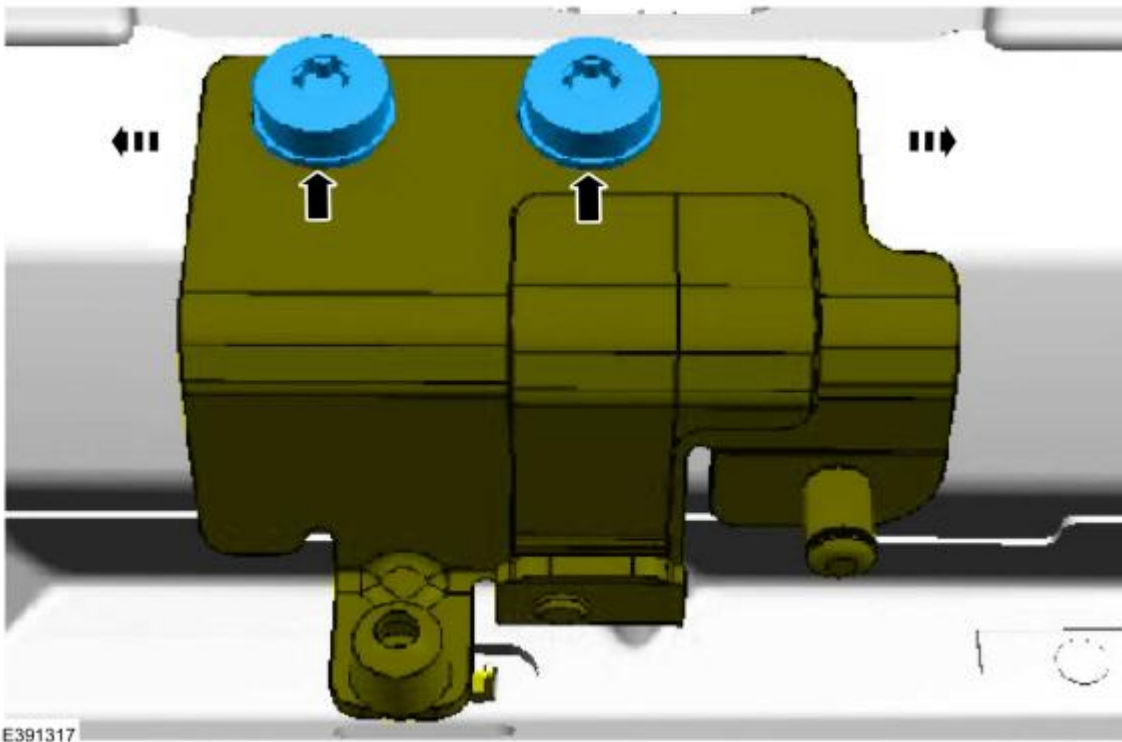
Figure 10 - Left side shown, right side similar

(2). Loosen the two bolts on each middle latch striker allowing them to shift in place. (Figure 10)

- Starting on the left side, find the correct position for the striker by operating the middle latch and slowly lifting and lowering the soft top until smooth operation is achieved with both latching and unlatching.
- Be sure the latch sits tight enough to the striker that it cannot be disengaged without operating the latch.
- Once the proper location of the middle striker has been achieved, tighten the middle latch striker bolts to 15 lb-ft (20 Nm).
- Repeat Step 10(9) on the right side. (Figure 10)

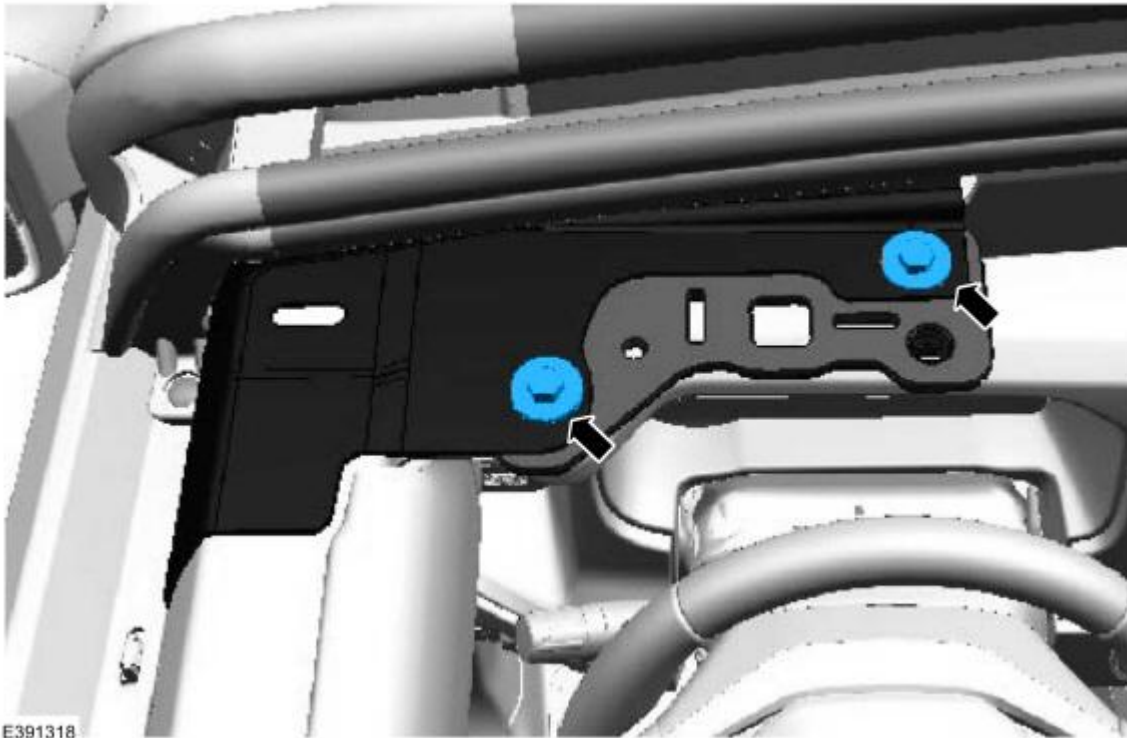
(4). Loosen the two bolts on each front latch striker allowing them to shift in place. (Figure 12)
 Figure 12 - Left side shown, right side similar

(6). Hand tighten the front latch striker bolts temporarily holding the strikers in place. These can be accessed using fingers from inside the vehicle.

(8). Tighten the front latch striker bolts to 15 lb-ft (20 Nm).
