GROUP	MODEL
CHA	2022MY Forte (BD/BDm)
NUMBER	DATE
115	July 2022

TECHNICAL SERVICE BULLETIN

SUBJECT: **SERVICE ACTION: BRAKE PEDAL ASSEMBLY INSPECTION AND REPLACEMENT (SA501)**

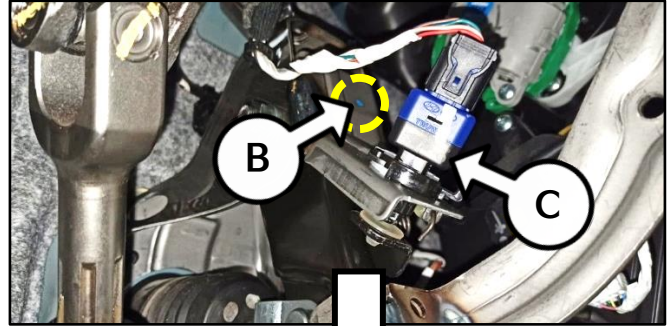
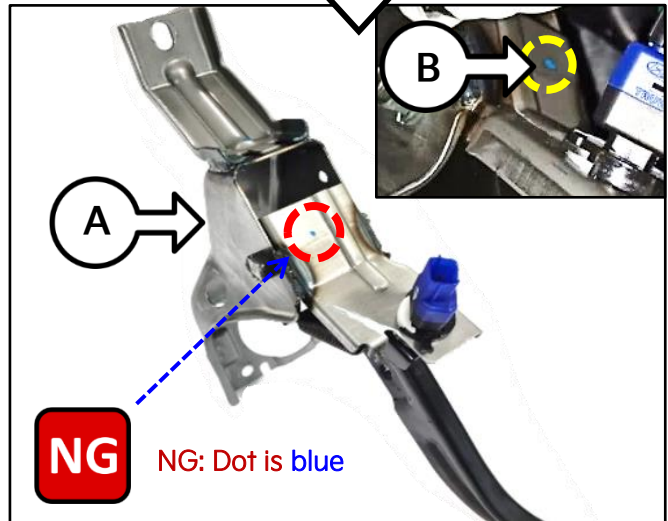
- 1a. Locate the brake pedal assembly (A) and look for a painted blue dot (B) on the flat surface of the brake pedal assembly bracket, above the brake pedal switch (C) where shown.
- 1b. Identify the color of the dot on the area shown:
 - **Blue (NG):** Proceed to the 'Replacement Procedure' below to replace the brake pedal assembly.
 - **Other color (OK):** If the dot is any color other than blue, this service action is complete. No further action is required.
