MAS003140 (MTB 22-17)  
Technical information  
From: After Sales - TSO  
To: Maserati Network

## Oil leakage from the front axle lifting hydraulic system

DATE: JUNE 6 2022

**SECTION:** 06.25 - 1 HYDRAULIC SYSTEM FRONT AXLE LIFT

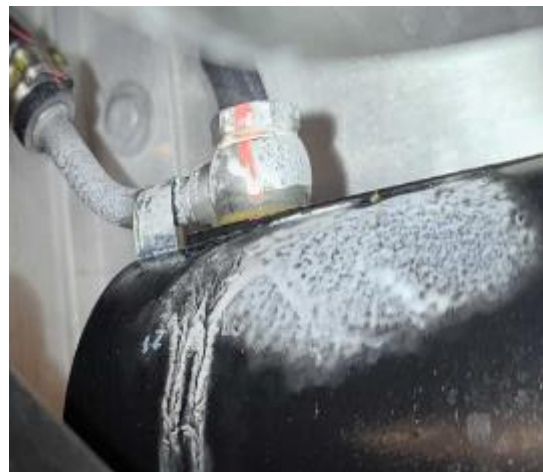
Picture 2

6. Take pictures of the Banjo Bolt and Lifter pump again. (Example pic. 2)
7. Open a BOL as "SUPPORT REQUEST" and attach, and report all the information collected throughout all the above checks including the "before" and "after" pictures.
