Subject: N222362090 - Customer Satisfaction Program
High Voltage Connector Backing Plate Corrosion

Models: 2022 BrightDrop EV600
2022 GMC HUMMER EV

N222362090 High Voltage Connector Backing Plate Corrosion

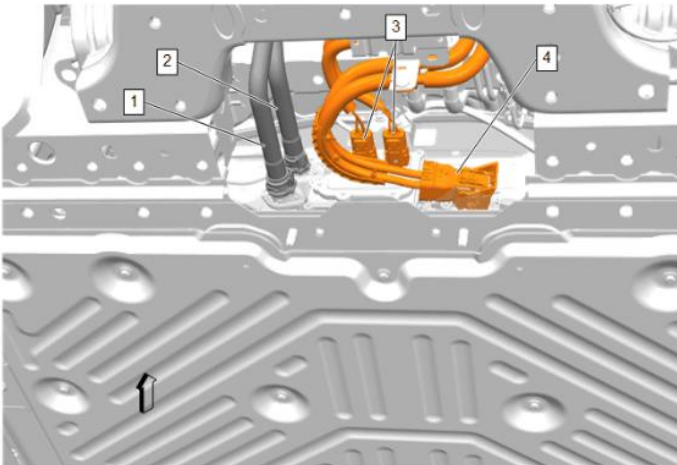
5792975

7. Disconnect the front electrical connector (4).

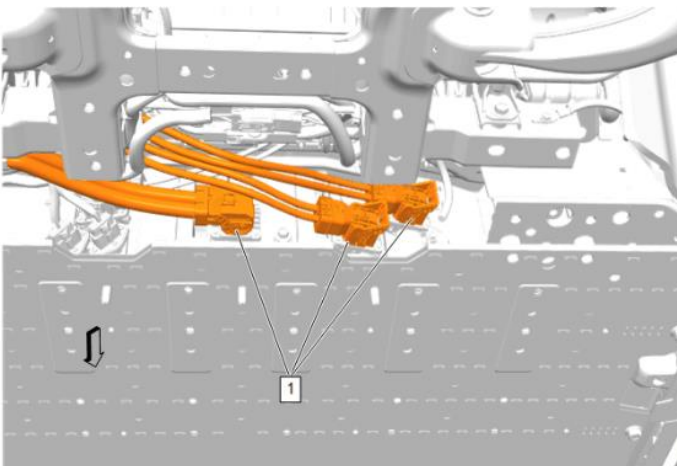
5793519

Note: The BrightDrop EV600 has only one electrical connector in the below graphic. The two EV headers on the right side have empty connectors installed. Remove all three connectors and seal all three EV Headers following the instructions below.

8. Disconnect the rear electrical connectors (1).

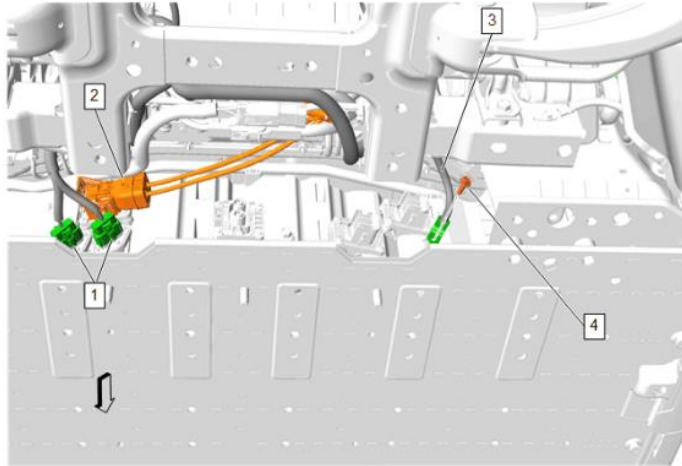
5821160

Note: On BrightDrop EV600 vehicles, it is not necessary to disconnect the #1 connectors in the step below.

9. Disconnect the rear electrical connectors (1 and 2).

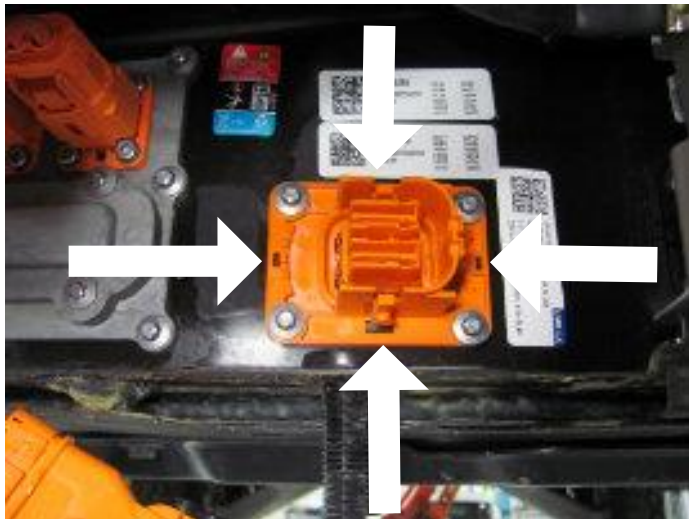
6124640

10. Using a general-purpose body solvent, such as Kent Industries Acrysol (or the equivalent) thoroughly clean the area around the five HV headers to be sealed (four in the rear, and one in the front). Use care to make sure all the area is clean to the base material. Due to restricted access, the use of a cotton swab or dauber is recommended. Dry the sealing area.
11. Cut the tip of the RTV Engine Sealant applicator to a size that will dispense 6.5mm (1/4in.) bead of material.

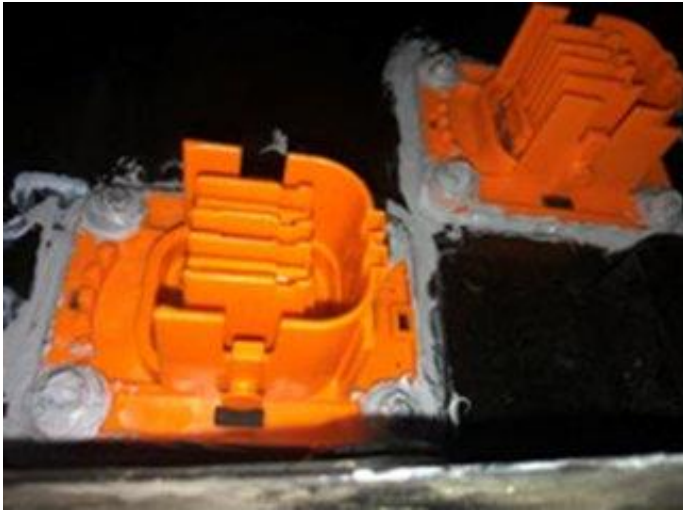
6124642

12. Carefully seal the perimeter of the HV header and the four mounting bolts as shown. Repeat this sealing process at all five locations.

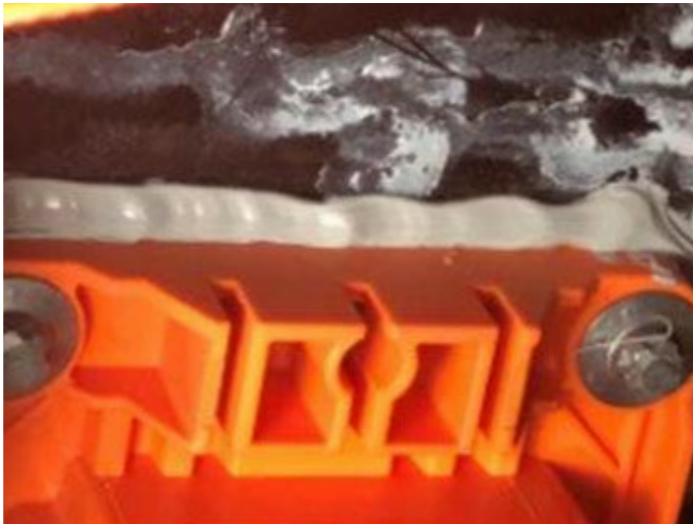
6124641

13. Ensure the seal bead is a minimum of 6.5mm (1/4in.).
14. Use a mechanics mirror to visually verify the seal path at all five locations.

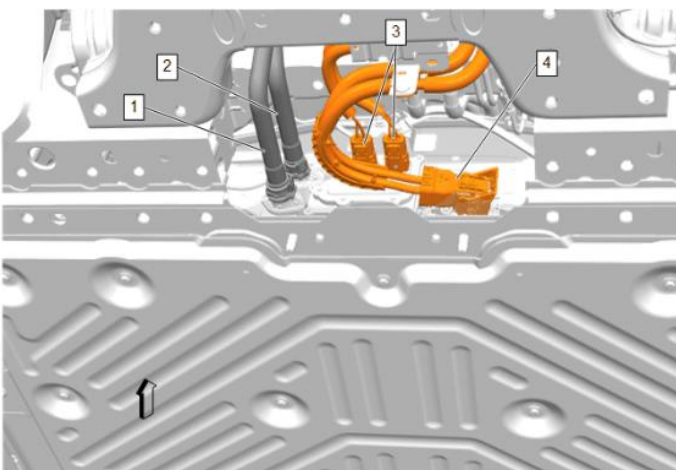
5792975

15. Reconnect the front electrical connector (4).

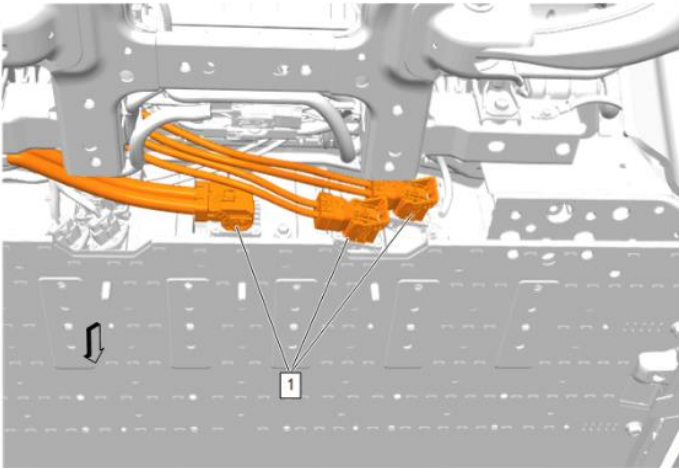
5793519

Note: The BrightDrop EV600 has only one electrical connector in the below graphic. The two EV headers on the right side have empty connectors installed.

16. Reconnect the rear electrical connectors (1).

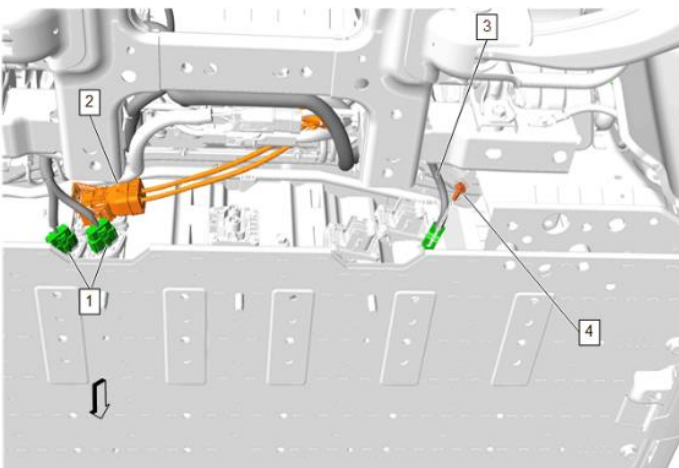
5821160

Note: On BrightDrop EV600 vehicles, it is not necessary to reconnect the #1 connectors in the step below.

17. Reconnect the rear electrical connectors (1 and 2).
