## Driver's Side Door Weatherstrip is Distorted

Year	Model	Trim Level
2023	Integra	ALL

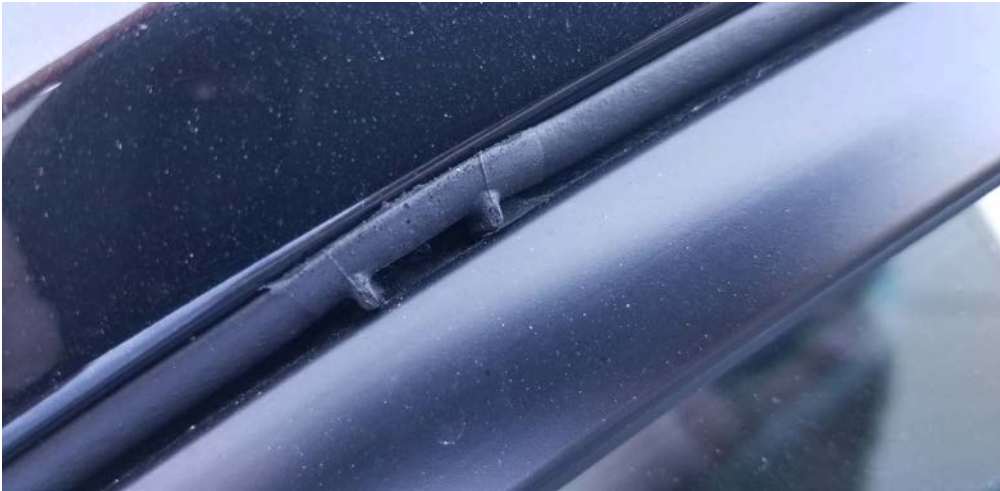
Now, rather than just leave you wondering why it's there, here's something interesting. The two nibs found on the weatherstrip was manufactured to channel the water away from the driver when the door is opened.

We've received a few contacts regarding a distorted driver's side door weatherstrip, and we wanted to let you know there is nothing wrong with the part.
