SS 3076-FTL2022 P4 Main Mirror Arm Covers Loose - Falling Off

All New Cascadia models.

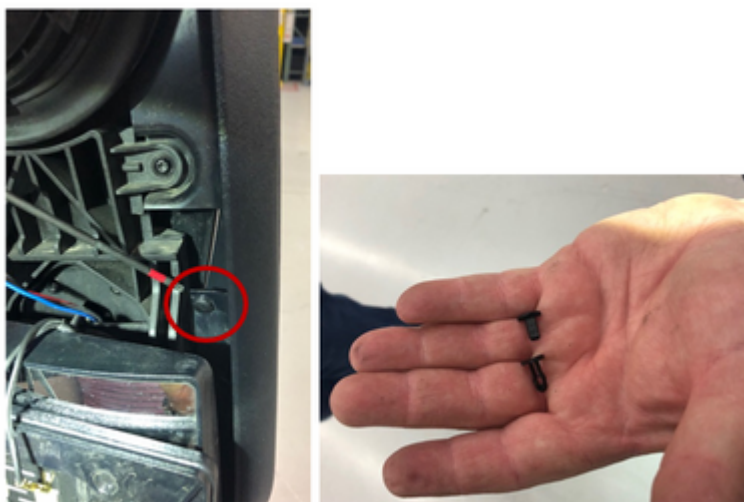
Lower arm covers designs have clips that hold the cover on but over time the clips can fail and allow the covers to become loose or fall off. Clip shown below falls off and cause the Lower Cover to fall off.

Figure 1: Arm Cover Clip installed-removed

- To improve the Lower Cover installation it is recommended to replace the factory installed Clip shown in Figure 1 with the following two part numbers:
- Spring Nut; Part Number: 23-09984-134
- Screw-TPG #10-16; Part Number: 23-11623-704

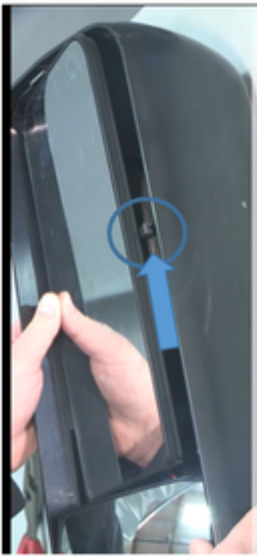
1. Remove the Flat Glass carrier from the Assembly pushing the Flat Glass carrier in the left side of the Glass to access the Flat Glass release lever as shown in Figure 2.

Figure 2. Push down on the left side of the Flat Glass carrier and then pull up the lever.

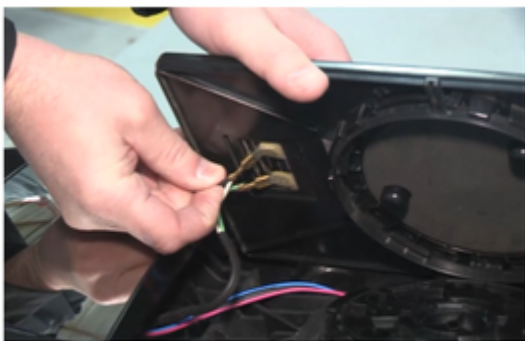
2. Lift the Flat Glass carrier and pull off the electrical terminals for the Mirror heat as shown in Figure 3.

Figure 3. Lifting Flat Glass carrier and disconnecting terminals for Mirror heat.

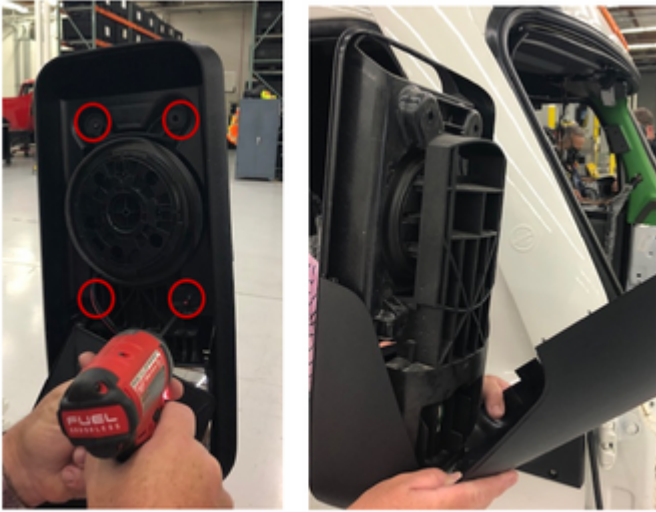
3. With the Flat Glass carrier down, remove the 4 screws holding the Mirror Cover and then remove the cover as shown in Figure 4.

Figure 4. Removing the Cover four mounting screws (arm cover shown in its place)

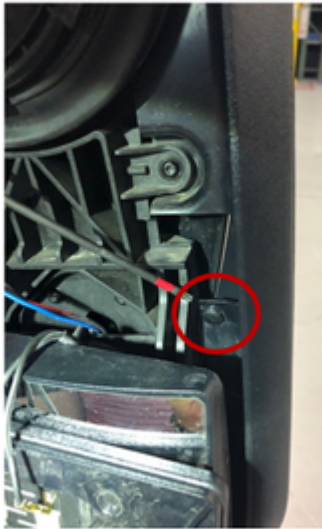
4. If the Arm Cover is still in place, proceed to remove the Clip holding it in place as shown in Figure 5.

Figure 5. Arm Cover retaining Clip to be replaced.

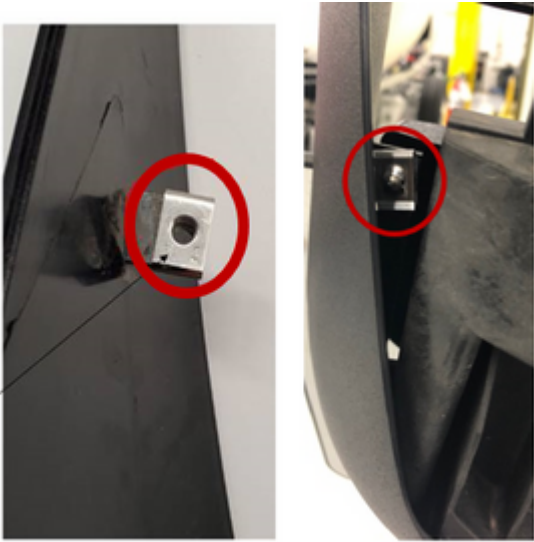
5. Grab the new Arm Cover or the installed Arm Cover if available; install the Spring Nut as shown in Figure 6.

Figure 6. Spring Nut mounted on Arm Cover mounting Tab

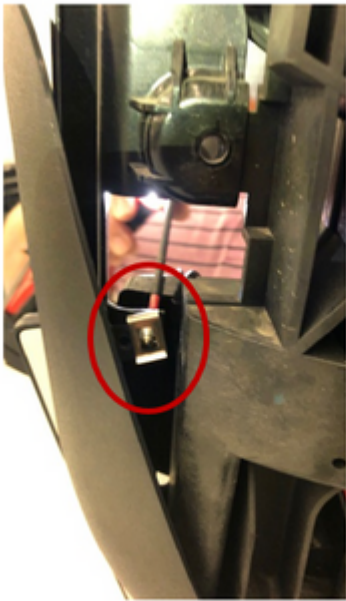
6. With the new Arm Cover positioned/aligned with the hole in the Mirror Housing, install the replacement Screw-TPG to secure the Arm Cover as shown in Figure 7.

Figure 7. Securing Arm Cover with new Spring Nut and Screw TPG.

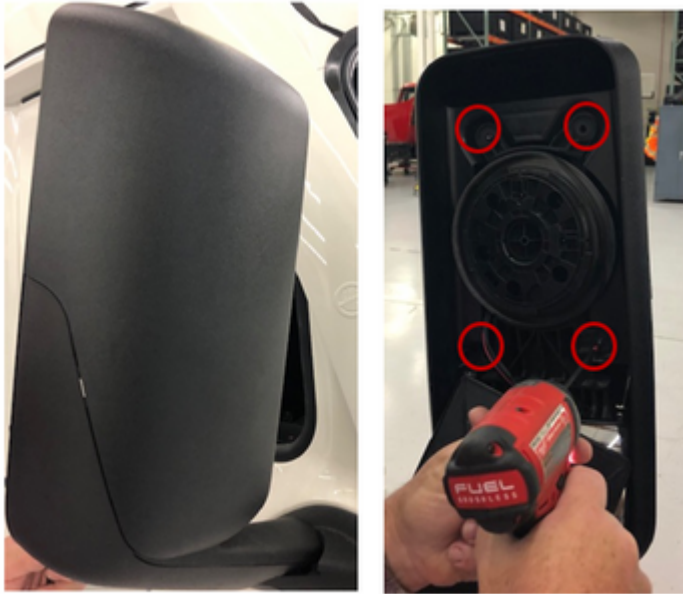
7. Proceed now to install the Mirror Cover, position it first and then fix it in place with the four mounting screws as shown in Figure 8.

Figure 8. Positioning and securing the Mirror Cover.

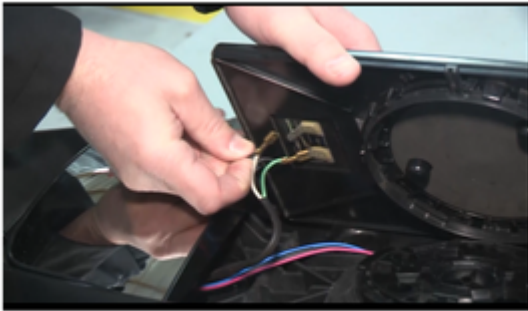
8. Grab the Flat Glass carrier and plug back the electrical terminals for the mirror heat, shown in Figure 9.

Figure 9. Reconnecting the electrical terminals for the mirror heat to the Flat Glass carrier.

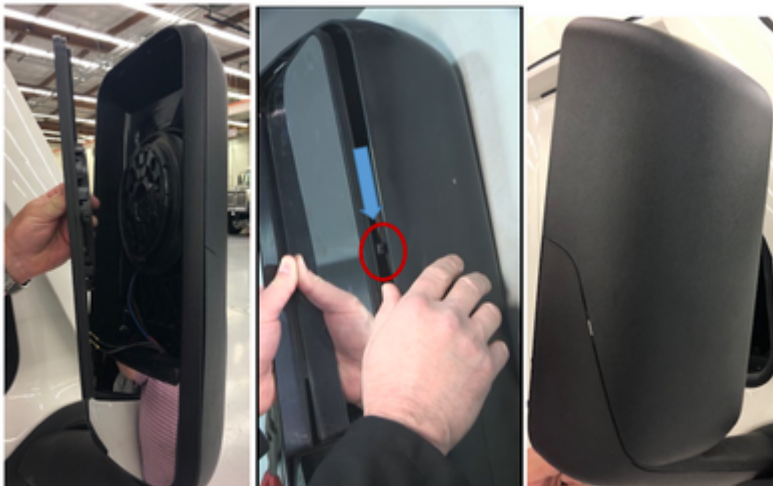
9. After completing the previous step, mount the Flat Glass carrier, position it, and then pull down the lever to secure the Flat Glass carrier in place to complete the reassembly of the Mirror, see Figure 10.

Figure 10. Positioning the Flat Glass carrier and securing it in place pulling down the lever
