**Title:** Potential A/C Compressor Parts Shortage - 4158126C1

**Applies To:** LT, HX, and LoneStar with 2021 Cummins X15 Engines

In the event of a backorder of A/C compressor PN 4158126C1, it may be necessary to use a 2017 X15 A/C compressor PN 3863068C4 on a 2021 X15 engine. This document will guide the user through modifying the 2017 X15 A/C compressor to be used on a 2021 X15 engine.

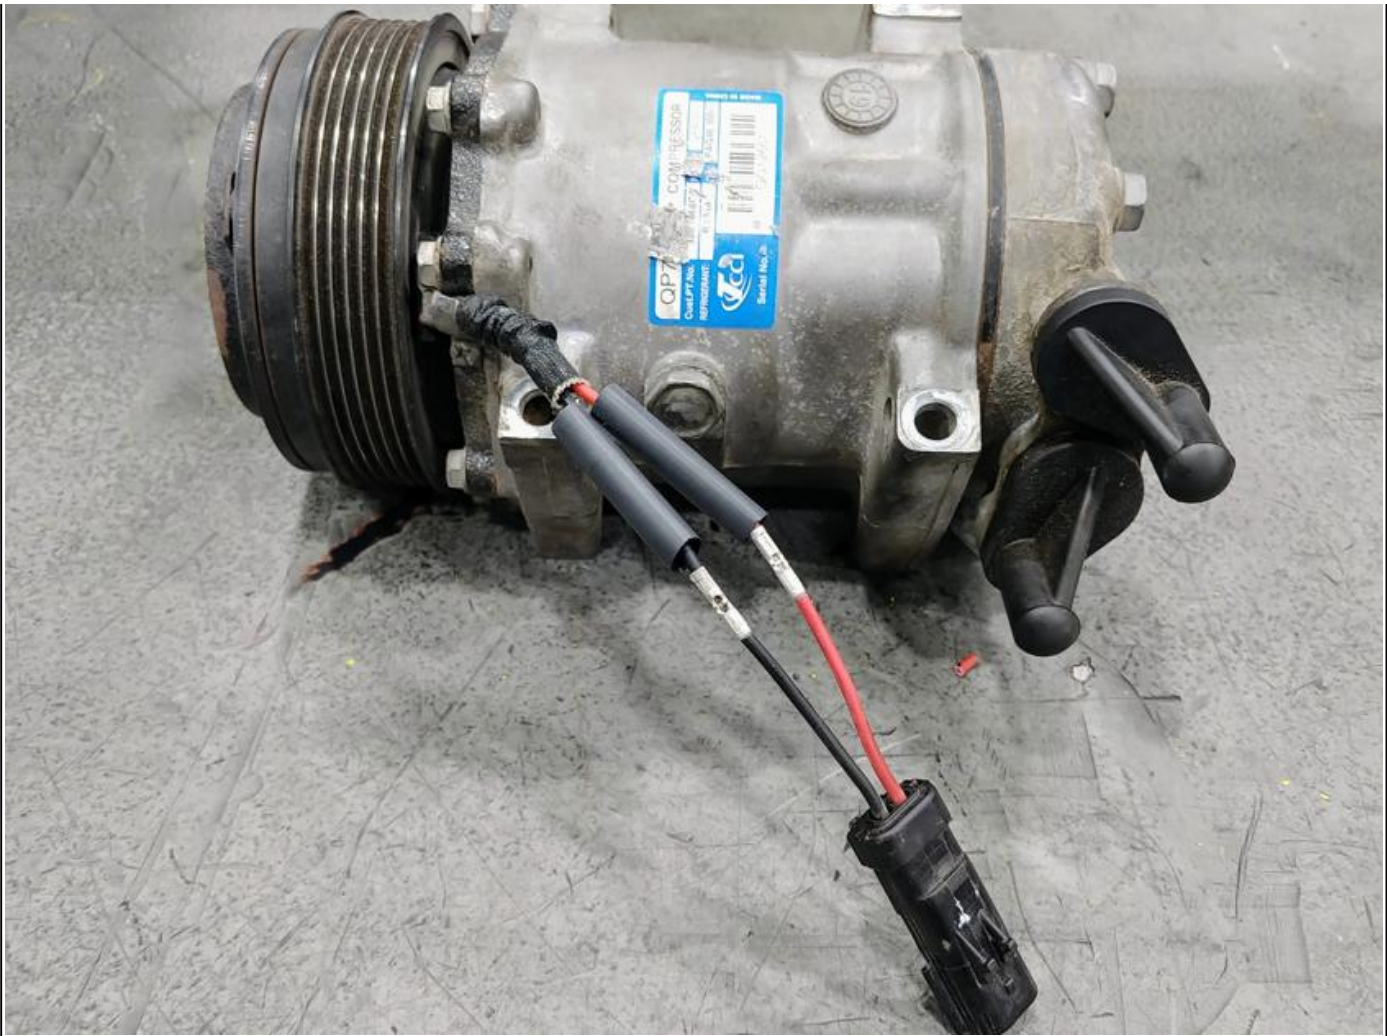
**Figure 3: Pigtail from failed compressor spliced on to replacement compressor**

- 1.) Remove the failed A/C compressor from the vehicle. (Reference appropriate service manual for removal instructions.)
- 2.) Failed compressor: Cut tie strap securing the connector to the compressor body, push back protective sheathing, then cut the compressor harness 2 inches away from the connector (**Figure 1**).
- 3.) Replacement compressor: Cut tie strap securing the connector to the compressor body, push back protective sheathing, then cut the compressor harness 2 inches away from the connector (**Figure 2**).
- 4.) Using the procedure found in [IK0800269 - Proper Wire Repair](#), splice the connector and pigtail from the failed compressor on to the replacement compressor harness (**Figures 3 and 4**)

-Be sure to solder this connection. Failure to do so will result in a weak connection.

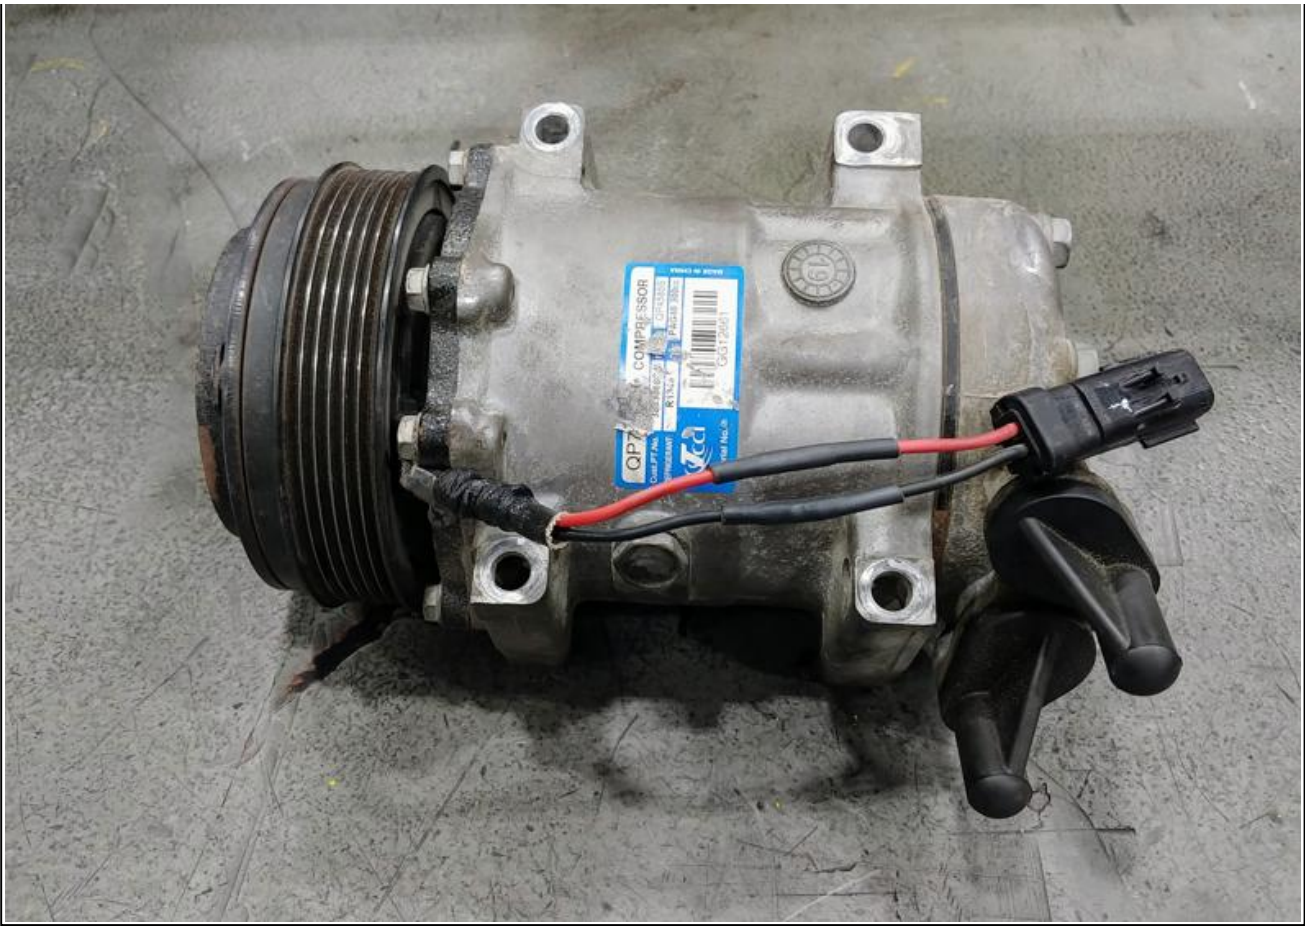
Figure 4: Completed splice

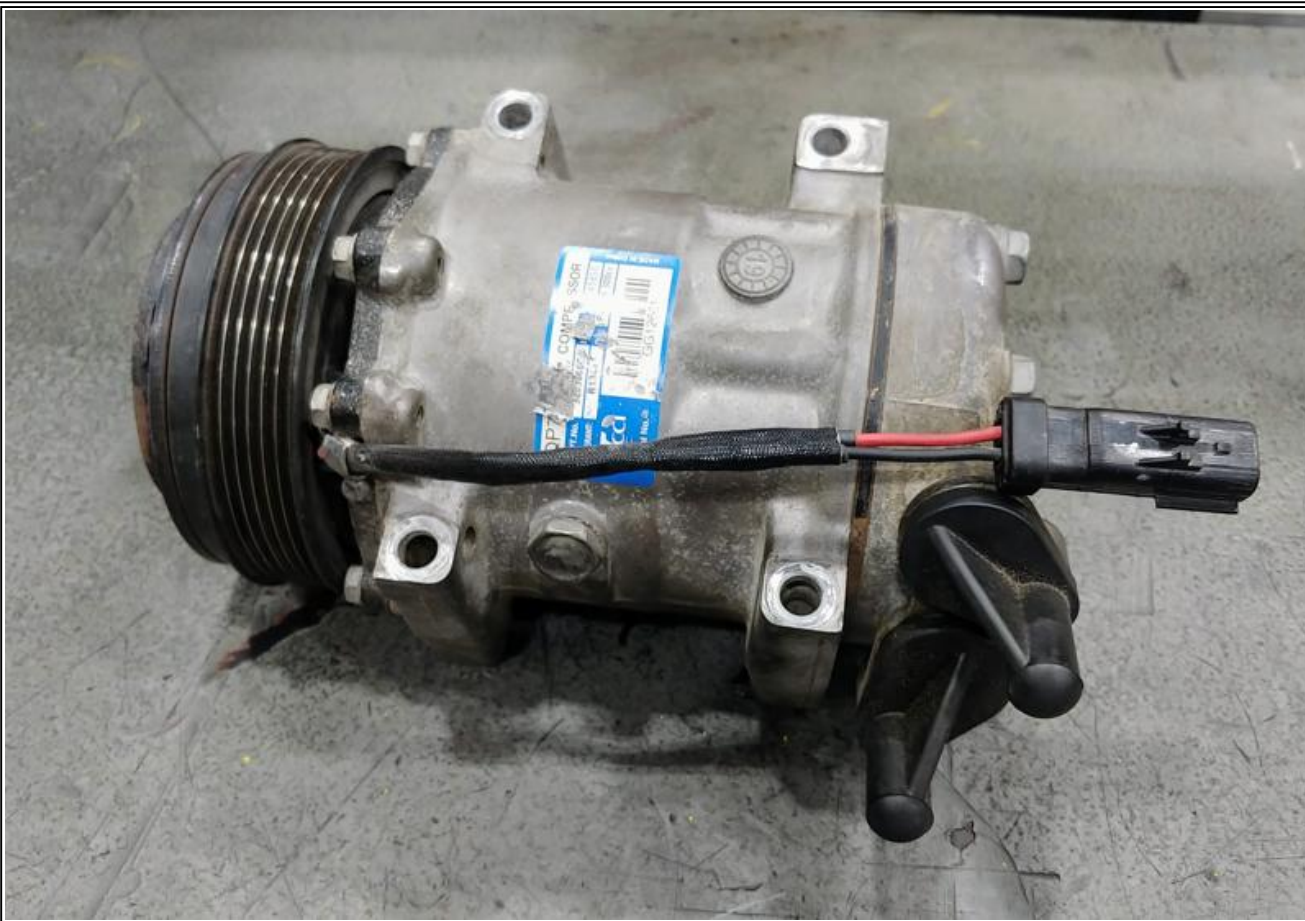
Figure 5: Wire sheathing positioned over splice

5.) Position harness sheathing so it covers the wire splices (**Figure 5**).
