# Volvo Particulate Matter (PM) Sensor Troubleshooting Guide - US14+OBD16 And Newer Emissions

# SCR Fittings, One Box, Replacement

# Exhaust Particulate Sensor, Repair

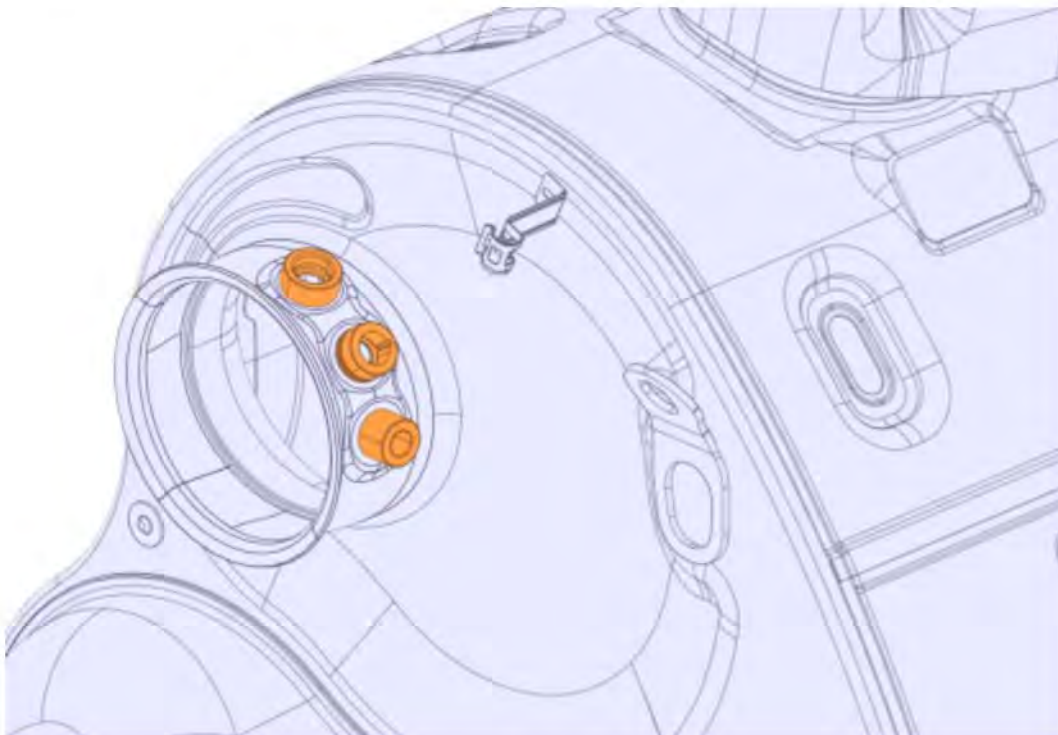
5. Install the new sensor boss and perform the welding.

Note: When replacing the PM sensor boss, position the notch of new boss as marked. The notch of PM sensor boss is always set in the 3'o clock position.

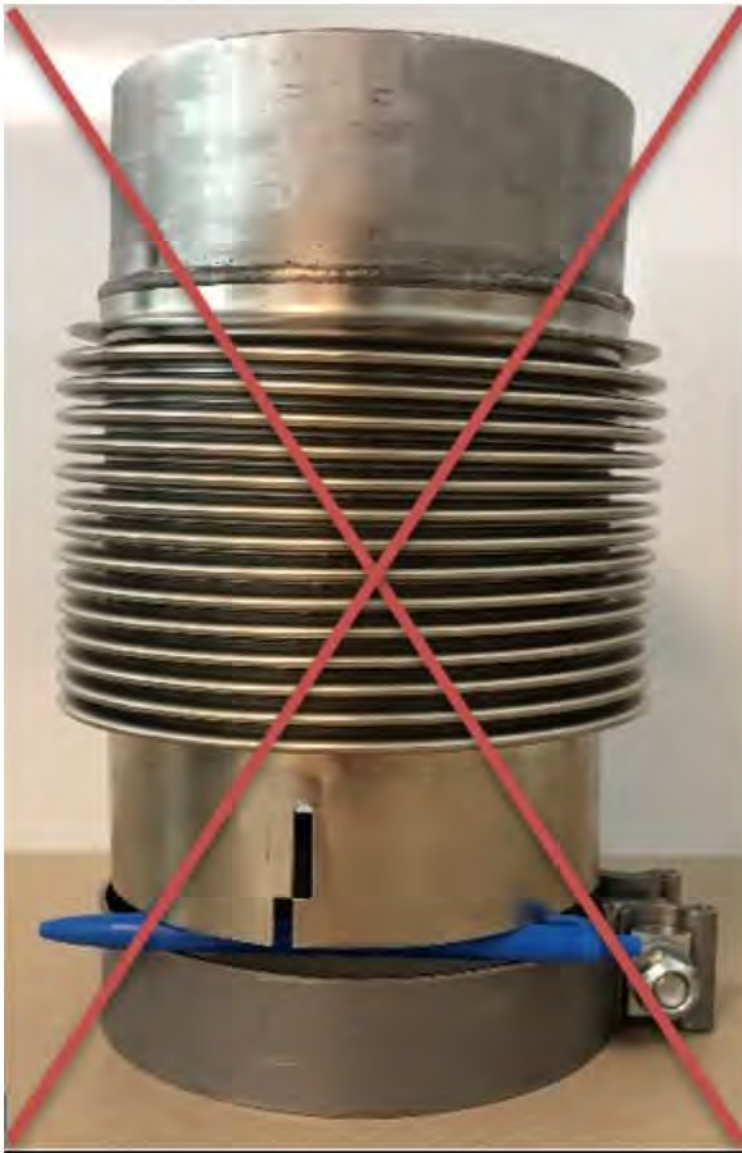
<p>Scenario 1</p> <p>This style Flex Pipe and Clamp will no longer work with the upper adjacent connecting pipe. The below parts in scenario 2 are required to perform this FSB.</p> <p>Follow the repair below that is applicable for your configuration.</p>
--	--

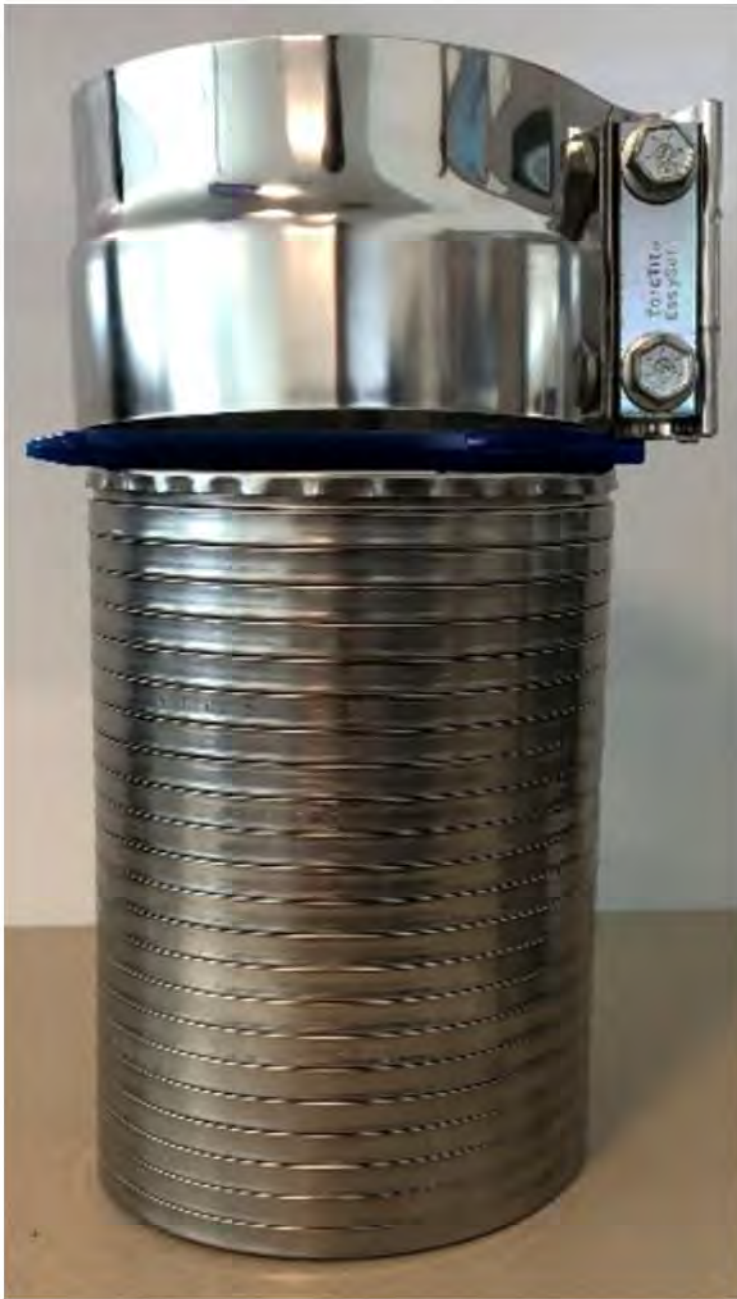
#### Scenario 2

This style Flex Pipe and Clamp only needs the upper adjacent pipe replaced. Reuse the existing Flex Pipe and Clamp, or order as needed.

Flex Pipe –  
21142254

Clamp –  
25172497

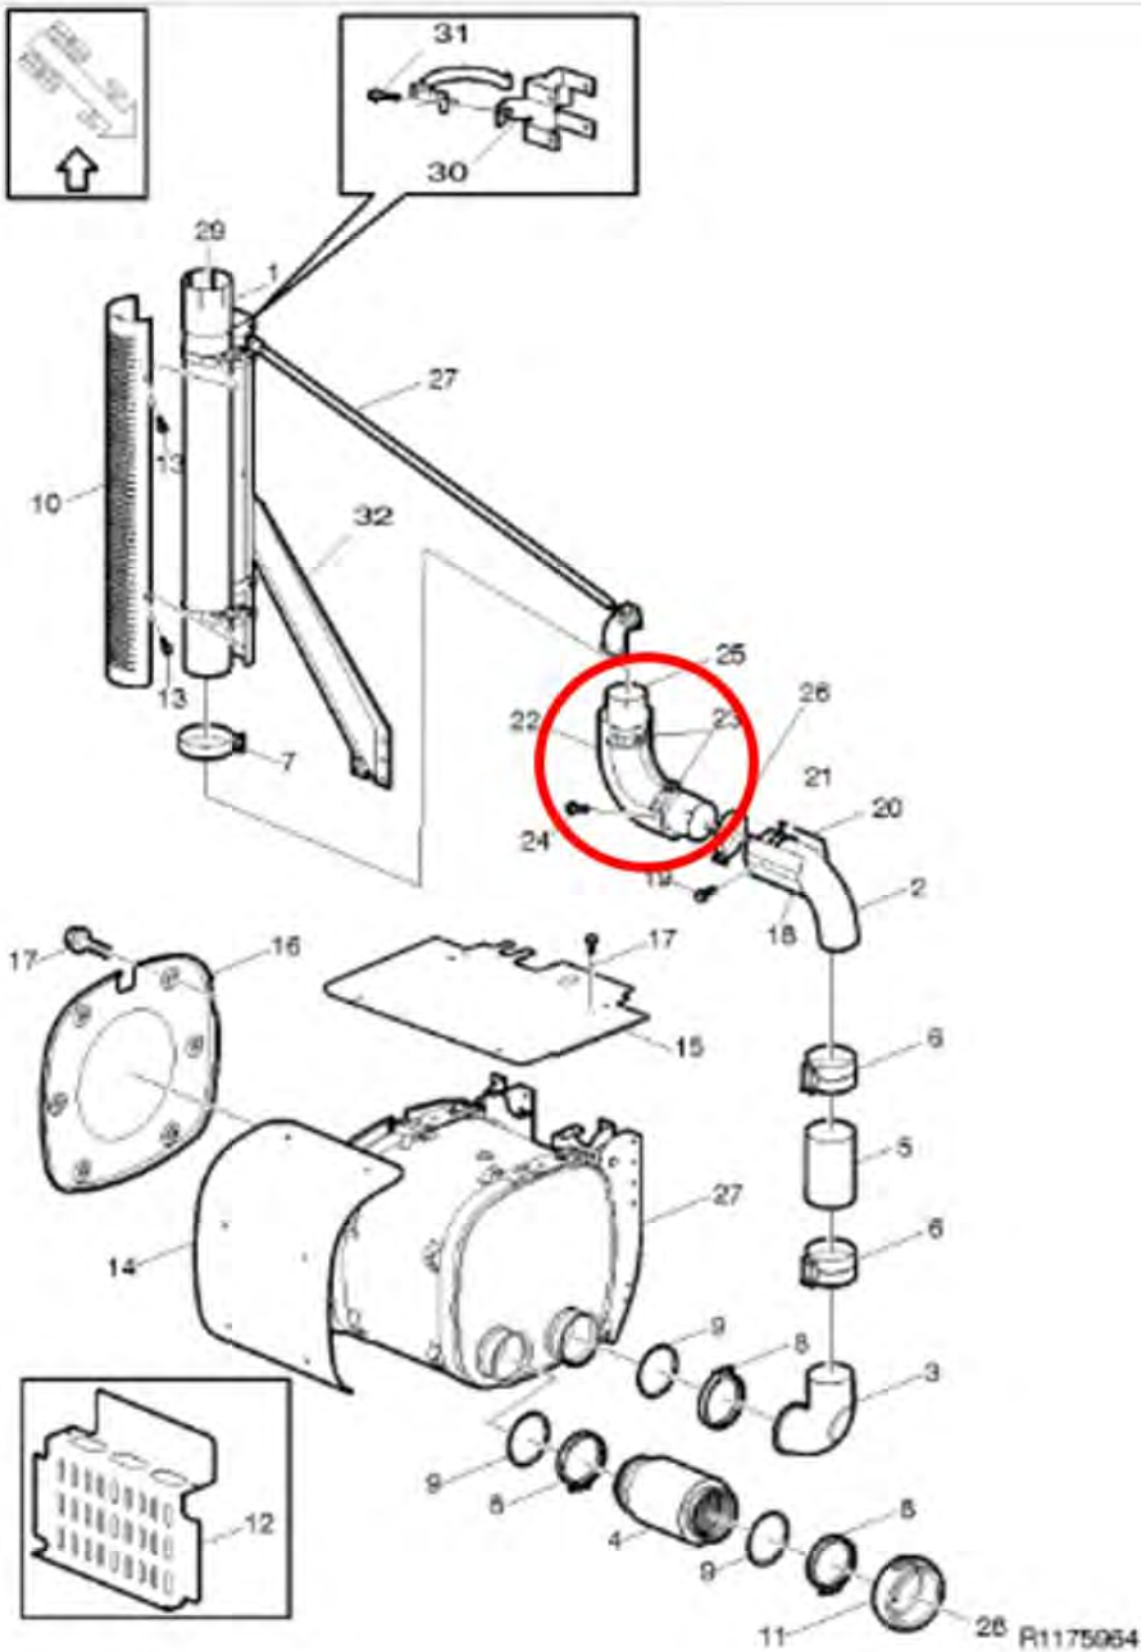
### Repair 1

Model	Cab Type	Exhaust Configuration	Pipe 1
VNL	Day Cab	Single Outlet Right Side Outboard	(Not Bright) 23154798 (Bright) 23154799

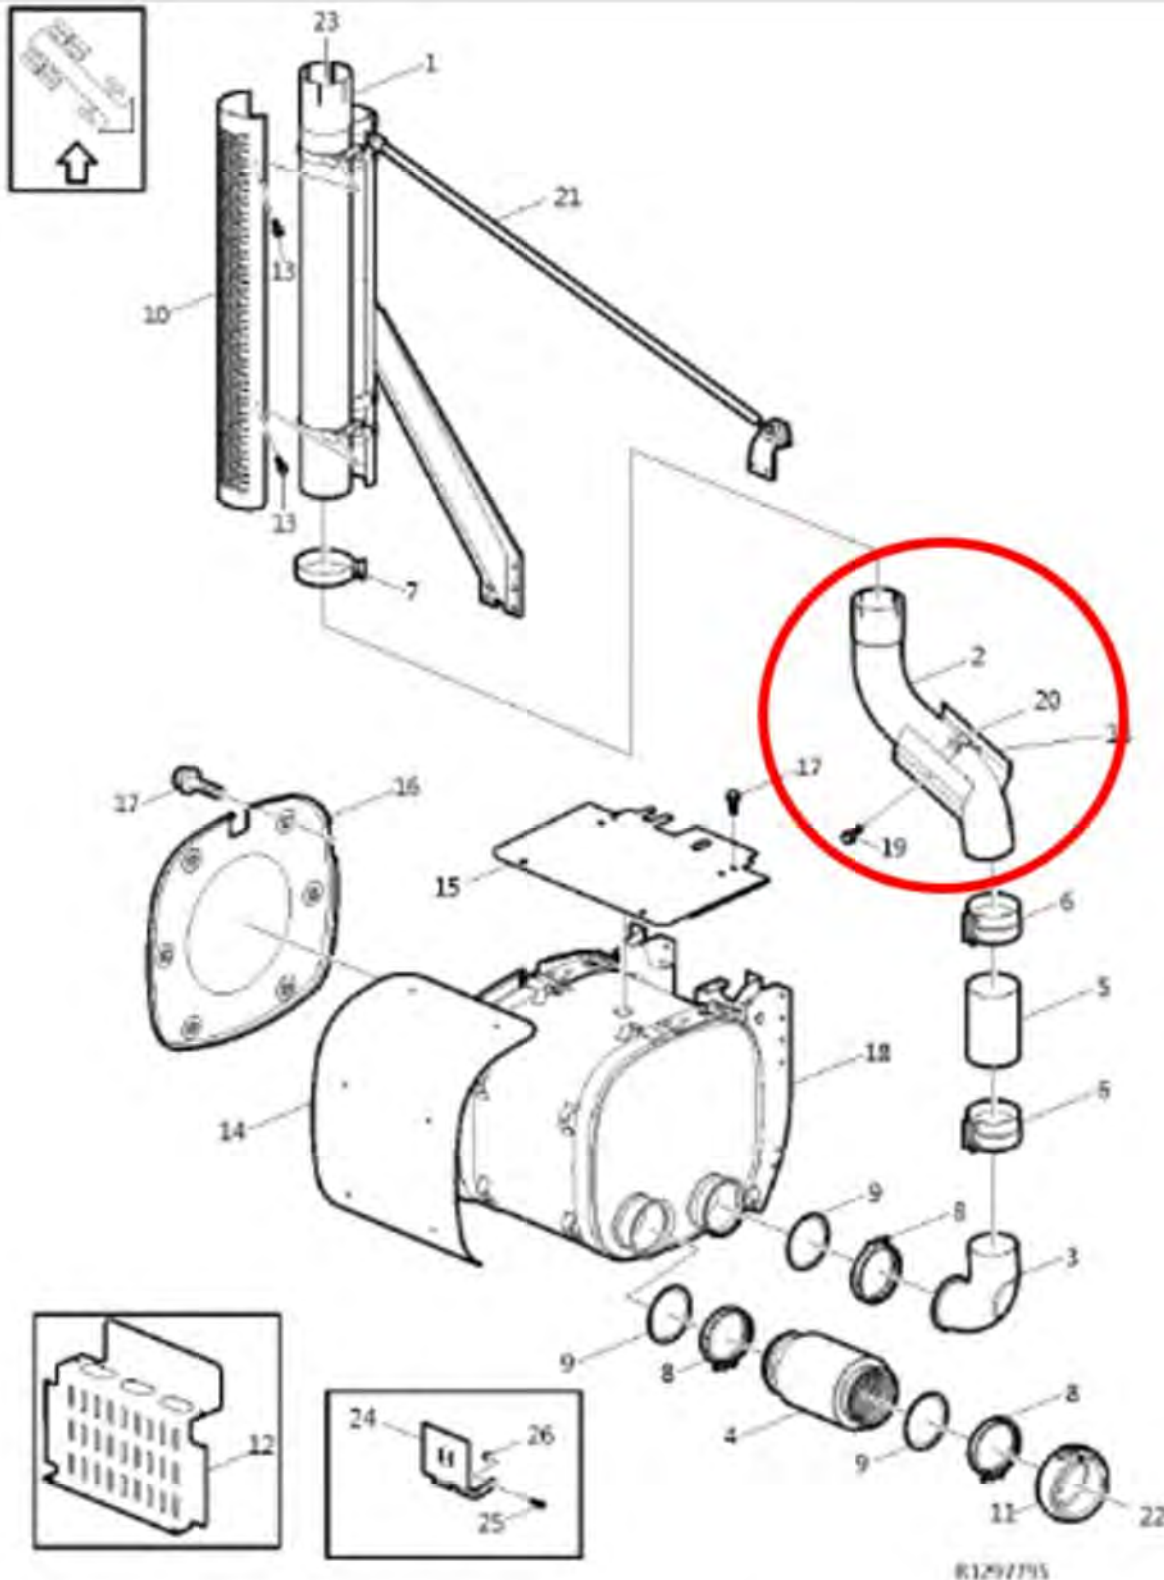
Repair 2

Model	Cab Type	Exhaust Configuration	Pipe 1
VNM/VHD	Day Cab	Single Outlet Right Side Inboard	23630037

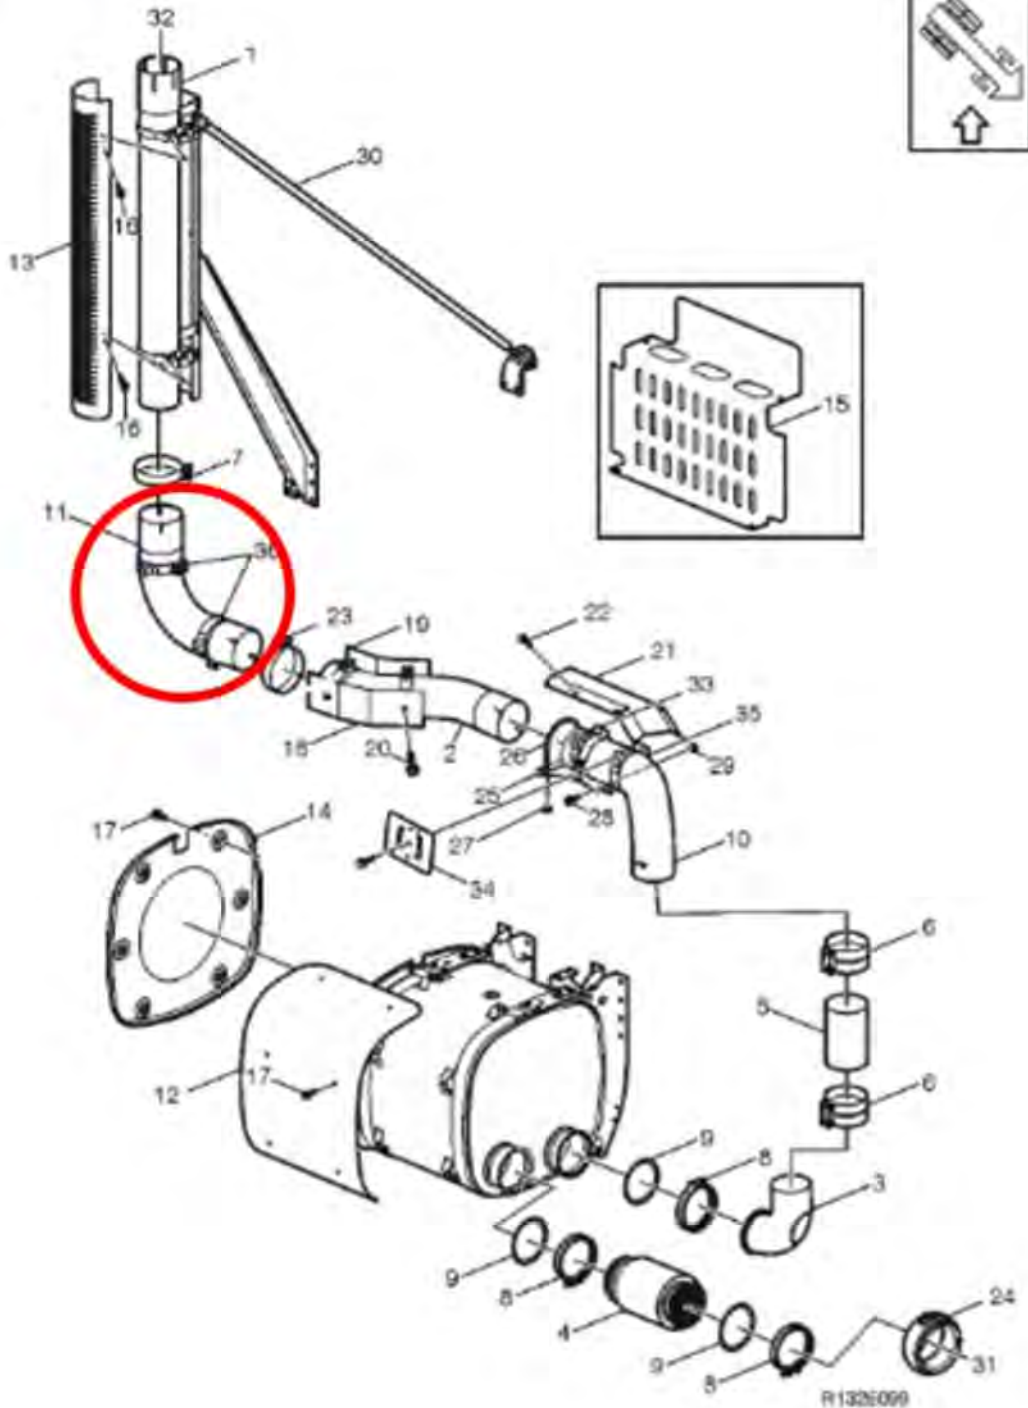
Repair 3

Model	Cab Type	Exhaust Configuration	Pipe 1
VNL/VHD	430/630 Sleeper	Single Outlet Right Side Inboard	(Not Bright) 23154798

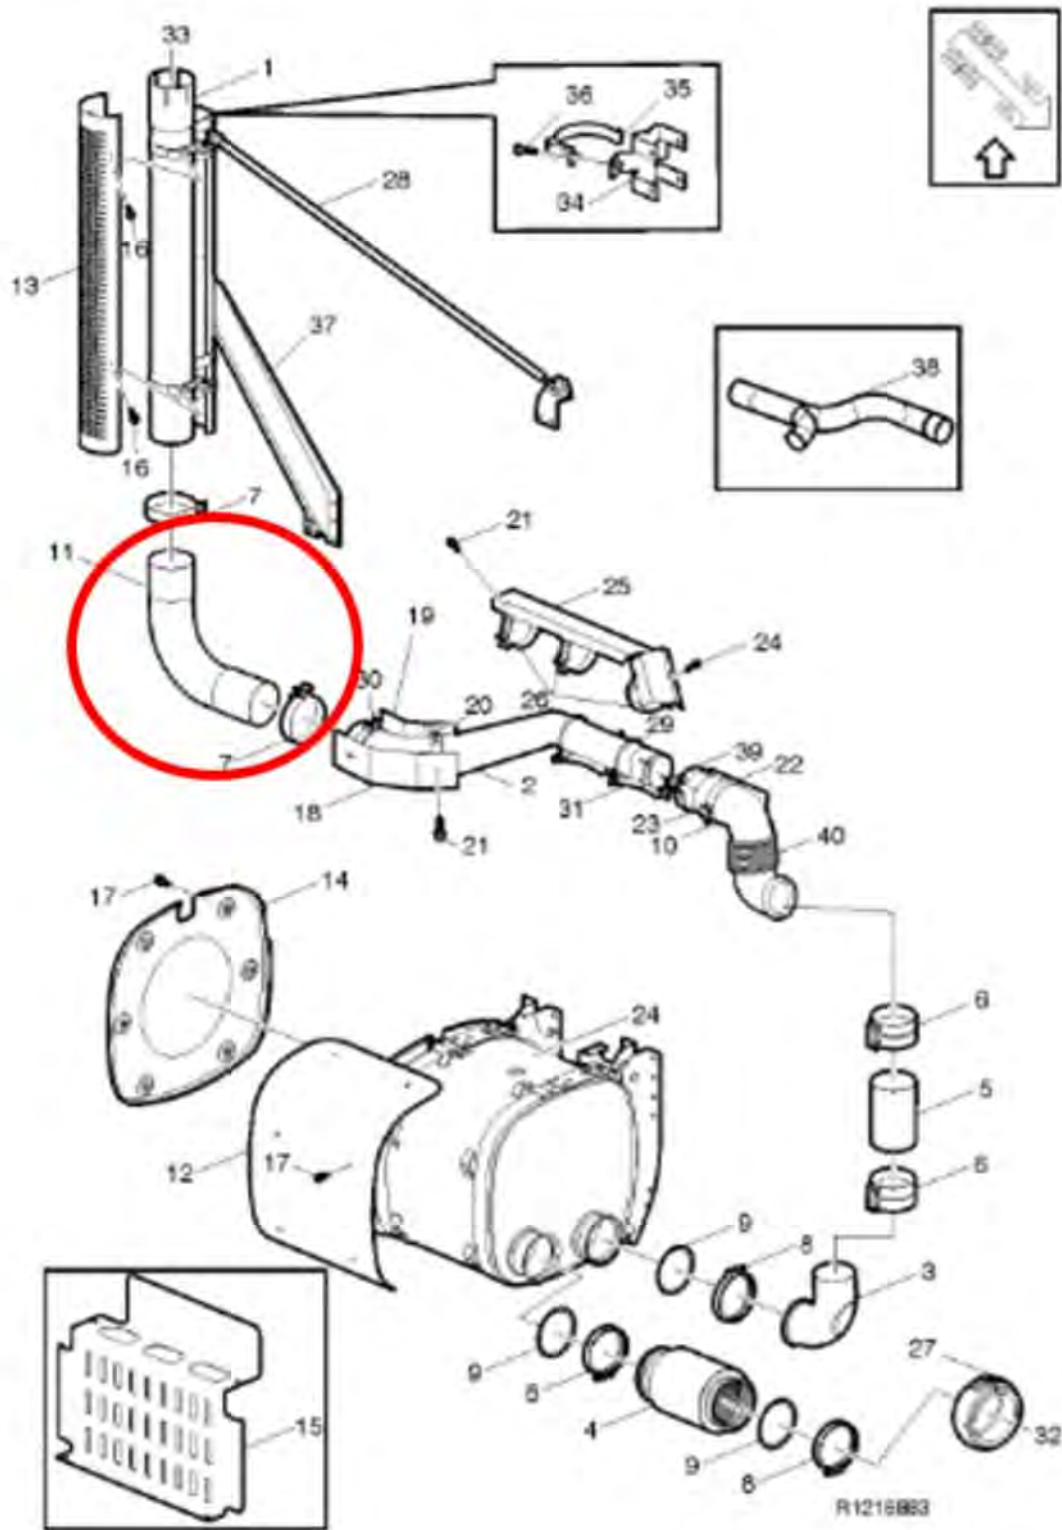
#### Repair 4

Model	Cab Type	Exhaust Configuration	Pipe 1
VNL	430/670/780 Sleeper	Single Outlet Right Side Inboard	(Not Bright) 23154798 (Bright) 23154799

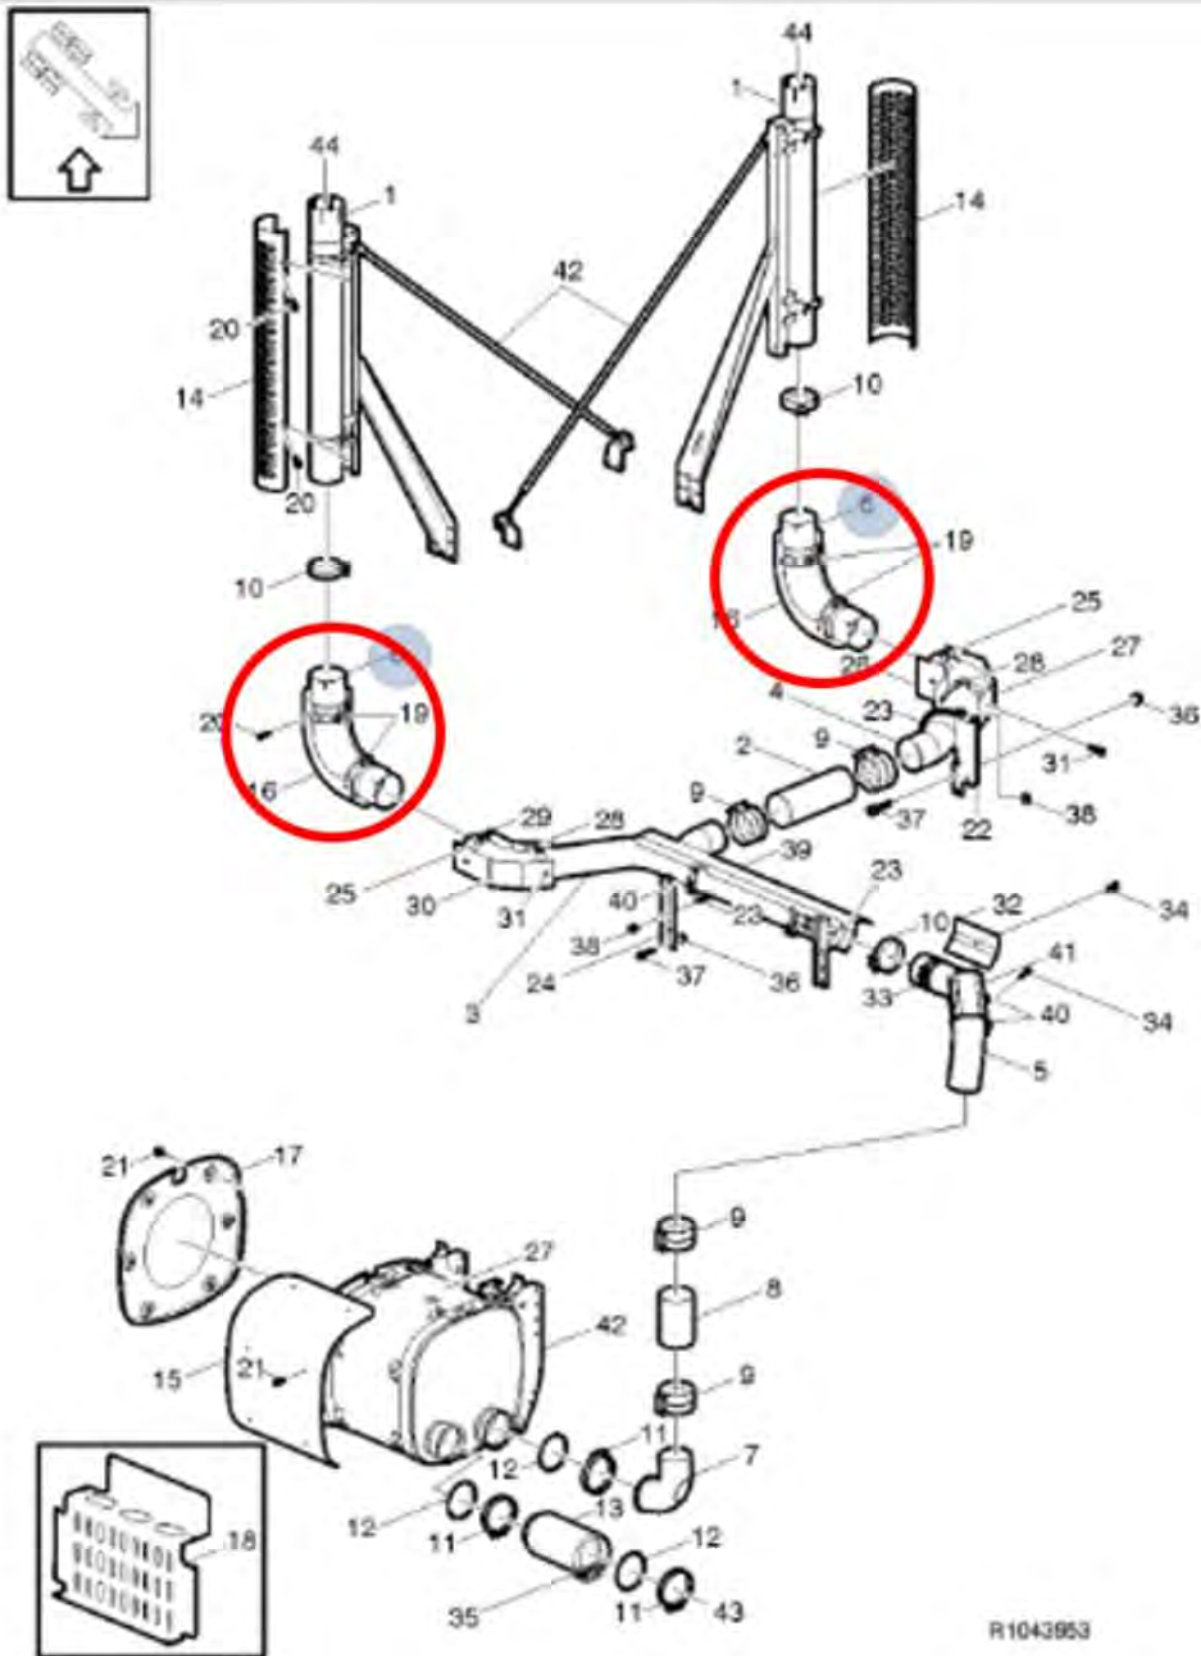
## Repair 5

Model	Cab Type	Exhaust Configuration	Pipe 1
VNL	430/670/780 Sleeper	Single Outlet Right Side Inboard	(Not Bright) 23154798 (Bright) 23154799

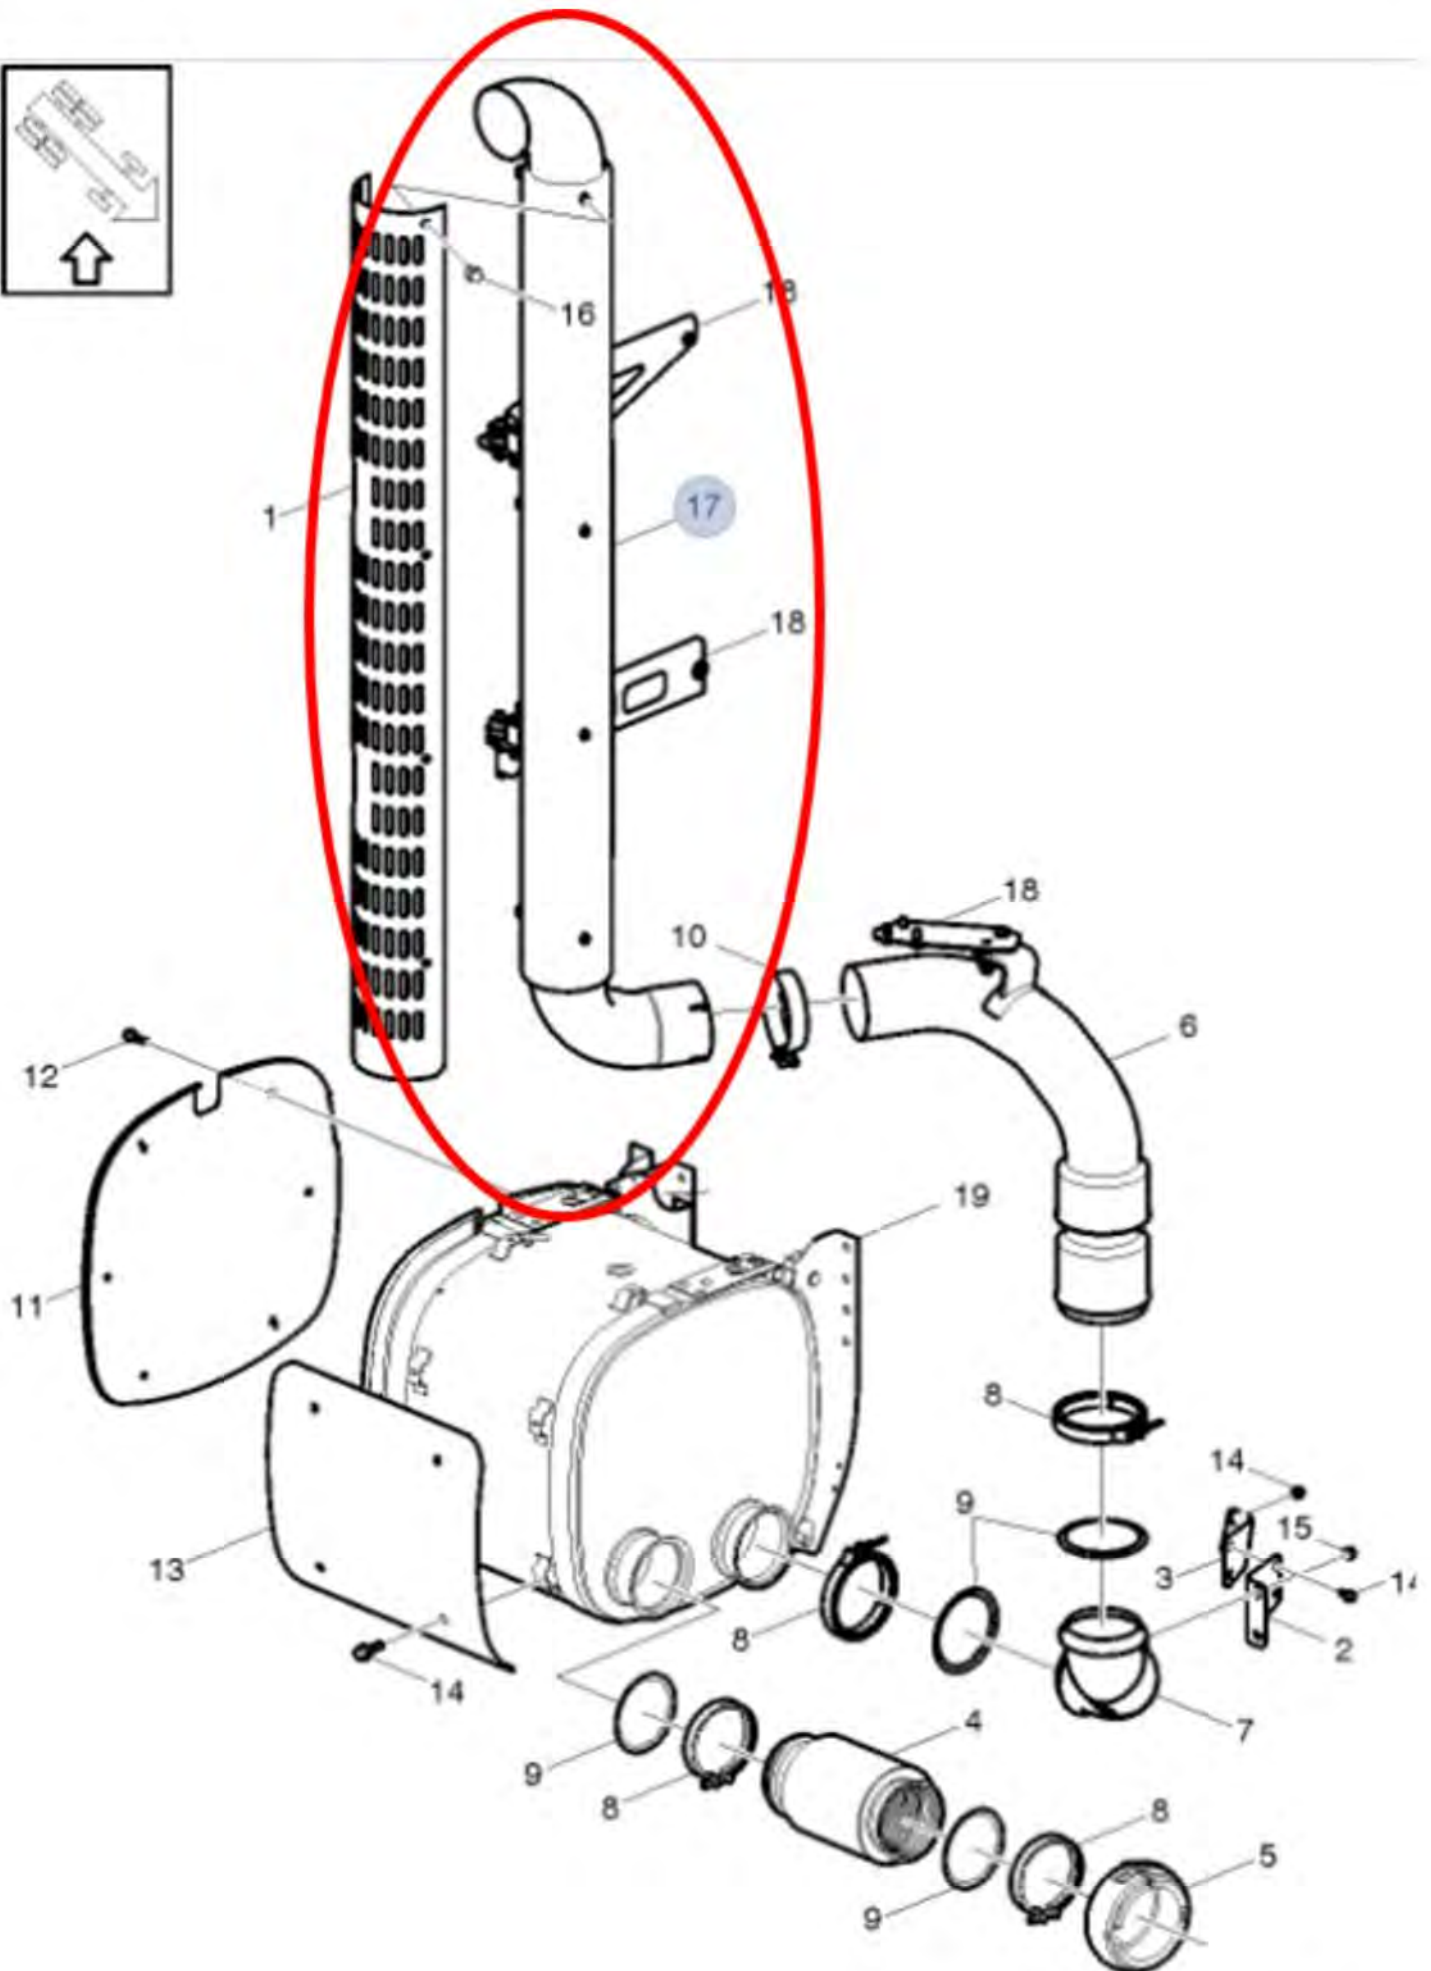
## Repair 6

Model	Cab Type	Exhaust Configuration	Pipe 1	Clamp (Qty will vary)
VHD/VNM	Cab Mounted	SCR RH Horizontal Forward Mount	23154823	20961913
VHD/VNM	Cab Mounted	SCR Horizontal	23154825	20961913
VNL 11/13	Cab Mounted	SCR Horizontal	23154827	20961913

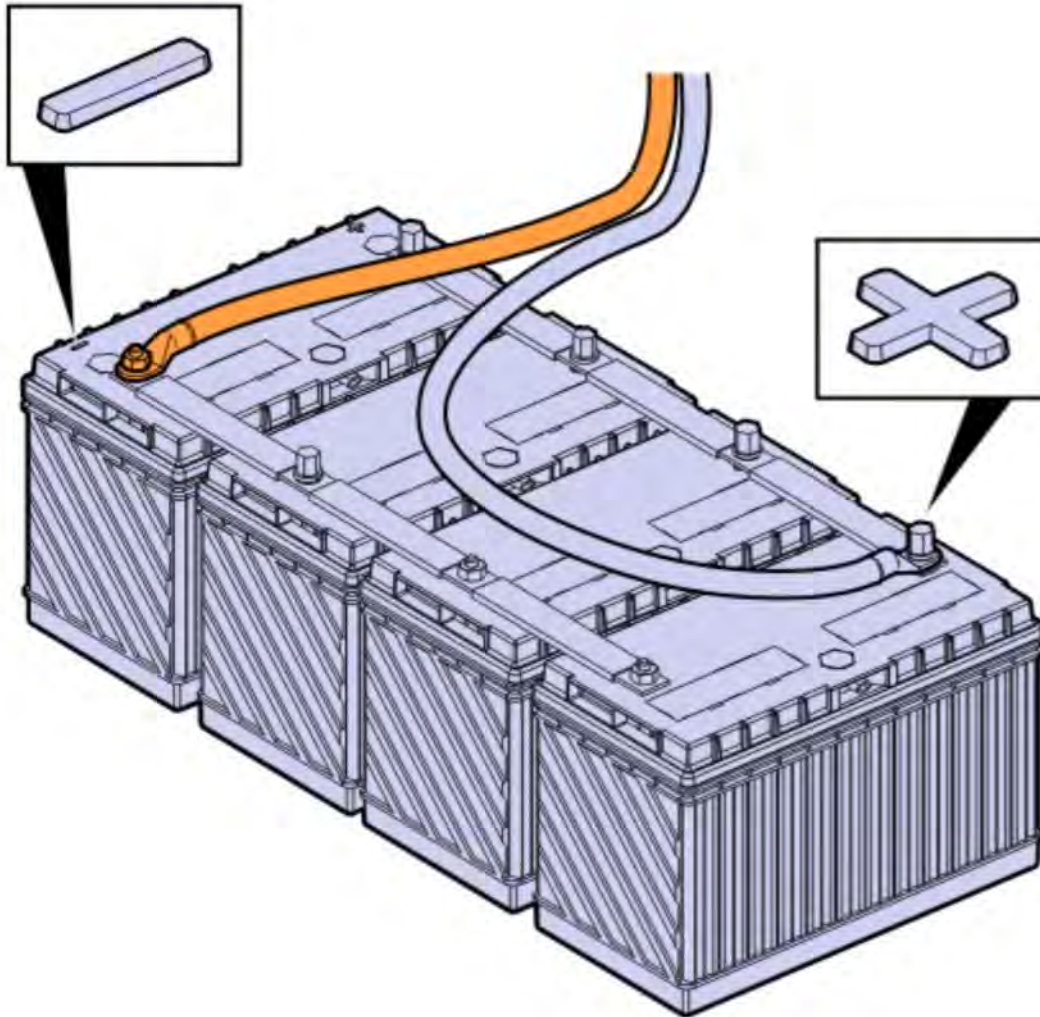
11. Install the new PM sensor and module.

Note: Do not use any lubricant of any kind on the PM sensor threads.

Note: Align the tab on the sensor with the slot.

12. Torque the sensor to 35 +/- 5 Nm (26 +/- 4 Ft lb)

13. Install the sensor module.
14. Torque the nuts to  
M6: 10 +/- 5 Nm (88 +/- 3 in lb)  
M8: 24 +/- 4 Nm (17.1 +/- 3 ft lb)
15. Install the wire ties and clamps.

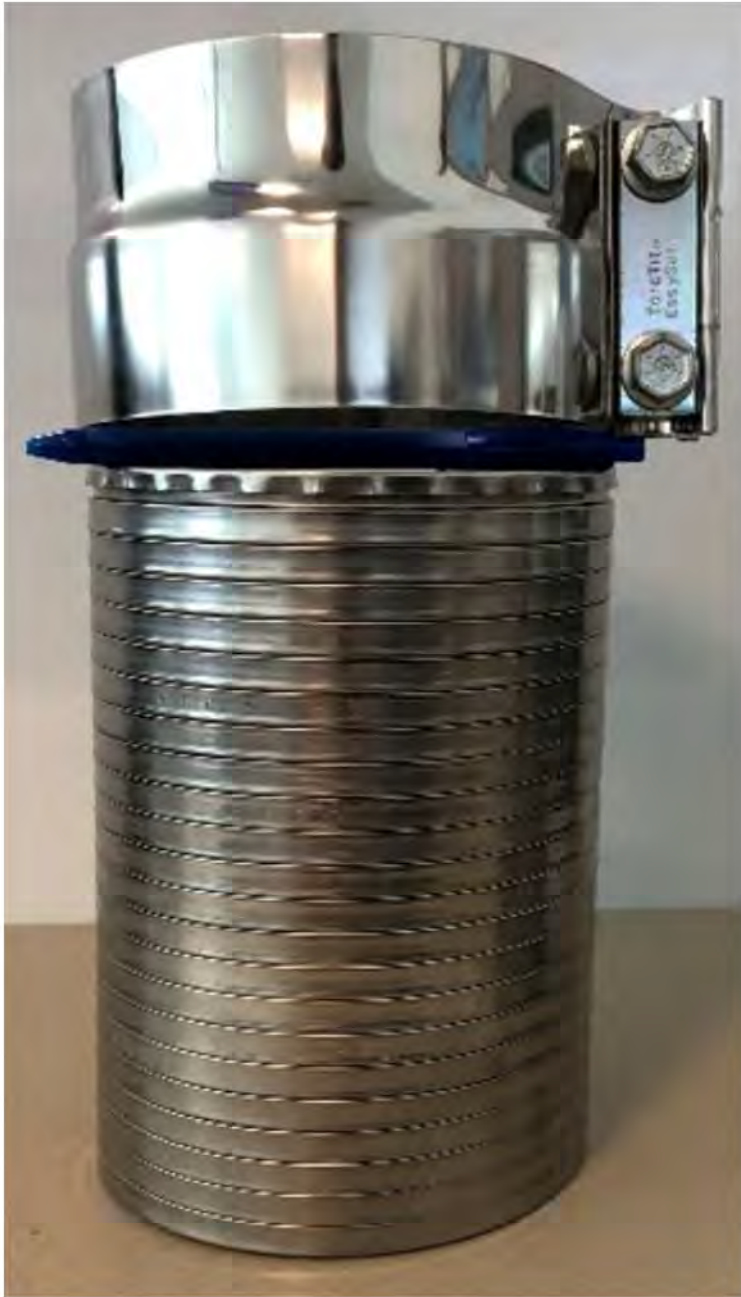
Scenario 2

This style Flex Pipe and Clamp only needs the upper adjacent pipe replaced. Reuse the existing Flex Pipe and Clamp, or order as needed.

Flex Pipe –  
21142254

Clamp –  
25172497
