**Airbag Warning Light Activated: Fault Code 1217 and/or 1218 in Airbag Control Unit Fault Memory**

Model Year: **As of 2003 up to 2004**

Vehicle Type: **Cayenne/Cayenne S/Cayenne Turbo**

Concerns: **Side airbag**

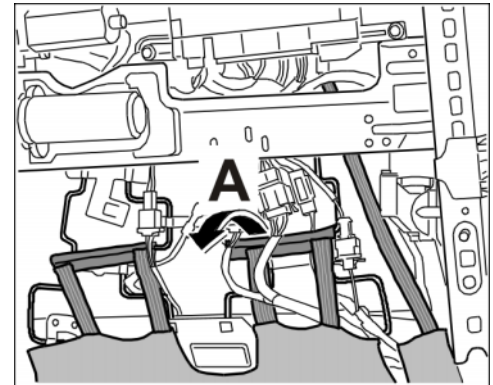
Figure 1

- 2.1 Disengage the right tensioning strap of the backrest cover (⇒ *Figure 1 -Arrow A-*).

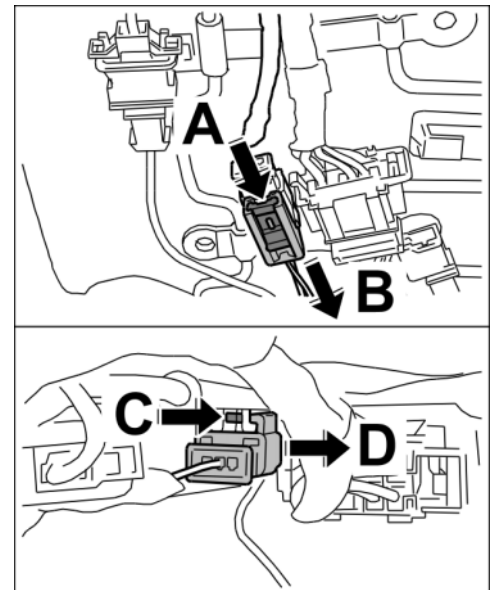
Figure 2

- 2.2 Push back lock on the side airbag plug (⇒ *Figure 2 -Arrow A-*) and remove from the plug socket on the side airbag (⇒ *Figure 2 -Arrow B-*).
- 2.3 Release side airbag plug at the seat frame (⇒ *Figure 2 -Arrow C-*) and push it out towards the front (⇒ *Figure 2 -Arrow D-*).
- 2.4 Unclip side airbag wire harness from the bracket on the front seat suspension. (The bracket is installed behind the control unit for memory seat adjustment).

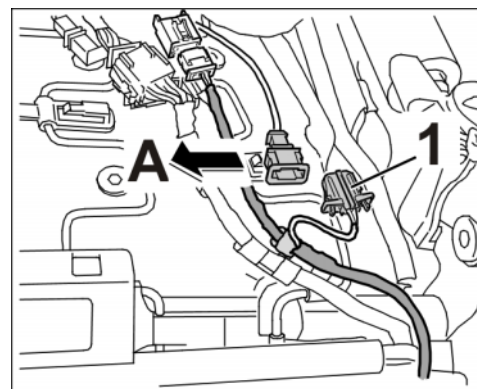
Figure 3

- 2.5 Release connector of ground strap from side airbag (⇒ *Figure 3-Item 1-*) and pull out of the socket.
  - 2.6 Release the rear connector bracket on the seat suspension and pull off socket for the ground strap (⇒ *Figure 3-Arrow A-*).
- 3 **Replace previous plug connection with a cable connection.**

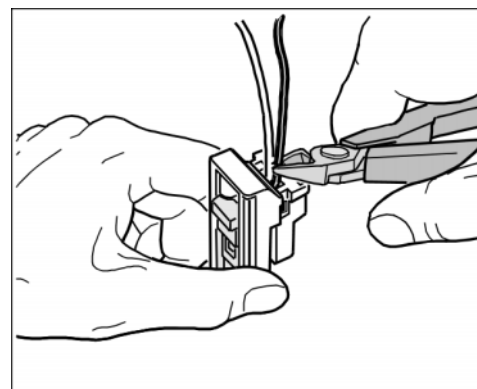
Figure 4

- 3.1 Position both lines of the wire harness on the control unit side flush on the connector and cut through them **individually** (⇒ *Figure 4*).
- 3.2 Position the two lines coming from the side airbag flush on the socket and cut through them **individually**.
- 3.3 Unwrap chafing prevention tape to a length of approx. 70 mm on the side airbag wire harness (clearance to slide on the shrink-fit hoses).
- 3.4 Slide a shrink-fit hose onto the **blue** line of the side airbag wire harness.

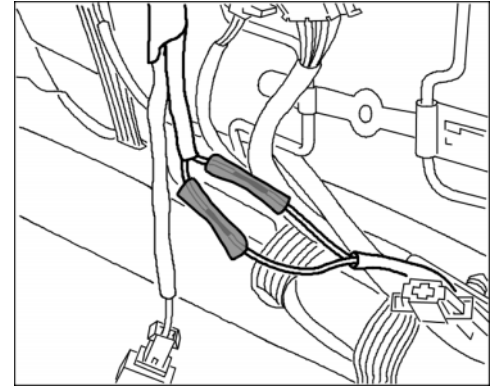
Figure 5

- 3.6 Position the shrink-fit hoses over the cable connections and then shrink the hoses with a hot-air gun (⇒ *Figure 5*).

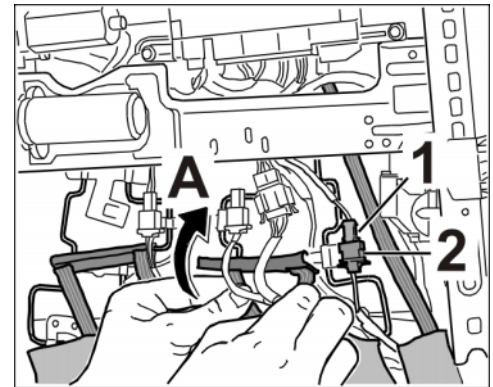
Figure 6

- 4.2 Clip the socket of the ground strap (⇒ *Figure 6 -Item 1-*) into the connector bracket of the rear seat suspension and connect to the connector for the side airbag ground strap (⇒ *Figure 6 -Item 2-*).

- 4.4 Engage the right tensioning strap for the backrest cover (⇒ *Figure 6 -Arrow A-*).
