RCA-46-22-001-1: Add Shock Tower Washers to Support Front Upper Control Arm Bushings

Document Type	Customer Satisfaction Campaign Bulletin
Date	July 27, 2022
Affected Region(s)	USA
Affected Model(s)	R1T
Model Year(s)	2022
Approximate Build Dates	August 2021 - October 2021

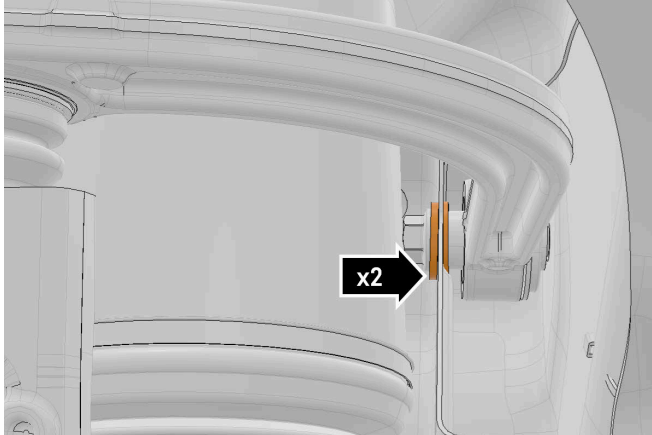
1. Remove: Wheel and Tire Assembly, Front, LH (refer to service manual procedure 221010011).
2. Check for the presence of washers on the shock tower flange.

- If washers are installed on the shock tower flange: Reinstall all components that were removed for access and replace all non-reusable components.
- If no washers are present: Continue to the [Washer Installation](#) section.

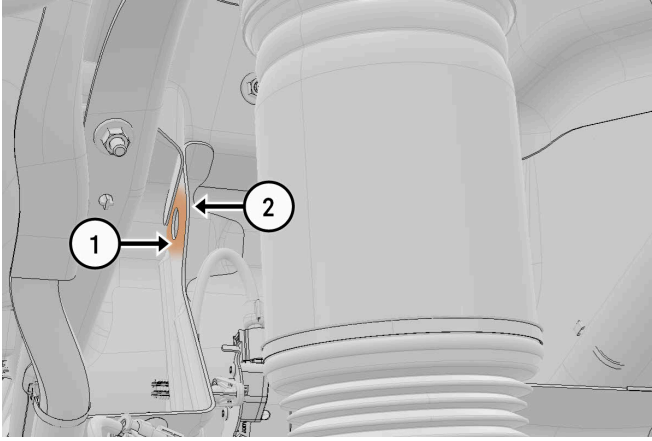
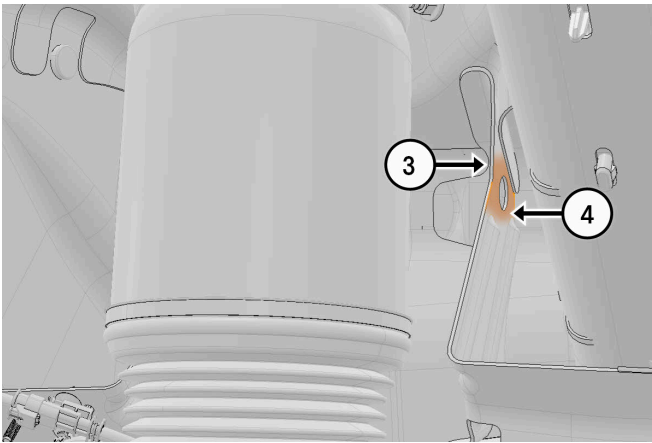
4. Clean the area(s) with a mild residue-free cleaning product.

1	Front flange outboard surface
2	Front flange inboard surface
3	Rear flange inboard surface
4	Rear flange outboard surface

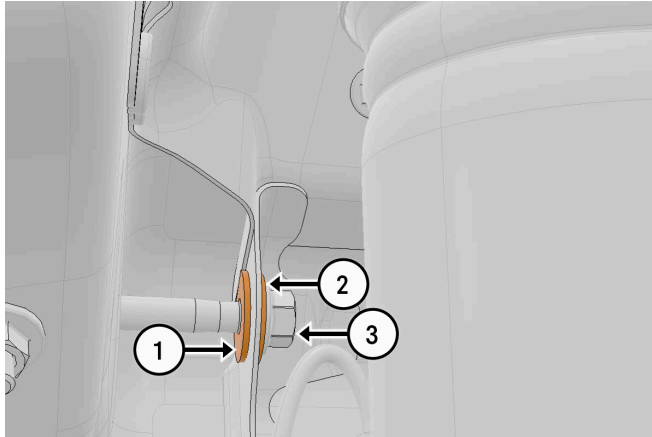
Figure 1. Front flange

b. Position the component(s) as shown. Loosely install the fastener(s).

1	Clipped washer
2	Round washer
3	Upper control arm bolt

a. Apply adhesive to 1 clipped washer and 1 round washer.

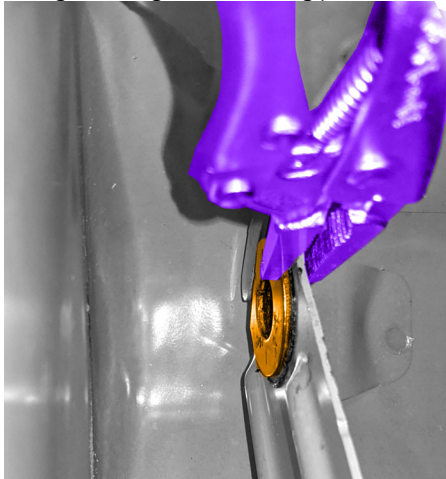
c. Using the long-nose locking pliers:

**Note:** Shown with components removed for clarity.

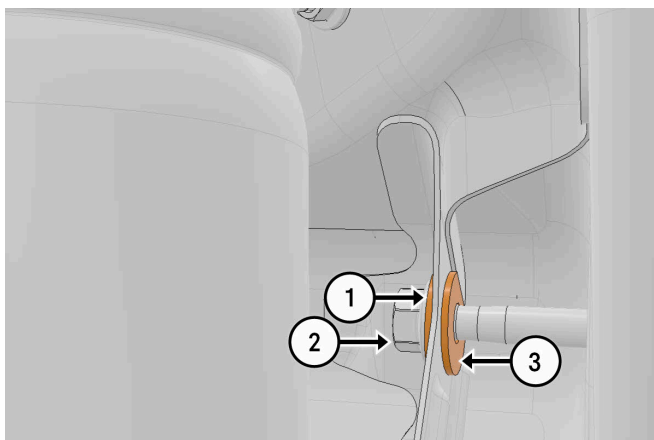
Figure 2. Rear flange

b. Position the component(s) as shown. Loosely install the fastener(s).

1	Round washer
2	Upper control arm bolt
3	Clipped washer

a. Apply adhesive to 1 clipped washer and 1 round washer.

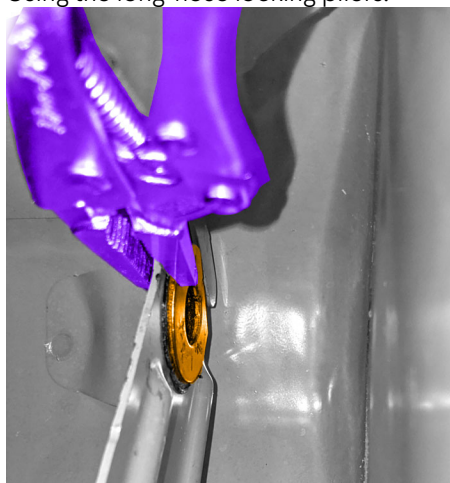
c. Using the long-nose locking pliers:

**Note:** Shown with components removed for clarity.

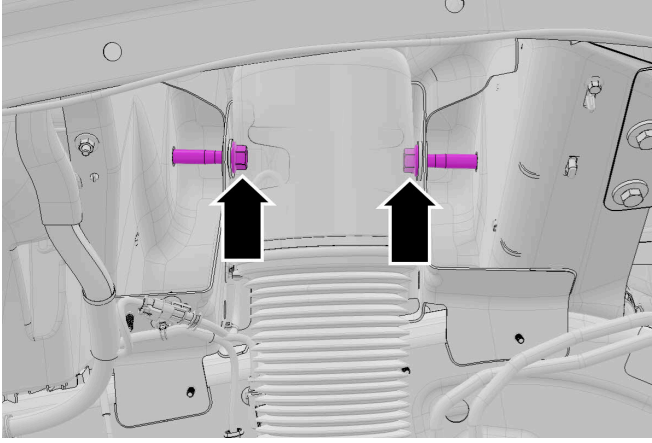
8. Remove:

Note: Shown with components removed for clarity.

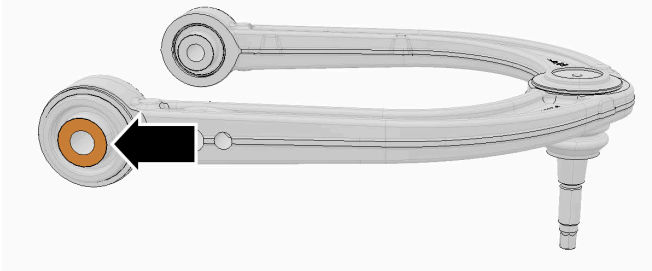
12. On both sides of the component: Check the highlighted area(s) for damage.

- If there is damage: Replace the component(s). Refer to service manual procedure 181010010.
- If there is no damage: Reinstall the component(s). Refer to service manual procedure 181010010.
