Technical Service Bulletin

66 Tail lamp trim molding is loose

66 22 90 2067733/1 August 4, 2022.

Model(s)	Year	VIN Range	Vehicle-Specific Equipment
A6	2019 – 2024	All	Not Applicable
A6 allroad, and S6	2020 – 2024		
RS 6 Avant	2021 – 2024

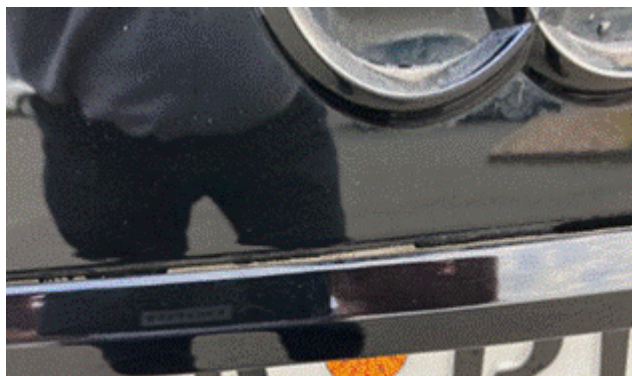
The bonding strip that affixes the center section of the tail lamp trim molding to the rear lid surface has weakened. The trim strip has pulled away to the extent that a gap can be seen.

Figure 1. Tail lamp trim molding loosening.

If any adhesion is found to be compromised or failed to any extent replace the center section of the tail lamp trim molding (section 3). Follow the procedure in ElsaPro to ensure proper seal adhesion paying particularly close attention to the adhesion surface preparation.

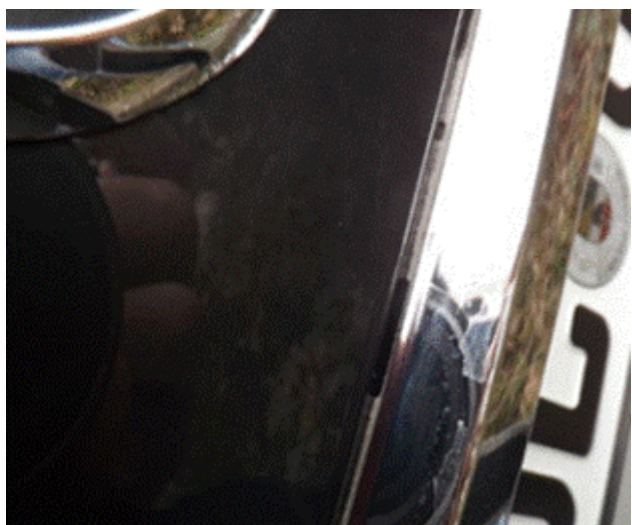
A visible gap is apparent between the tail lamp trim molding and the rear lid surface.

Figure 2. Debonding tail lamp trim molding with a visible gap.

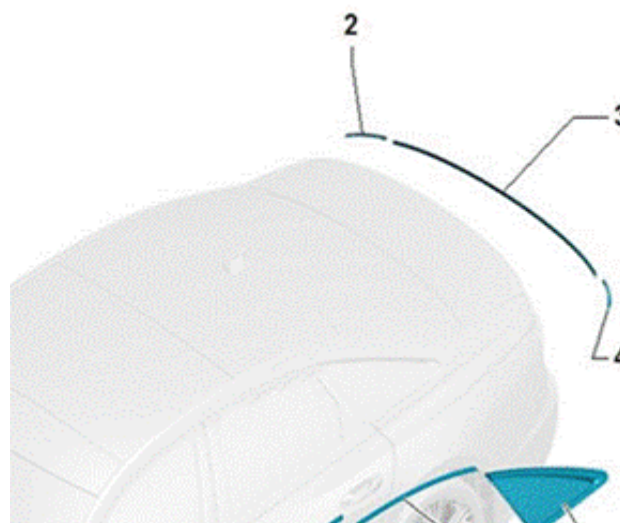
Figure 3. The Center section of the tail lamp trim molding to be replaced.

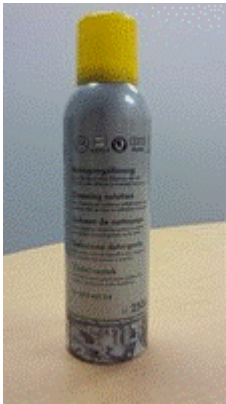
<p>All Purpose Cleaner</p>	<p>0.2</p>
<p>D 355205A2 or equivalent adhesion promoter (e.g. 3M™ 111 Adhesion Promoter or AC77 Adhesive Primer)</p>

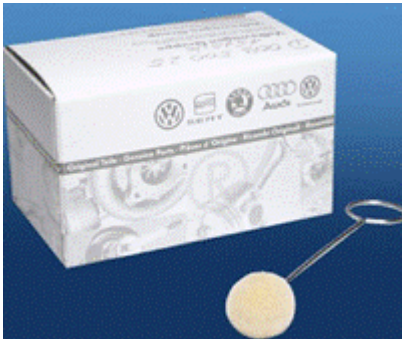
<p>Bonding agent</p>	<p>0.2</p>
<p>D 00950025 (or equivalent)</p>
