# Preliminary Information

## PIC6464 Variable Red Line Tachometer

Brand:	Model:	Model Years:	VIN:		Engine:	Transmissions:
			from	to		
Chevrolet	Corvette	2014 - 2019	All	All	All	All

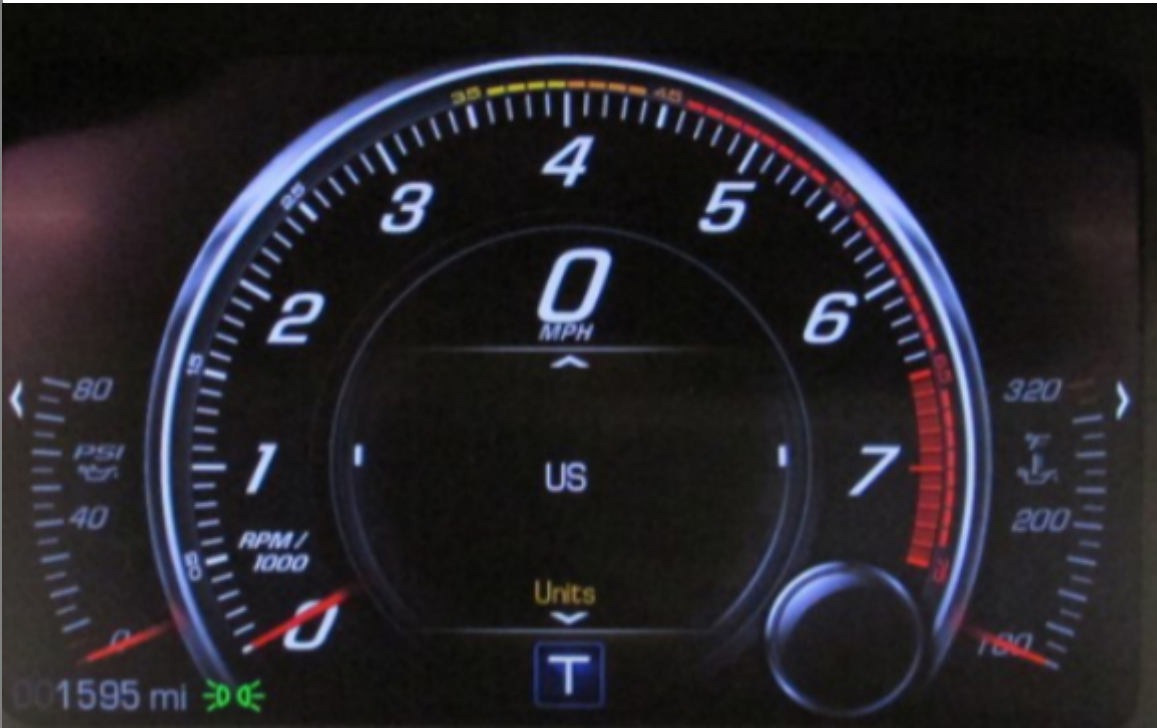
The first picture can be seen with a "cold" engine coolant temperature (ECT) reading taken just as the vehicle's engine was first started for the day. The redline reading can be seen at the 4,500 RPM mark.

**Correction:** If a customer has a concern with an intermittent or toggling redline, as indicated by the red LED segments on the outer edge of the tachometer, the dealership technician should check the ECT reading in the scan tool.

When the concern is acting up, the reading will also be erratic in nature.

The wiring to and from the sensor, as well as the sensor operation itself, should be inspected for any loose connections, terminal issues, etc. and repaired as needed.

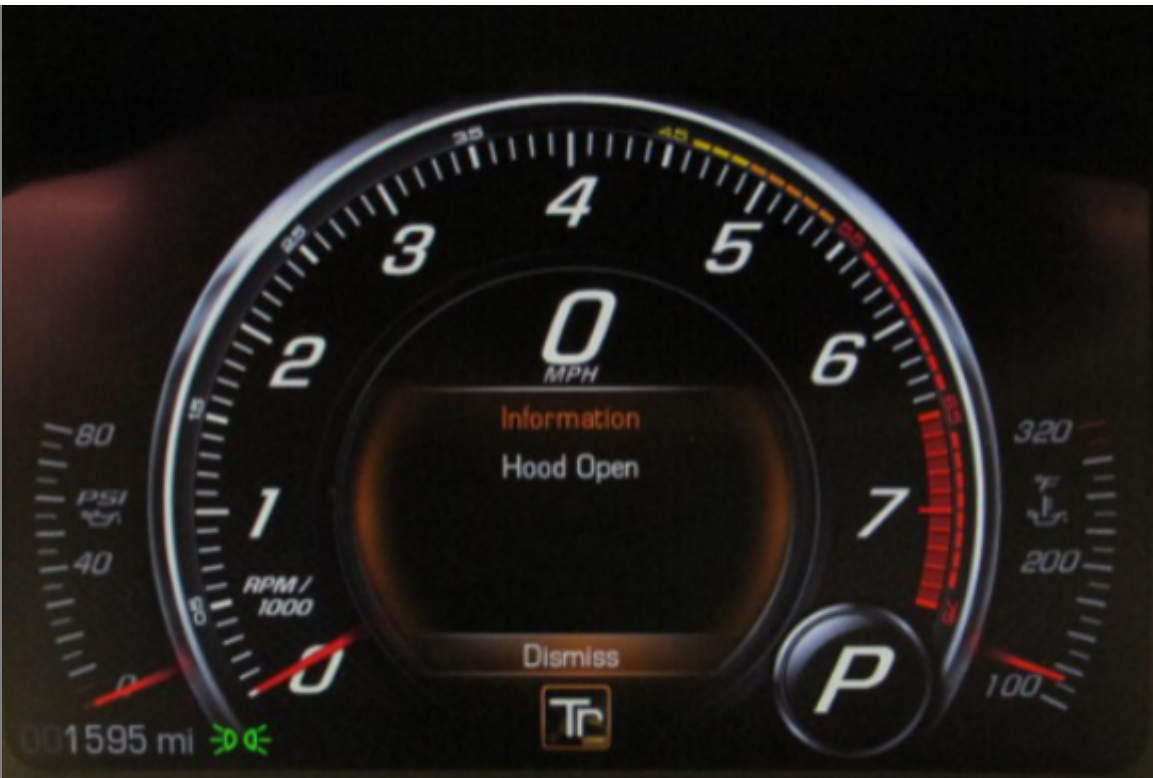
The second picture was taken as the vehicle has been started and allowed to warm up for a few minutes. Notice how the redline has increased to the 5,500 RPM mark.

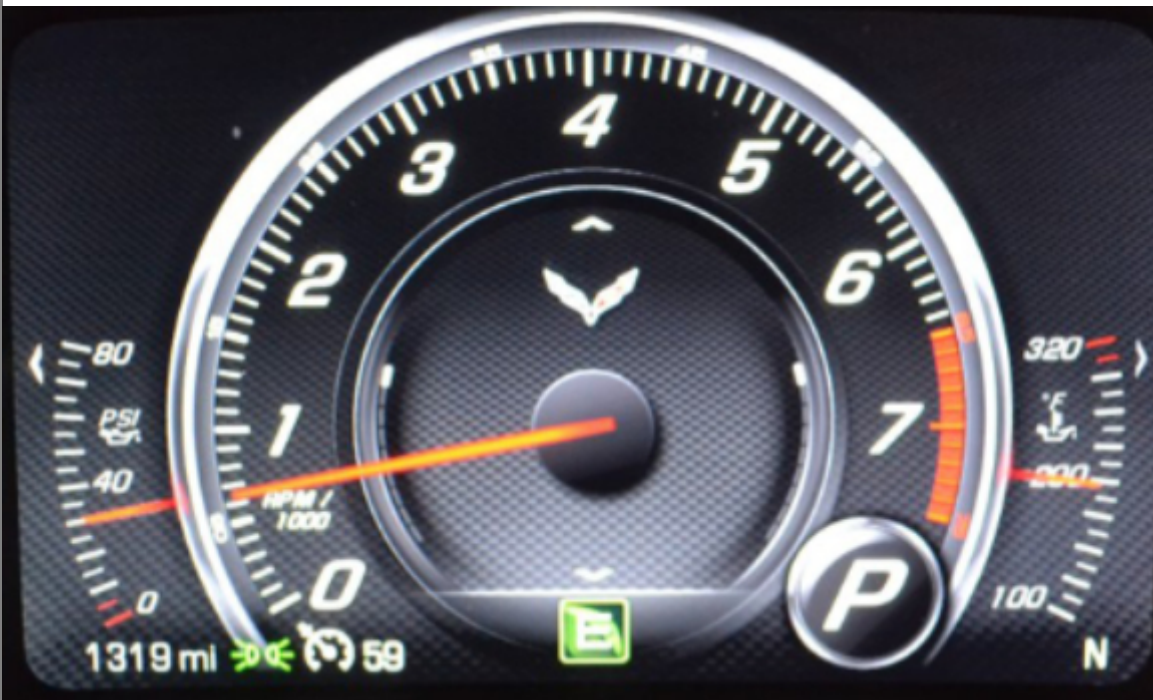
The last picture below was taken after the vehicle reached operating temperature. The redline in this photograph is at the 6,500 RPM mark.
