Bulletin No.: PIC6293G Published date: 07/15/2022

PIC6293G Installation Of the GM Accessory Interior Spectrum Lighting Kit

Brand:	Model:	Model Years:	VIN:		Engine	Transmissions:
			from	to	Engine:	Transmissions.
Chevrolet	Camaro	2016 - 2023	All	All	All	All

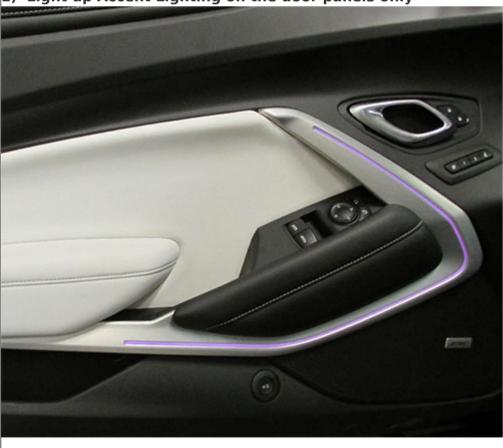
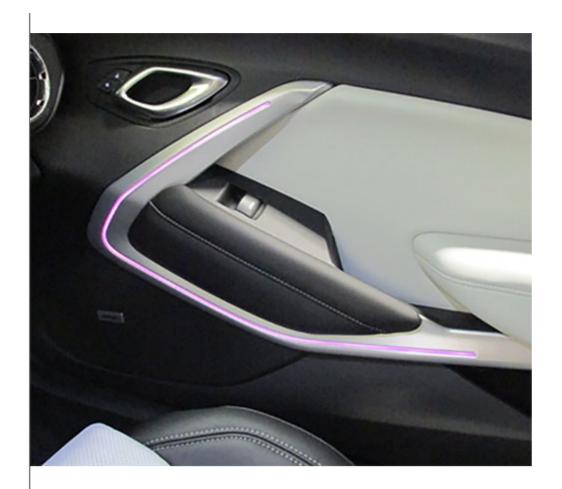
1) Light up Accent Lighting on the door panels only

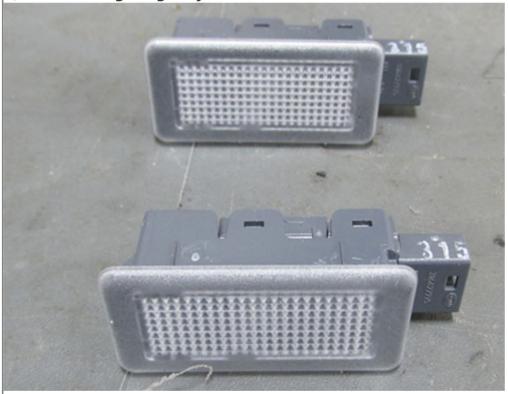
2) Footwell Lighting only

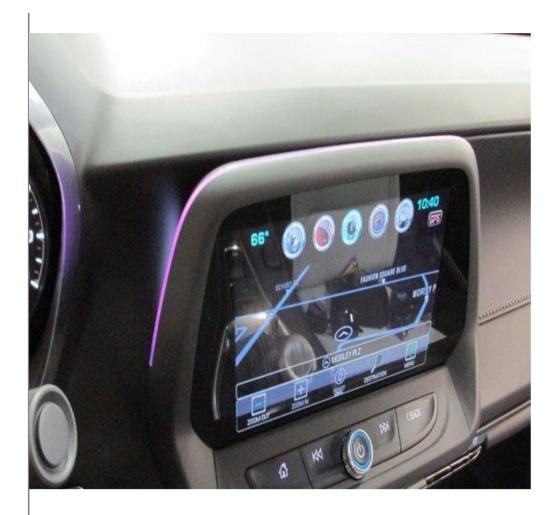
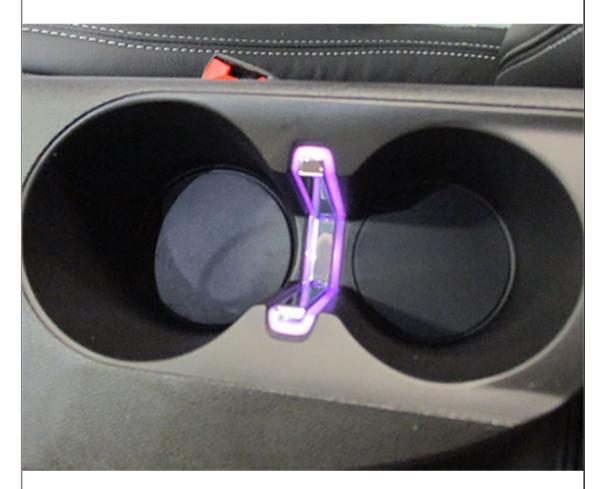
IMPORTANT: When installing a GM Accessory Lighting Kit, the light strips around the radio display and the center cupholders will NOT illuminate. The only way to get these two lights to operate is to purchase the vehicle with the factory C70 RPO. The radio display and the center cupholder will NOT illuminate with installation of the GM Accessory Lighting Kit.

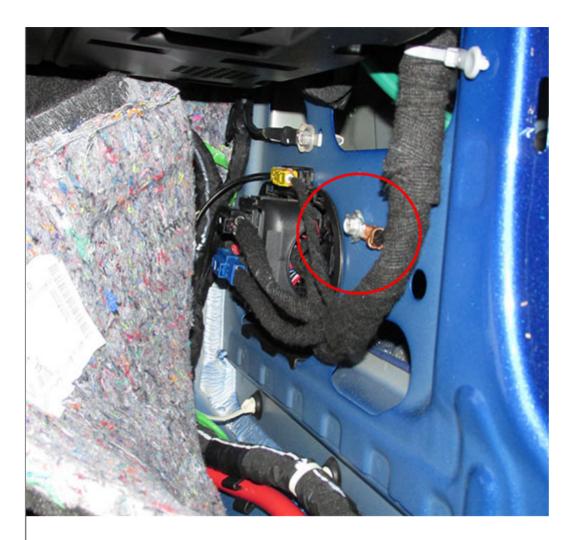
• If the entire kit has been installed and the lighting is entirely inoperative, there are a few things to go back and check. The most common area for concern is G202, which is located at the right hand kick panel. Typically, this ground has paint on it when the kit's eyelet is installed. Just tightening the fastener does not provide a good ground path if there is still paint covering the sheet metal. The fastener will have to be removed, the paint needs to be cleaned or ground off, and the ground path verified.

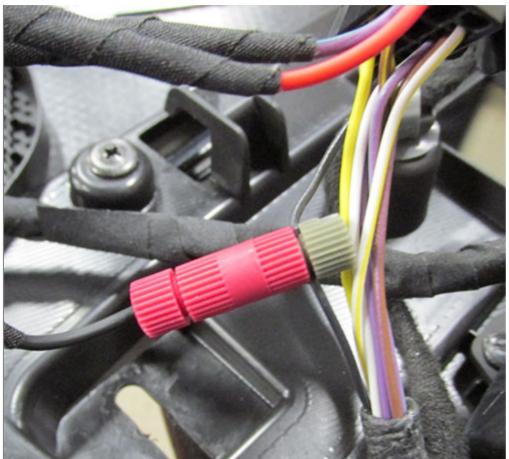
- Another common issue that is seen relates to the Posi-Tap connectors used in the kit. These connectors are used to splice the accessory harness to the vehicle's wiring harness.
 Dealership technicians are to go back through the installation and verify that each connector is tight. If one or more of these connecters is/are loose, this will cause any number of performance issues with the kit. The connector shown in the photo below does not have tape or a zip tie covering it for clarity. Once the connector is properly installed, the instructions have the technician tape back the splice to the main harness using cloth tape. This will prevent the connector from loosening up over time.

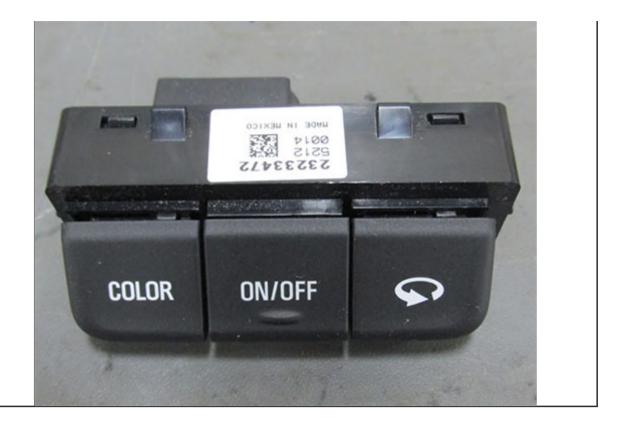
Vehicles equipped with the base radio (RPO IOB or IOR) do not require any programming. That is why the color selections are not available on the radio screen. This system uses a dashmounted switch to change the system's lighting colors. It is installed on the left hand side of the steering column. This switch can be seen in the photo below.
