TECHNICAL SERVICE BULLETIN

Moan Noise In The Rear Brakes When Vehicle Is Driven In Reverse On Cold Weather And/Or High Humidity

22-2326

Ford
2021-2022 Bronco Sport
2020-2022 Escape

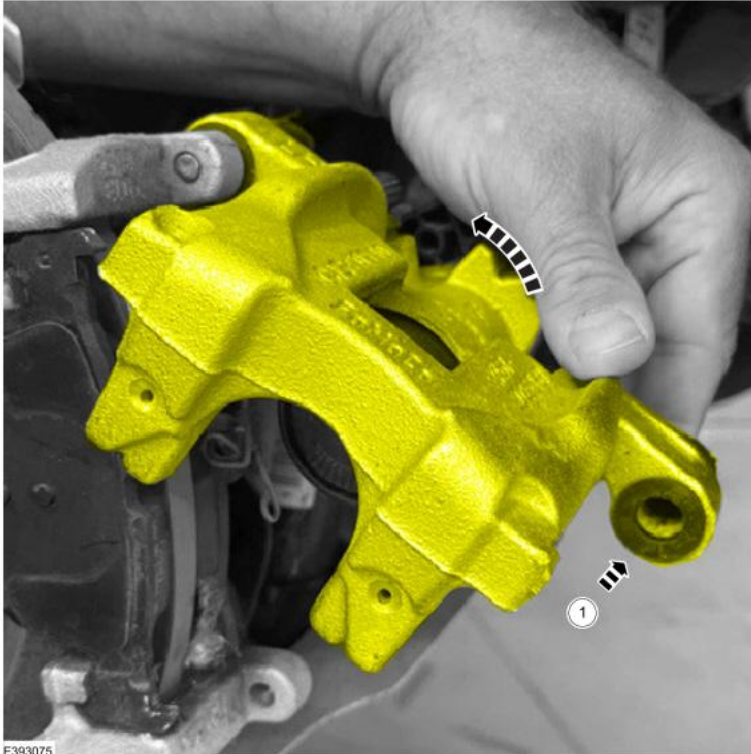
6. Rotate the rear caliper upwards to access to the bushing housing. (Figure 6, Callout 1)
Figure 6

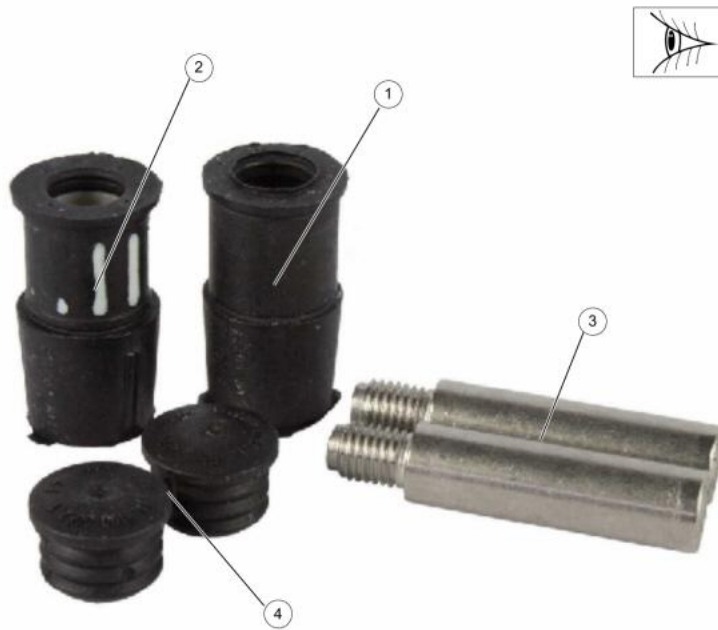
Figure 8 - Rear reinforced bushing kit contents

Item	Description
1	Standard bushing (1 piece)
2	Reinforced bushing (1 piece)
3	Guide pins (2 pieces)
4	Guide pin caps (2 pieces)

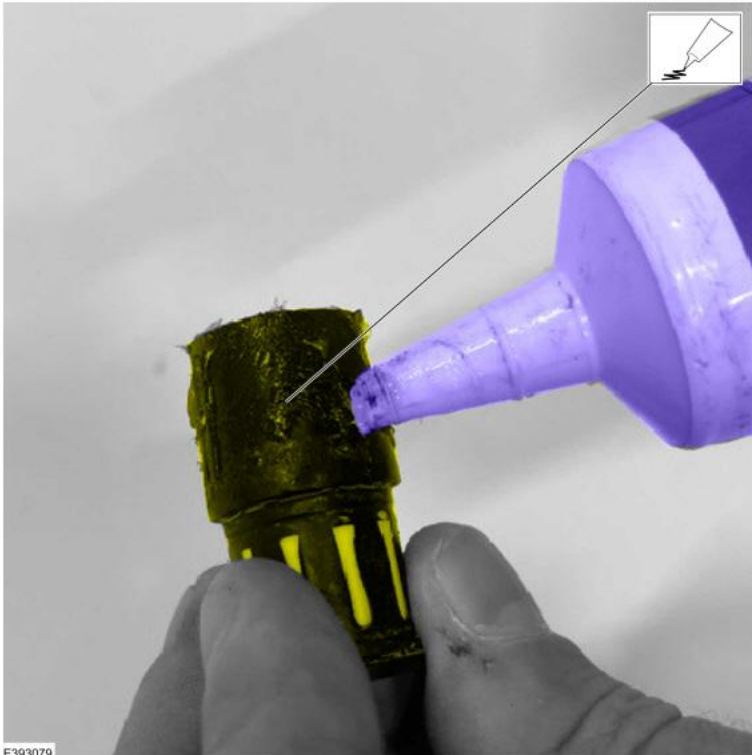
Figure 10

(3). Lubricate the bushing and bushing housing with Motorcraft® Silicone Brake Caliper Grease and Dielectric Compound. (Figures 10-11)
