VOLUNTARY SERVICE CAMPAIGN

Classification: HA22-004	Reference: NTB22-059	Date: July 22, 2022
-----------------------------	-------------------------	------------------------

VOLUNTARY EMISSION SERVICE CAMPAIGN 2022 PATHFINDER; A/C CONDENSER PIPE

CAMPAIGN ID #: PC899
APPLIED VEHICLES: 2022 Pathfinder (R53)

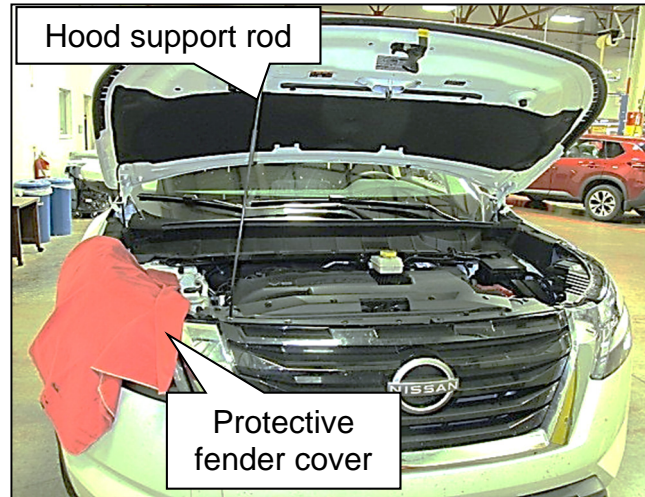
Figure 1

1. Open the hood and use the hood support rod to support the hood.
2. Install a protective fender cover.

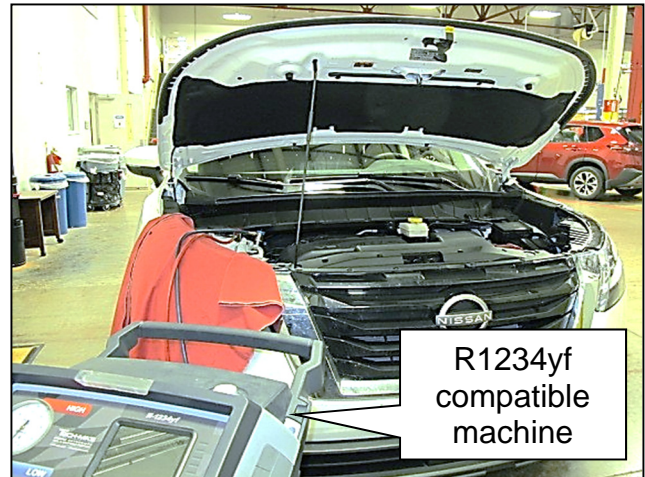
Figure 2

3. Recover the refrigerant using approved equipment.
 - Refer to the ESM: **VENTILATION, HEATER & AIR CONDITIONER > HEATER & AIR CONDITIONING SYSTEM > PERIODIC MAINTENANCE > REFRIGERANT > Recycle Refrigerant**

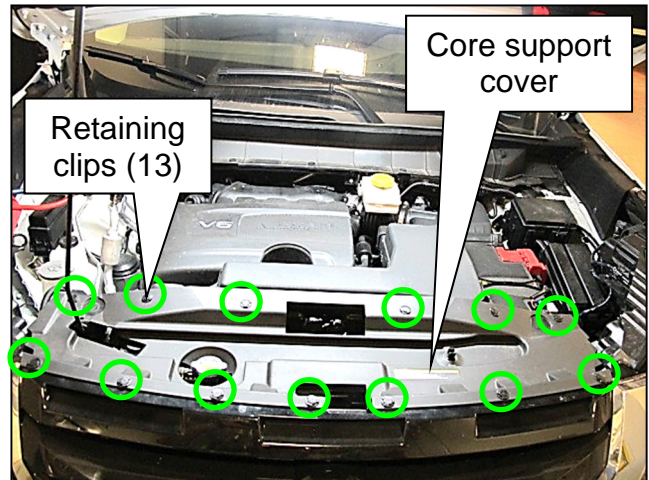
Figure 3

4. Remove the core support cover.
 - Using a suitable tool, remove the thirteen (13) retaining clips, and then remove the core support cover.

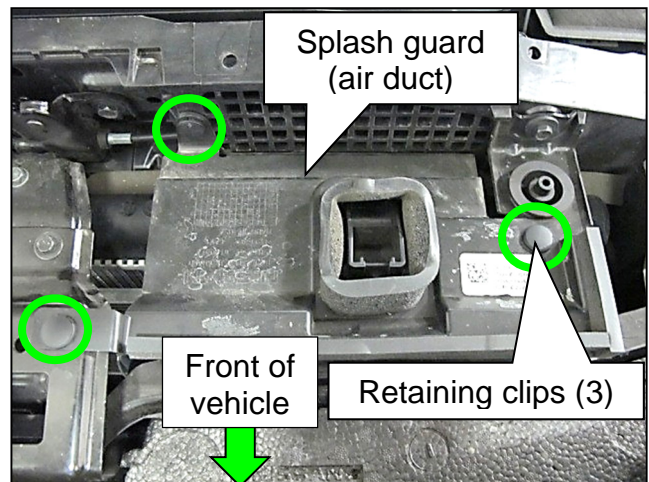
Figure 4

5. Remove the splash guard (air duct).
 - Using a suitable tool, remove the three (3) retaining clips, and then remove the splash guard.

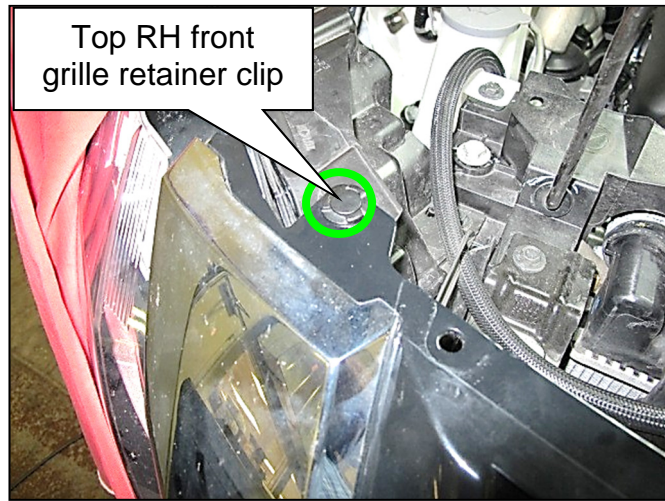
Figure 5

- Using a suitable tool, remove the top passenger (RH) side (Figure 5) and the top driver (LH) side (Figure 6) front grille retainer clips.

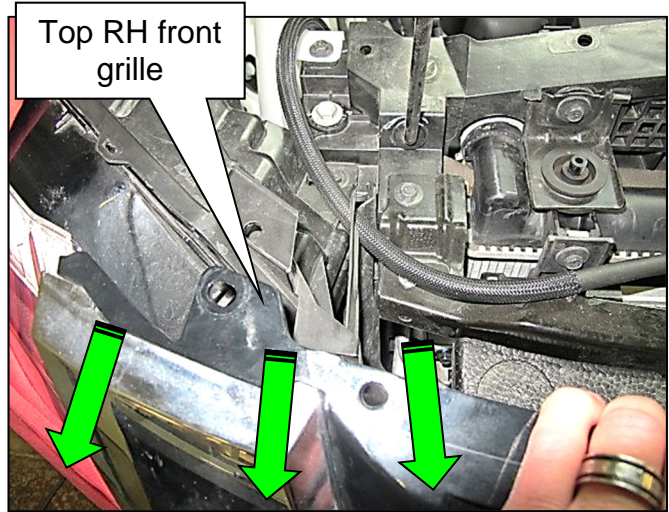
Figure 7

7. Gently pull out the top of the passenger (RH) side (Figure 7) and the driver (LH) side (Figure 8) front grille ONLY.
- When gently pulling forward on the front grille, the clips/pawls should release and allow the front grille to move forward.

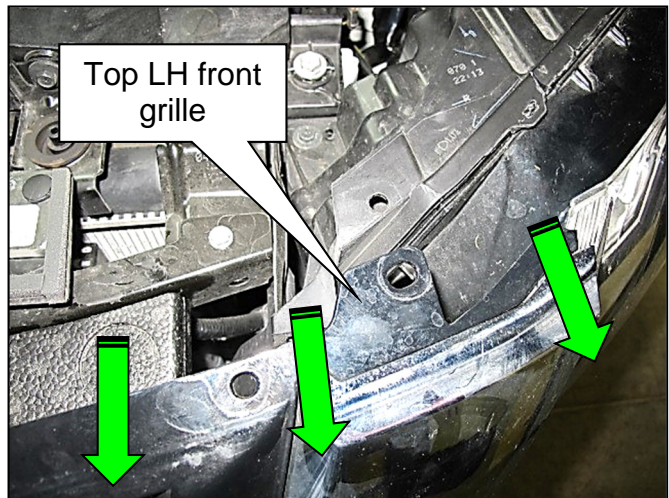
Figure 8

NOTE: Complete removal of the front grille assembly from the vehicle is not required.

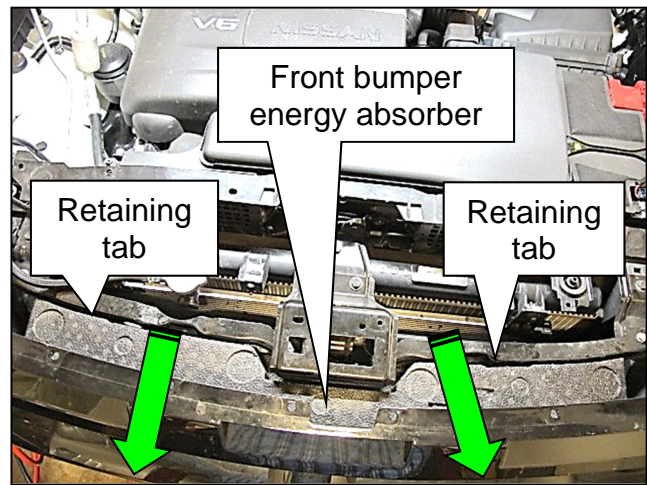
Figure 9

8. Remove the front bumper energy absorber.
 - a. Locate the backside of the two (2) retaining tabs in the core support and push them forward with a finger to release them from the core support.
 - b. Push the front bumper energy absorber forward and lift it out.
 - c. Discard the front bumper energy absorber, it will not be reused.

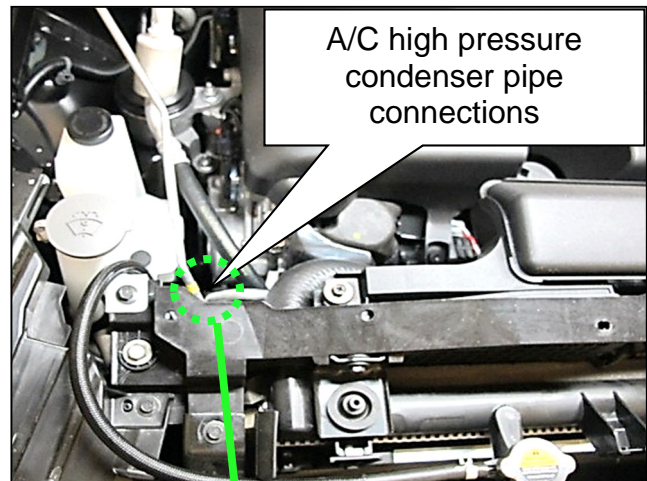
9. Locate the A/C high pressure condenser pipe connections in the engine compartment, where shown in Figure 10 and Figure 11.

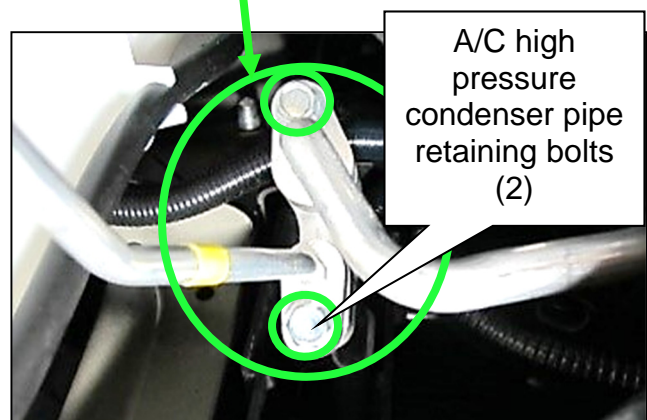
Figure 11

10. Remove the two (2) 12 mm A/C high pressure condenser pipe retaining bolts in the engine compartment, where shown in Figure 11.

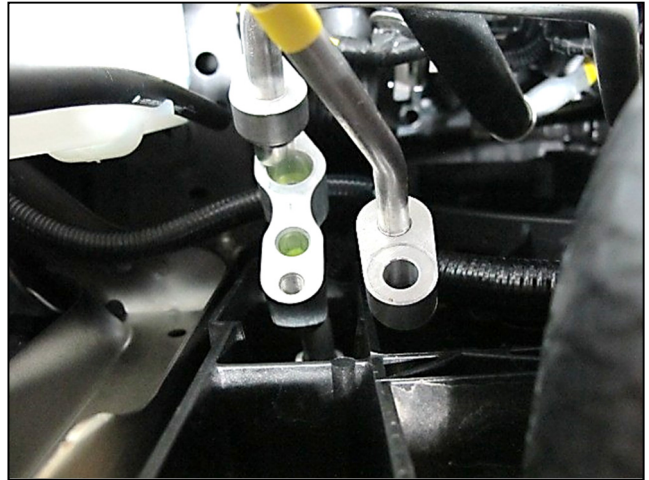
Figure 12

11. Disconnect the high pressure pipe and the high pressure flex-hose connections (Figure 12).
 - a. Gently pull and wiggle each pipe to allow the O-ring and captured seal to release.

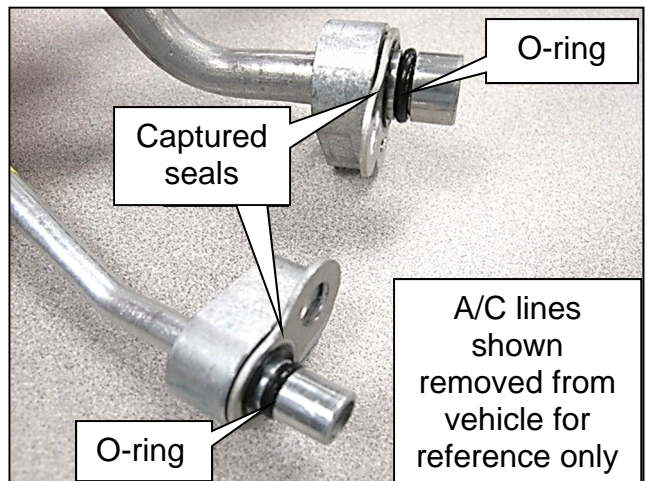
Figure 13

- b. Remove and discard the O-ring seal and the captured seal from each high pressure pipe, they will not be reused (Figure 13).
 - c. Cap off or use a suitable material such as vinyl tape, to wrap the high pressure pipe and the high pressure flex-hose connections (vehicle side) to avoid the entry of air.

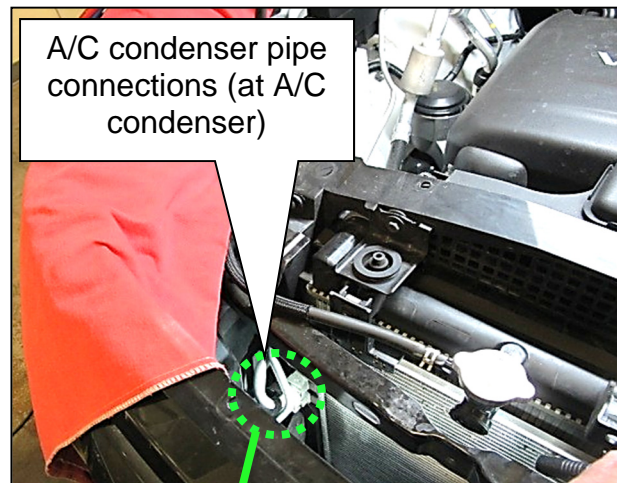
Figure 14

12. Locate the A/C condenser pipe connections at the A/C condenser (Figure 14).

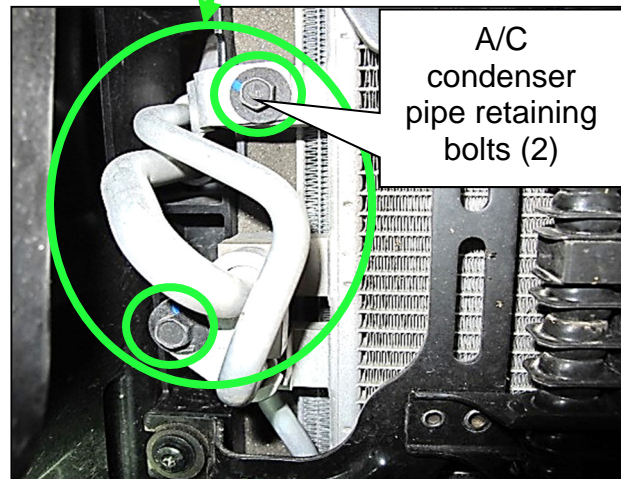
Figure 15

13. Remove the two (2) 10 mm A/C condenser pipe retaining bolts at the A/C condenser, where shown in Figure 15.

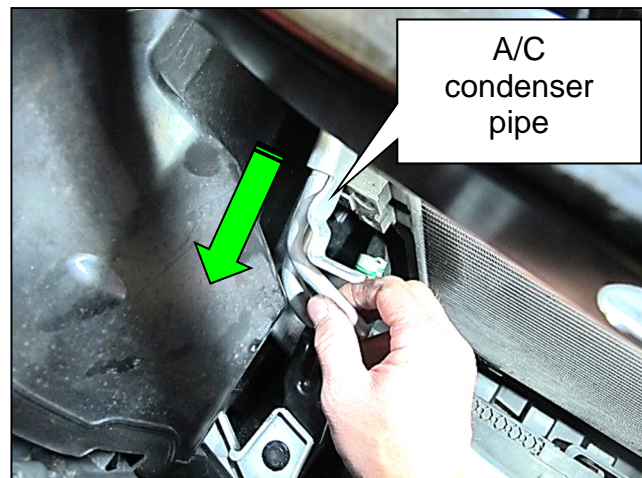
Figure 16

14. Disconnect the A/C condenser pipe from the A/C condenser (Figure 16).
- Gently pull the A/C condenser pipe away from the A/C condenser.

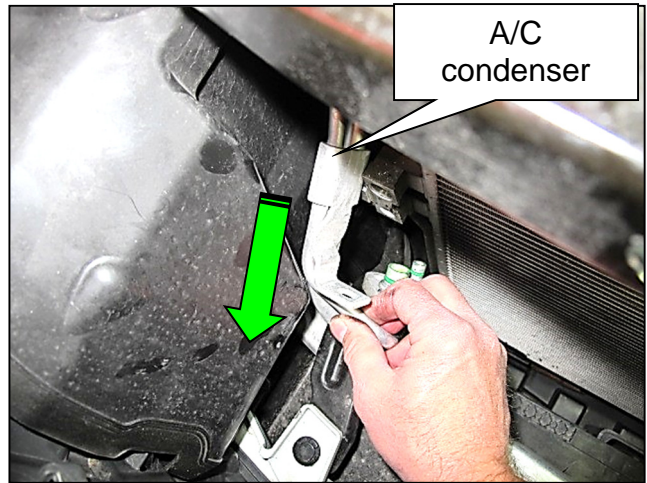
Figure 17

- a. Pull the A/C condenser pipe forward, halfway through the radiator core support (Figure 17).

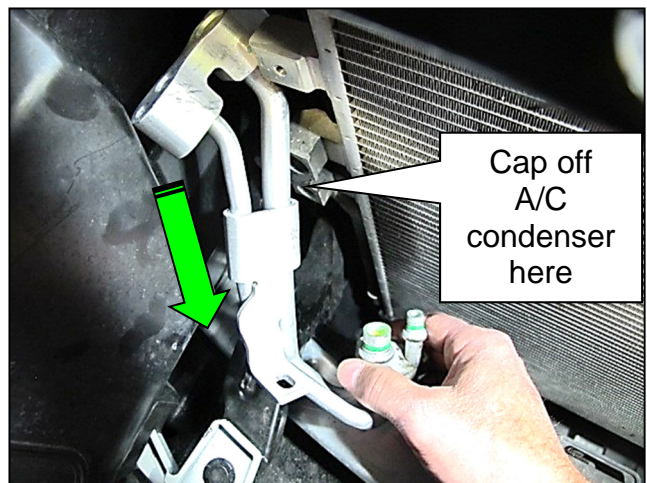
Figure 18

- b. Pull down on the A/C condenser pipe as it threads through the radiator core support to remove it from the vehicle (Figure 18).
- c. Cap off or use a suitable material, such as vinyl tape, to wrap the A/C condenser pipe openings on the A/C condenser to avoid the entry of air.

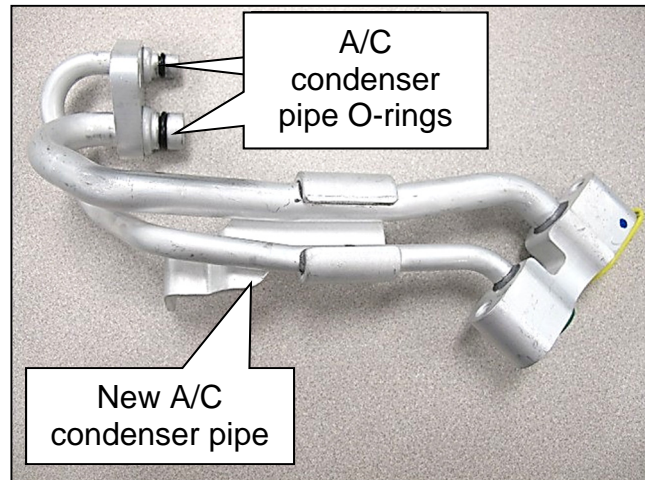
Figure 19

16. Install the new A/C condenser pipe.
- a. Remove the protective covers from the new A/C condenser pipe.
 - b. Verify the O-rings are present and undamaged (Figure 19).
 - o The new A/C condenser pipe will be supplied with new O-rings installed on the end that mates to the A/C condenser.
 - c. Apply the correct refrigerant oil (PAG VC100YF) to all the new A/C condenser pipe O-rings and seals.

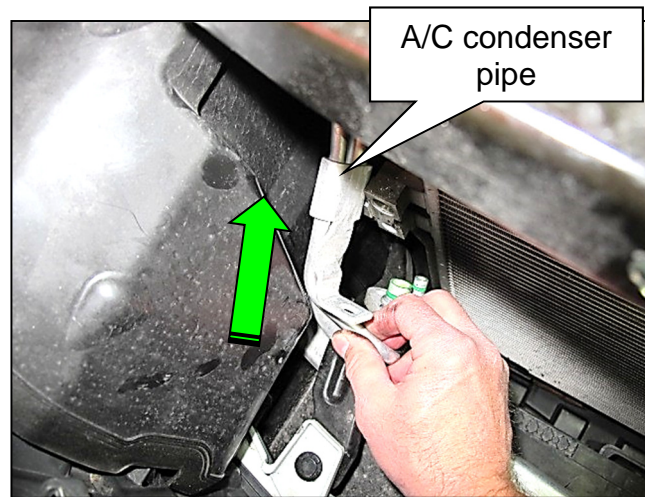
Figure 20

- d. Thread the new A/C condenser pipe through the radiator core support (Figure 20).
- e. Install the A/C condenser pipe into the engine compartment.
- f. Remove any caps and/or protective covering from the A/C condenser openings.

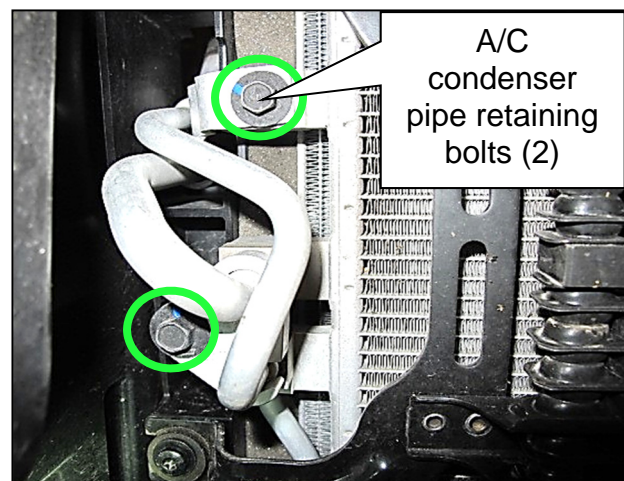
Figure 21

- g. Install and torque the two (2) 10 mm A/C condenser pipe retaining bolts (Figure 21).
 - o A/C condenser pipe retaining bolt torque: 8.0 N•m (0.82 kg-m, **71 in-lb**)

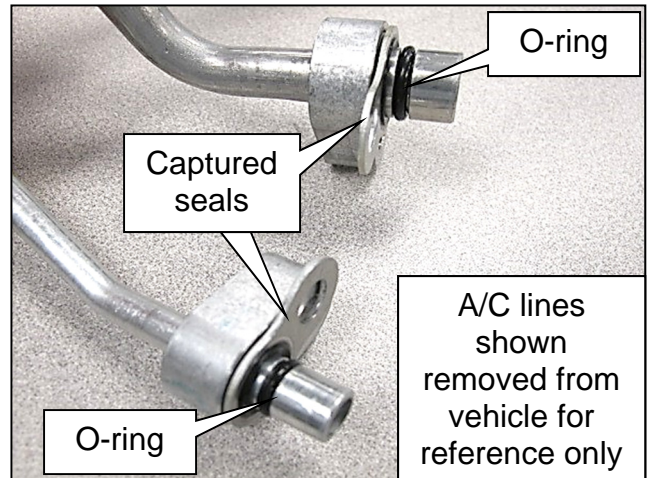
Figure 22

17. Install the high pressure pipe and the high pressure flex-hose connections.
 - a. Remove any caps and/or protective covering from the A/C high pressure pipe and the high pressure flex-hose connections.
 - b. Install new O-rings and captured seals onto the high pressure pipe and the high pressure flex-hose connections (Figure 22).
 - c. Apply the correct refrigerant oil (PAG VC100YF) to the new high pressure pipe and high pressure flex hose O-rings and captured seals.

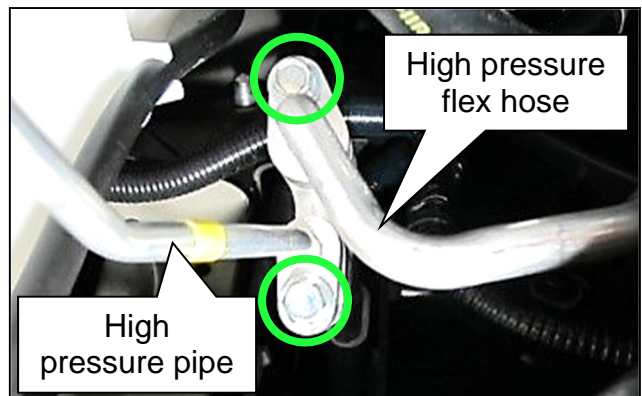
Figure 23

- d. Connect the high pressure pipe and the high pressure flex-hose connections (Figure 23).
- e. Install and torque the two (2) 12 mm retaining bolts for the high pressure pipe and the high pressure flex-hose connections.
 - o High pressure pipe and high pressure flex-hose connection bolt torque: 11.0 N•m (1.1 kg-m, **8 ft-lb**)

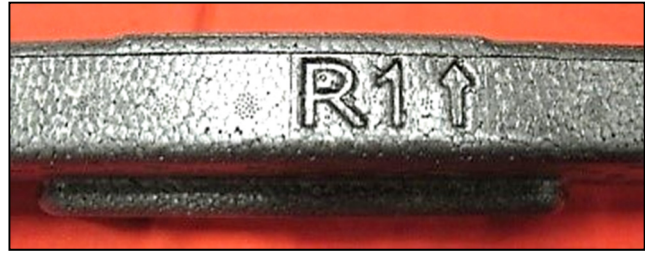
Figure 24

a. The front bumper energy absorber is directional. Install it with the "R1" and arrow facing up (Figure 24 and Figure 25).

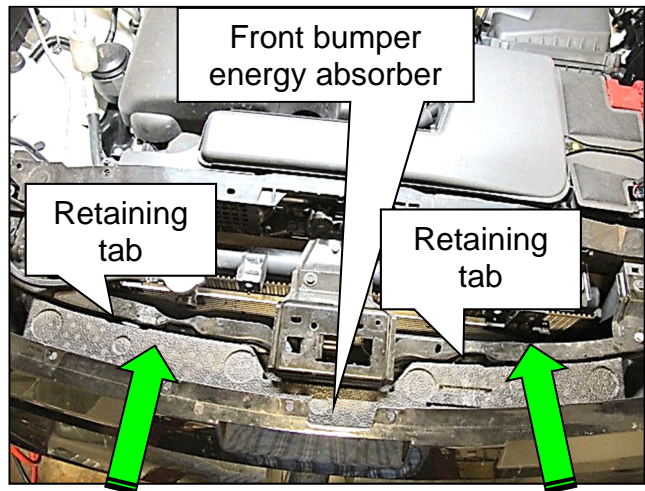
Figure 26

b. Locate the two (2) retaining tabs on the back of the front bumper energy absorber and gently install them into the radiator core support holes (Figure 26).

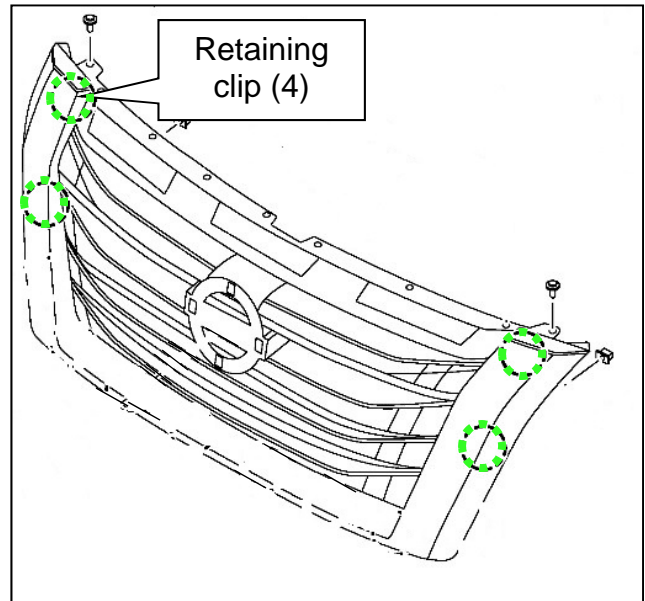
Figure 27

19. Reposition the top right and left sides of the front grille (Figure 27).

- a. Push down on the top corners of the front grille to align the retaining clips on the sides into the respective holes, then latch the front grille into place.

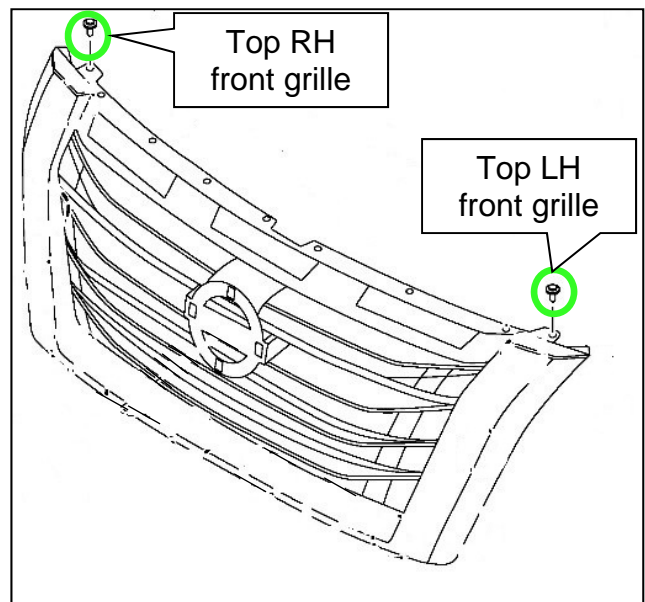
Figure 28

- b. Install the top passenger (RH) side and the top driver (LH) side front grille retainer clips (Figure 28).

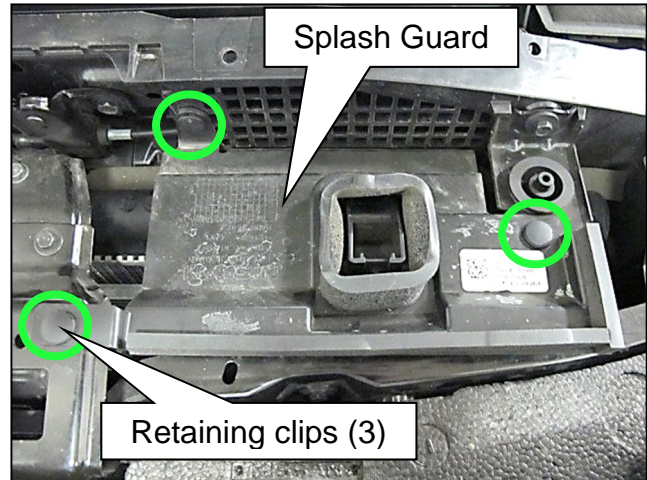
Figure 29

20. Install the splash guard (Figure 29).
- Install the three (3) retaining clips and the splash guard.

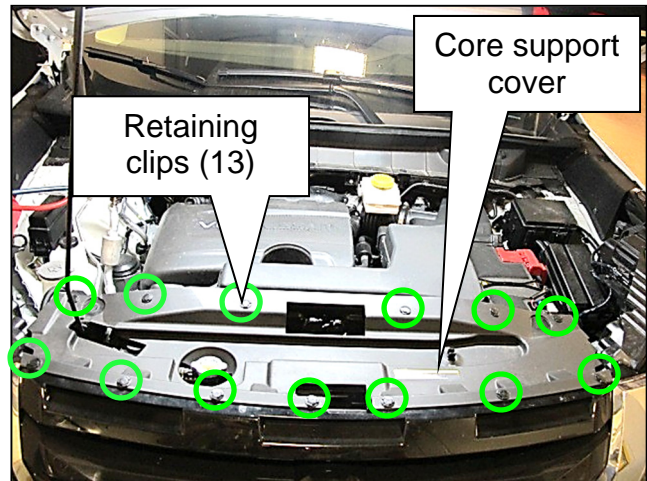
Figure 30

21. Install the core support cover, and then install the thirteen (13) core support cover retaining clips (Figure 30).

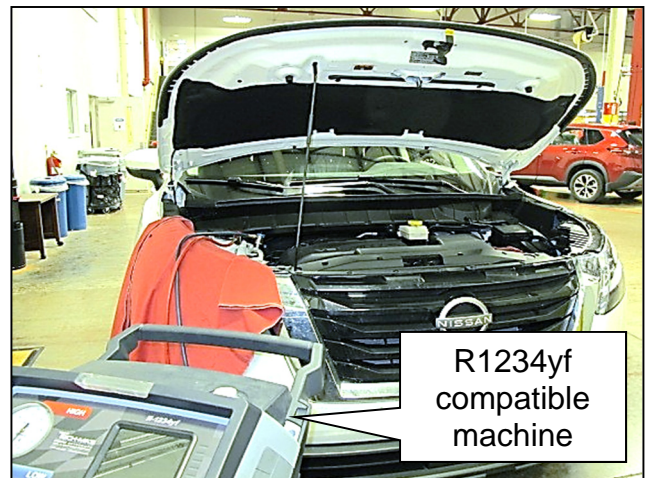
Figure 31

22. Recharge the refrigerant using approved equipment.
- Refer to the **ESM: VENTILATION, HEATER & AIR CONDITIONER > HEATER & AIR CONDITIONING SYSTEM > PERIODIC MAINTENANCE > REFRIGERANT > Charge Refrigerant**
 - Verify there are no refrigerant leaks at the condenser pipe connections.
