VOLUNTARY SERVICE CAMPAIGN

Classification: RS22-003A	Reference: NTB22-063A	Date: July 28, 2022
------------------------------	--------------------------	------------------------

VOLUNTARY SERVICE CAMPAIGN 2021 ROGUE; PASSENGER SIDE SEAT BELT RETRACTOR AND AIRBAG MODULE

CAMPAIGN ID #: P2A08
APPLIED VEHICLES: 2021 Rogue (T33)
APPLIED VINS: 11th character of VIN is W
APPLIED DATES: Built before January 28, 2021

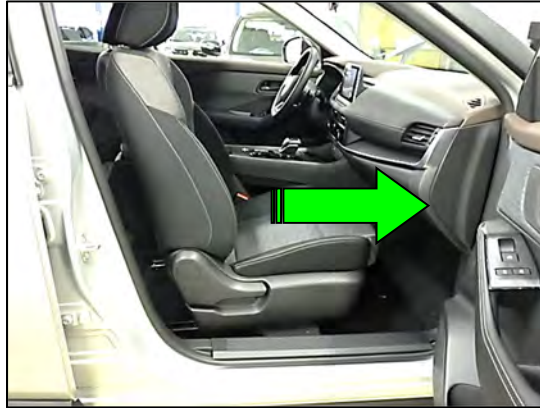
Figure 1

1. Open the front and rear passenger (RH) side doors, and then slide the front passenger seat to the forward-most position, as shown in Figure 1.

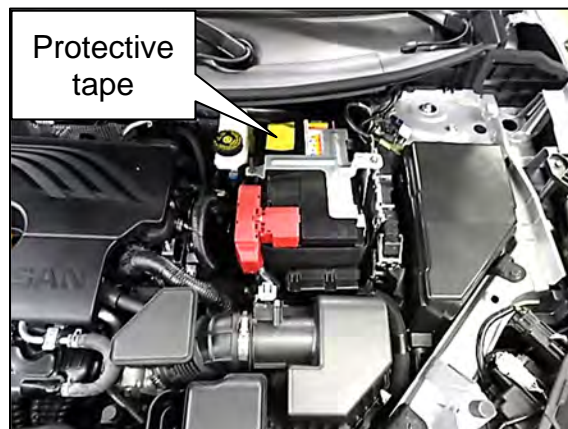
Figure 2

To prevent the risk of personal injury or damage to the vehicle, verify the ignition switch is OFF and a minimum of 3 minutes has elapsed since the negative battery terminal was disconnected, before proceeding to step 3.

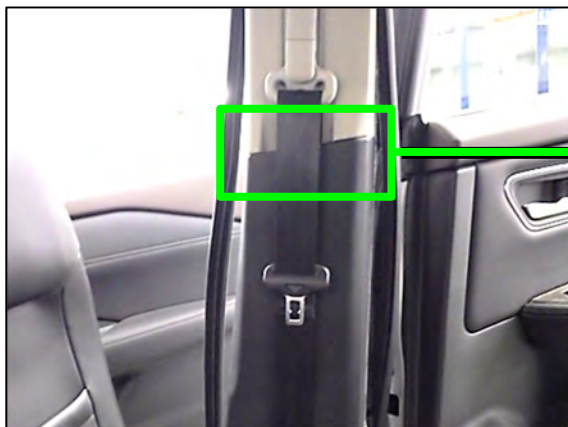
Figure 8

7. Disengage the two (2) center pillar lower garnish upper fixing pawls.

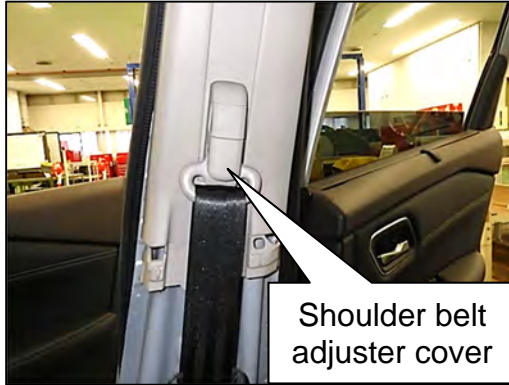
Figure 16

- a. Pull out on the shoulder belt adjuster cover's lower side, and then disengage the adjuster cover lower side fixing pawls.

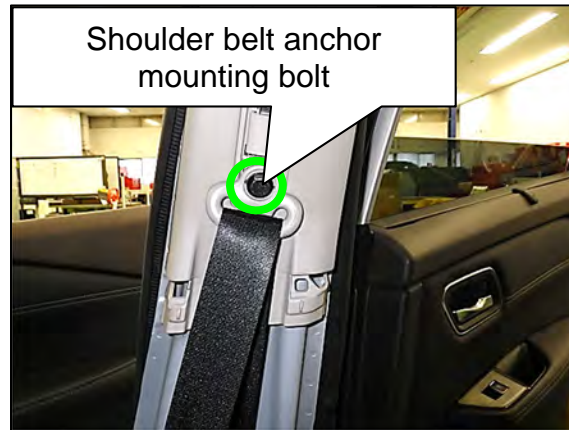
Figure 20

13. Remove the shoulder belt anchor mounting bolt, and then remove the shoulder belt anchor.

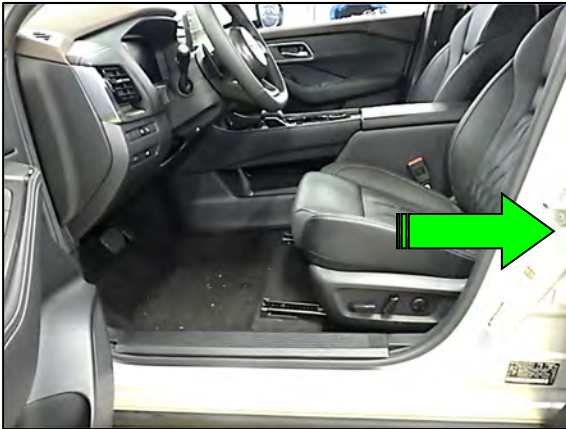
19. Open both front doors, and then slide both front seats to the rear most position, as shown in Figure 22 and Figure 23.

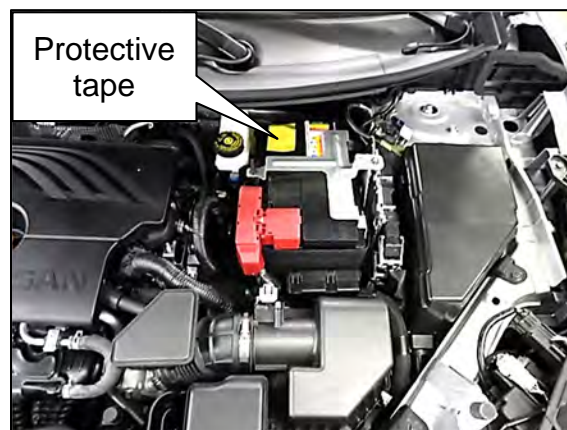
Figure 24

20. Open the hood and disconnect the negative battery terminal.
 - Verify the ignition is OFF before disconnecting the terminal.
 - Install protective tape over the negative battery terminal.
 - Wait a minimum of 3 minutes before proceeding so that the air bag diagnosis unit may fully discharge any remaining electricity.

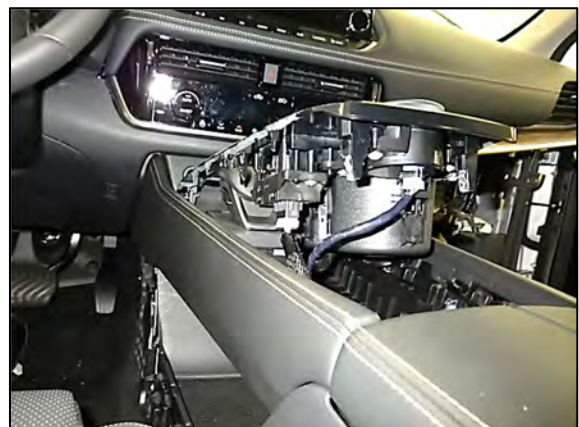
Figure 34

26. Disconnect the wire harness connectors, and then remove the center console finisher assembly.

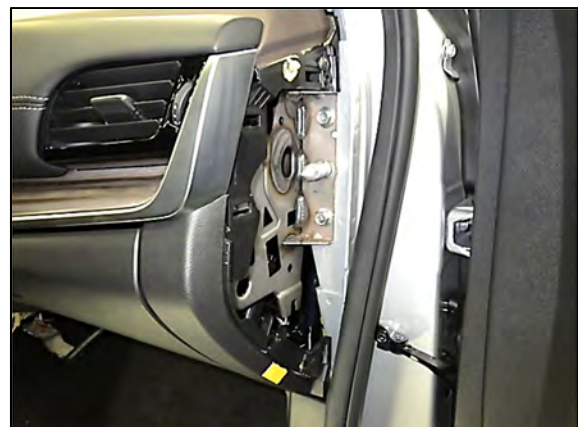
Figure 50

35. Using a remover tool, disengage the five (5) instrument mask fixing pawls, as indicated by the arrows shown in Figure 49, and then remove the RH instrument mask (Figure 50).

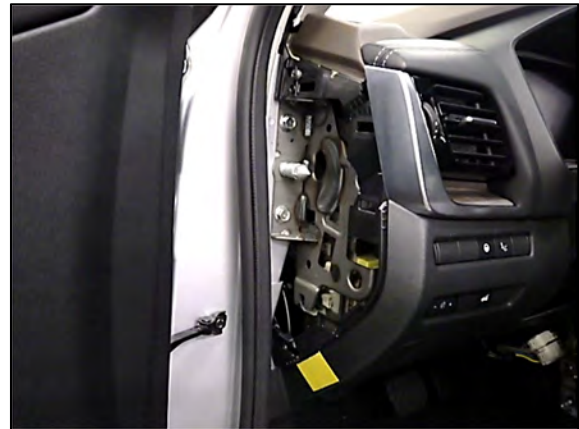
Figure 57

39. Using a remover tool, disengage the five (5) instrument mask fixing pawls, as indicated by the arrows shown in Figure 56, and then remove the LH instrument mask (Figure 57).

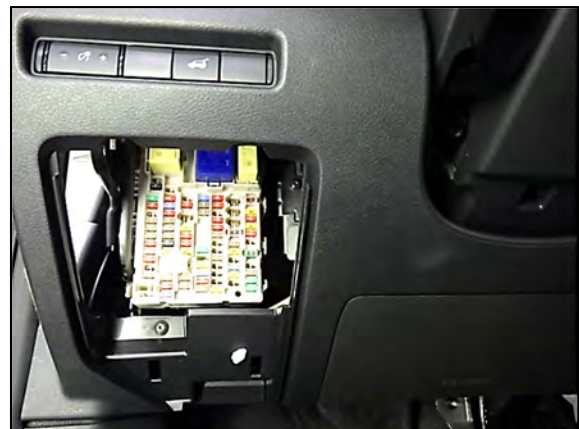
Figure 59

40. Disengage the four (4) fuse block lid fixing pawls, as indicated by the arrows shown in Figure 58, and then remove the fuse block lid (Figure 59).

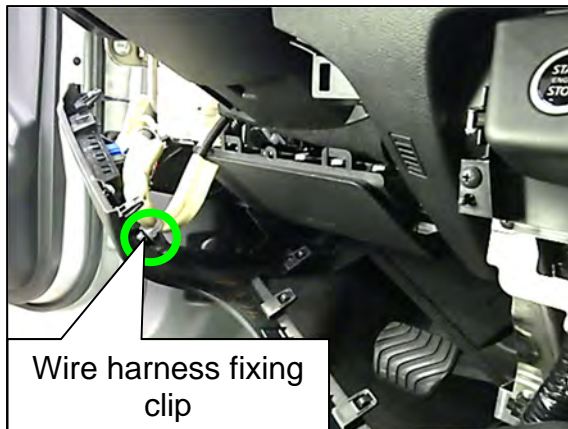
Figure 62

43. Disengage the wire harness fixing clip (Figure 62), disconnect the wire harness connectors, data link connector (Figure 63), and then remove the LH instrument lower panel.

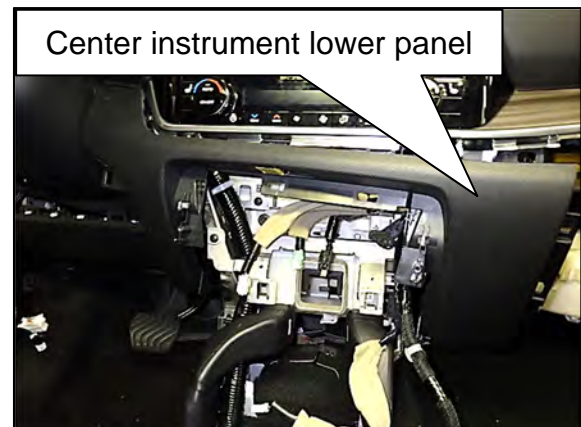
Figure 72

51. Disengage the five (5) center instrument lower panel metal clips, as indicated by the arrows in Figure 71, and then pull out the center instrument lower panel (Figure 72).

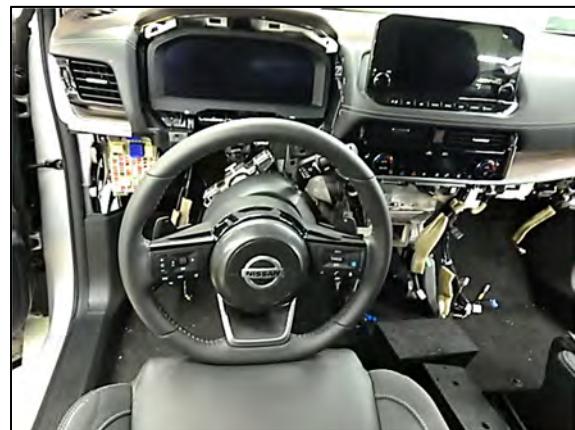
Figure 85

58. Slightly pull the steering column out just enough to rest the steering wheel on the driver seat cushion, as shown in Figure 85.

IMPORTANT: Carefully lift the steering column to unlatch it from the dash, and then pull it out slightly to rest it on the driver seat. Do not excessively pull on the steering column as the steering column shaft will over-extend and the shaft splines will disengage.

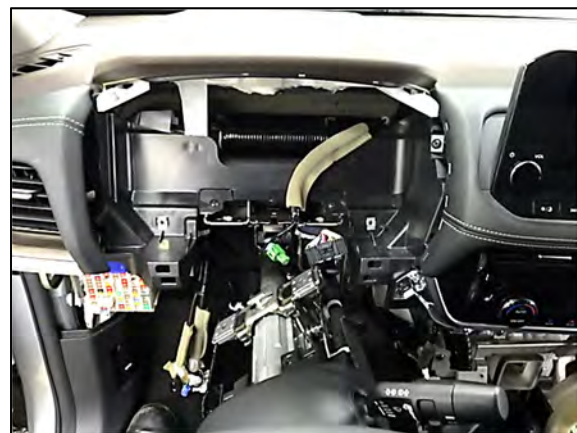
Figure 89

60. Disconnect the wire harness connectors (Figure 88), and then remove the combination meter (Figure 89).

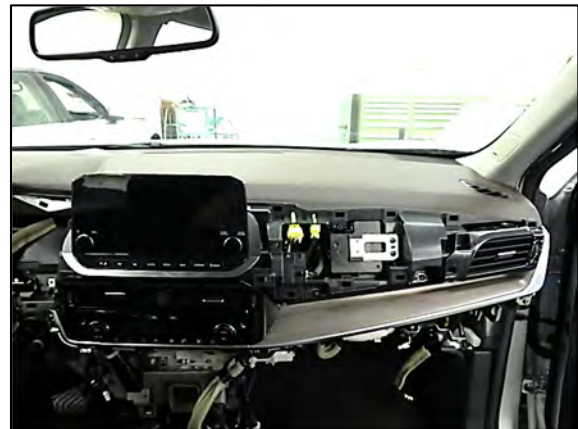
Figure 94

63. Disengage the two (2) instrument pad B fixing pawls and fifteen (15) metal clips, as indicated by the arrows in Figure 93, and then remove instrument pad B (Figure 94).

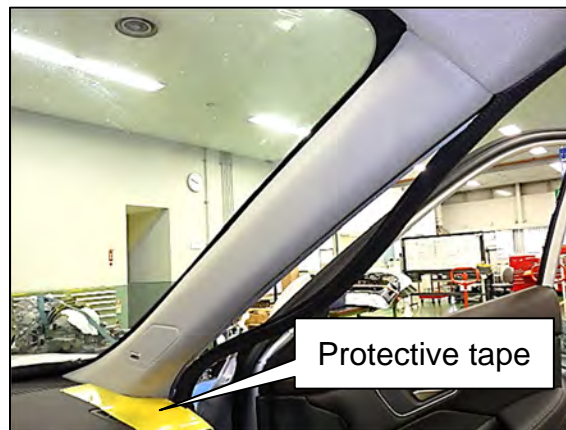
Figure 105

72. Apply protective tape to the RH side of the instrument panel assembly, as shown in Figure 105.

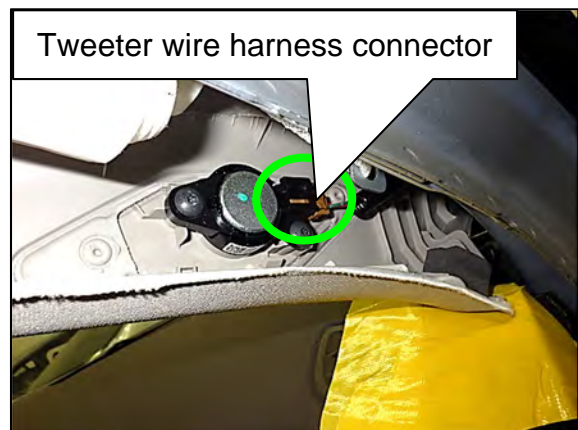
Figure 111

- If equipped, disconnect the tweeter wire harness connector (Figure 111).

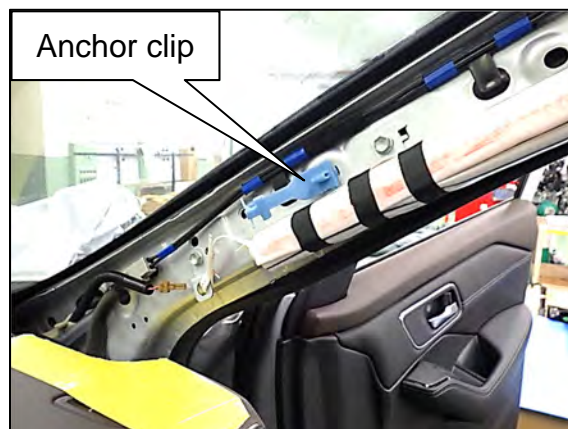
Figure 112

76. Remove the anchor clip from the RH A-pillar and replace with a new one.
