VOLUNTARY SERVICE CAMPAIGN

Classification: BT22-006A	Reference: NTB22-024A	Date: May 19, 2022
------------------------------	--------------------------	-----------------------

VOLUNTARY SERVICE CAMPAIGN 2013-2018 ALTIMA SEDAN; FRONT COMBINATION LAMPS (HEADLAMPS) INSPECTION

CAMPAIGN ID #: PC861
APPLIED VEHICLES: 2013-2018 Altima Sedan (L33)
APPLIED SYSTEMS: Front Combination Lamps (Headlamps) – Halogen ONLY

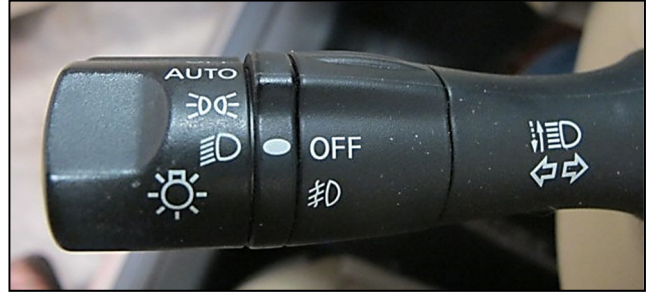
Figure 1

1. Open the driver (LH) side door.
2. Set the parking brake.
3. Start the engine.
4. Turn the headlamps ON using the combination switch.
 - Ensure the low beams are ON, high beams are OFF.
 - If equipped, turn the fog lights OFF.

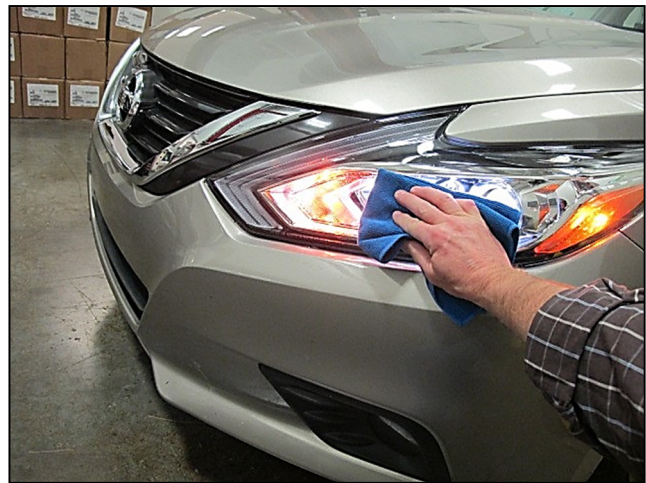
Figure 2

5. Clean both front headlamp assemblies using clean water and a clean, soft car towel.

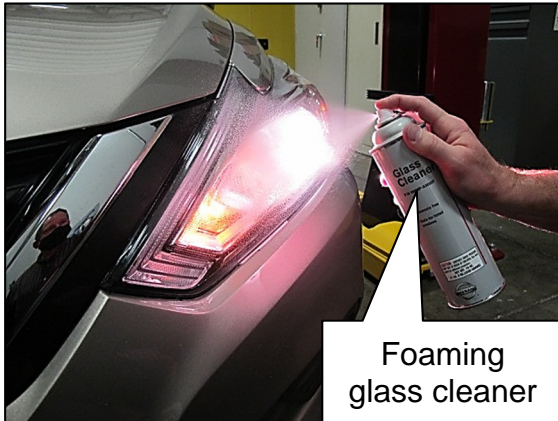
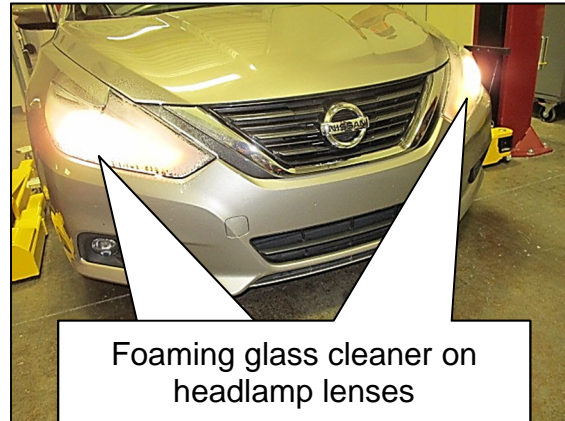
HINT: To help highlight the headlamp low beam light pattern on the headlamp lenses, you can spray both headlamp assemblies with Nissan Foaming Glass Cleaner (PN: 999MP-A3050P) or an equivalent foaming glass cleaner (Figure 3 and Figure 4).

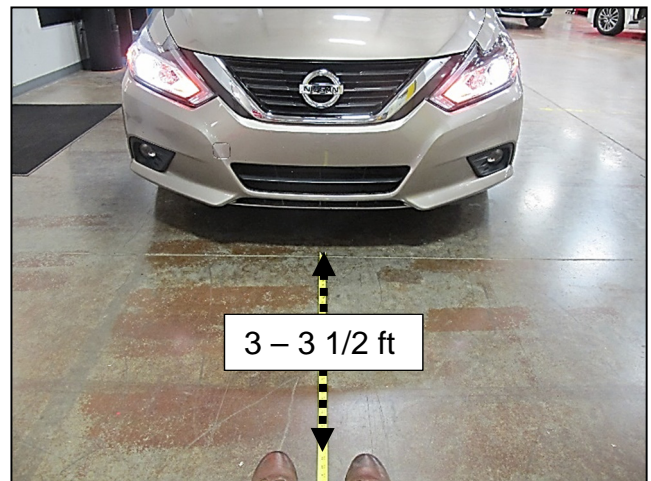
Figure 5

6. Stand approximately 3 – 3 1/2 feet back from the center of the front bumper to view the headlamp low beam light pattern on the headlamp lenses.

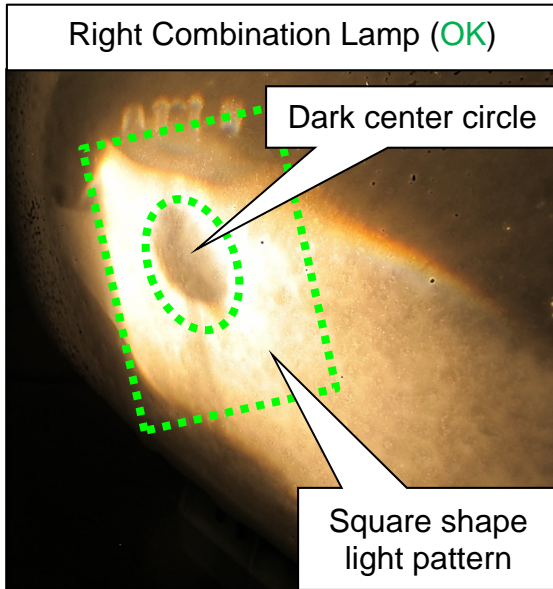
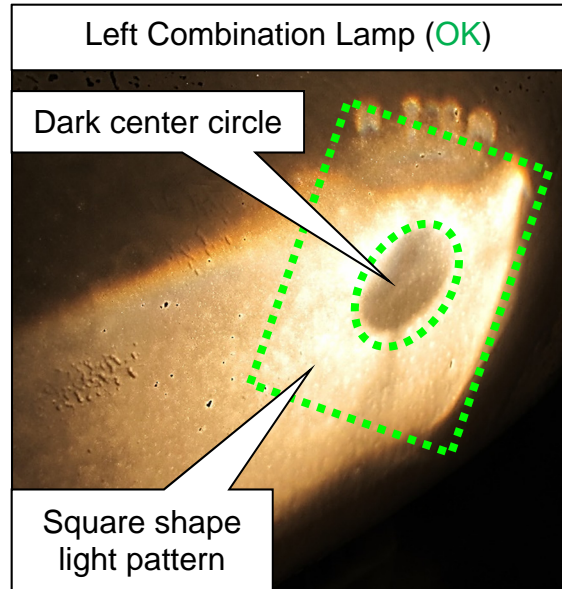
Good (OK) Examples

NOTE: The figures below show the low beam light pattern enhanced with Nissan Foaming Glass Cleaner.

2013-2015 Models

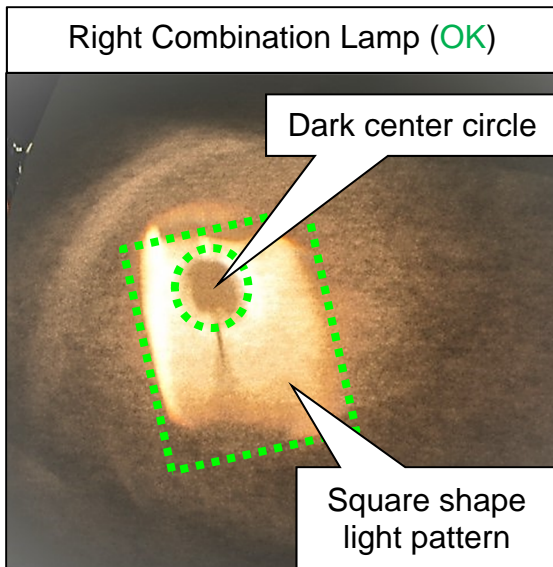
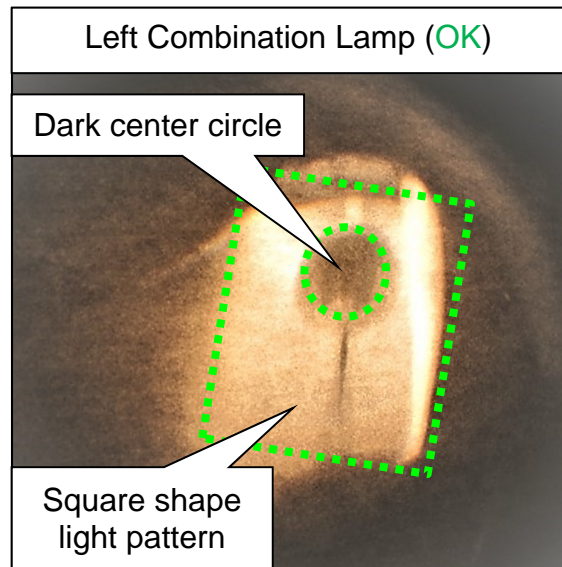
2016-2018 Models
