# TECHNICAL SERVICE BULLETIN

Classification: BT22-008	Reference: NTB22-036	Date: May 11, 2022
-----------------------------	-------------------------	-----------------------

## KNOCK NOISE OVER BUMPS FROM SECOND ROW SEATS

**APPLIED VEHICLES:** 2022 Pathfinder (R53)  
**APPLIED DATES:** Built on or before January 31, 2022  
**APPLIED SEATS:** Second row Captain Seats and 60/40 Bench Seats

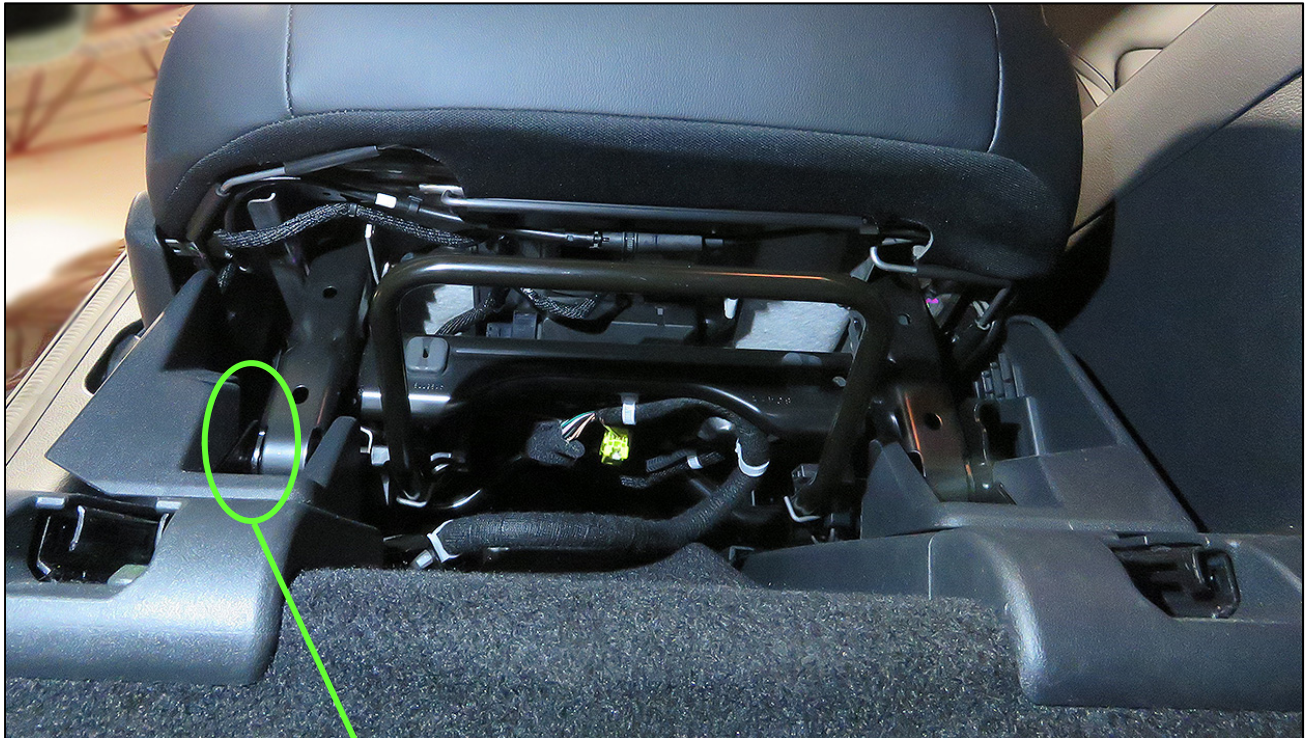
Figure 6

5. Move to the opposite seat pivot and gently pry the seat frame pivot assembly toward the seat's center line, and then insert one (1) plastic washer.
  - Pry to the right (driver side) for a left hand seat pivot assembly.

6. Push the plastic washer onto the seat pivot until it snaps into place.
  - A blunt ended tool may be used to apply enough pressure to the plastic washer to snap it into place.
7. Perform steps 2-6, starting on page 3, to install the two (2) remaining plastic washers to the remaining rear seat.
