Thor Motor Coach Technical Service Bulletin

TSB #	TSB 22-11		
Description/Title:	2022-2023 Sequence & Tellaro with Relion batteries		
Affected Product Line(s):	Certain model year 2022-2023 Sequence & Tellaro		
Service Campaign # :	RC000278	Released Date:	
Codes:	Inspect Only: 0.2 TMCTS80276Y	Document Date:	8/22/2022
Time Allowed:	Inspect with Repair: 0.3 TMCTS80276W	Document Revision:

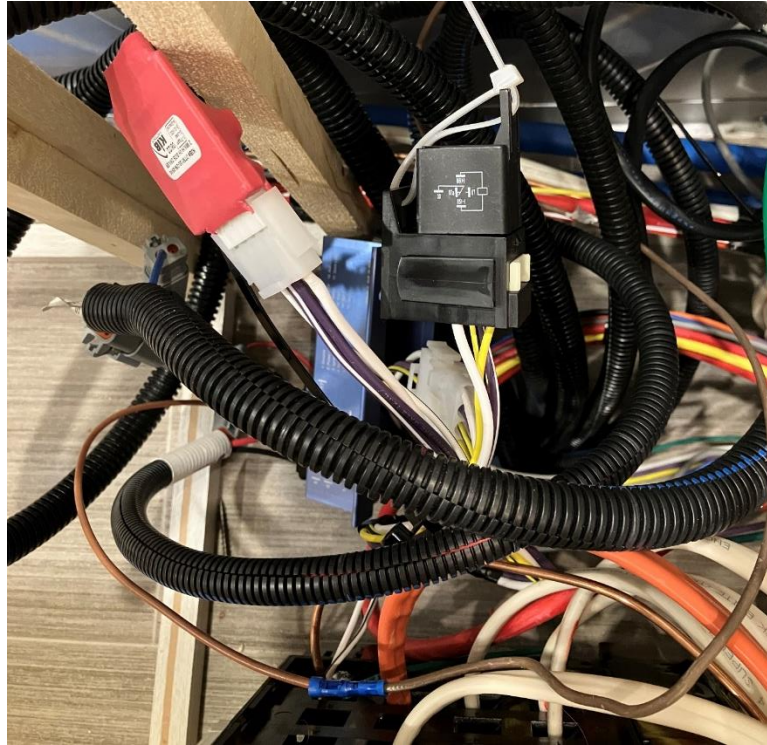
1. Locate the Relion pigtail behind the load center.

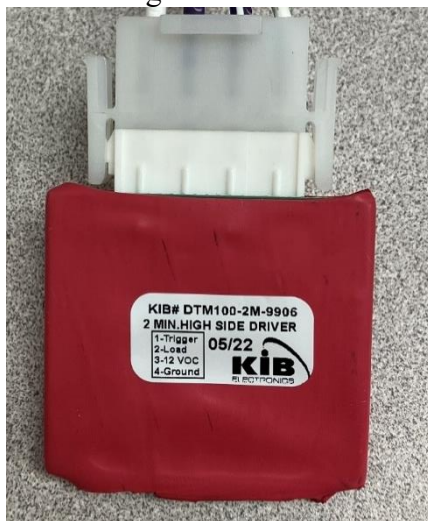
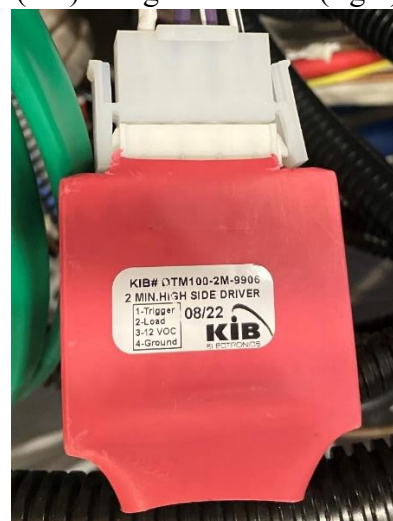
2. Check date code on timer sticker.
 - a. Replace timer if dated prior to 8/22

Below images show dates on a bad module (left) & a good module (right)

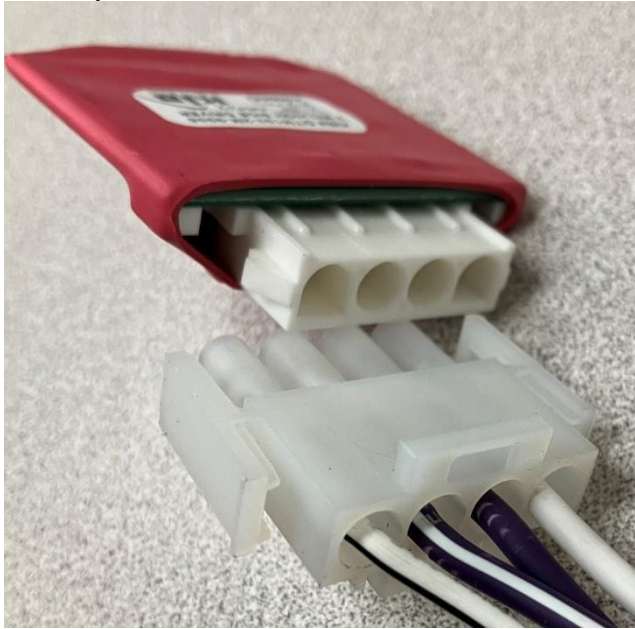
3. Replace the timer if needed, timer connector is directional and will only connect one way.

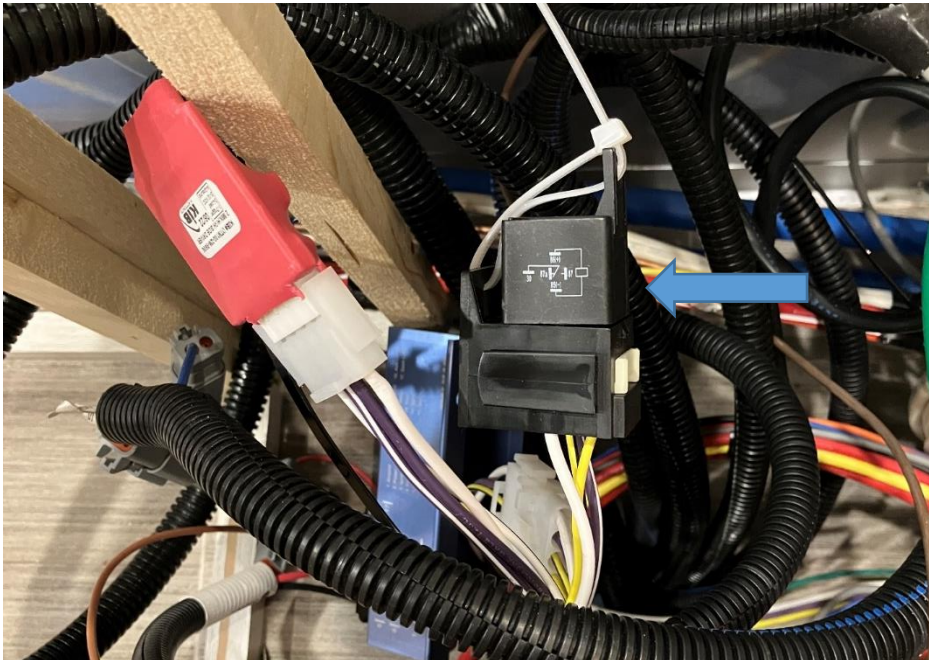
1. Behind the load center, locate the relay on the Relion pigtail.

2. While holding the relay, apply a load to the microwave circuit.
 - a. Ex: Turn on microwave, use load tester or large fan.
 - b. This will trigger the relay causing the A/C compressor to be disconnected by the relay.
 1. You will be able to feel the relay click.
3. Remove the applied load from the circuit.
 - a. The timer should keep the relay engaged for 2 minutes after the load is removed from the circuit.
4. Set a timer on your phone or another device for 1 min 45 seconds.
5. After timer goes off, hold the relay again for approx. 15 seconds.
 - a. At the 2-minute mark the relay should click again, reengaging the A/C compressor.
