# QUALITY ACTION

## CAMPAIGN BULLETIN Fuel Tank Dealer Inventory

Reference: PC903  
Date: August 18, 2022

## PC903 – 2022 ROGUE FUEL TANK INSPECTION

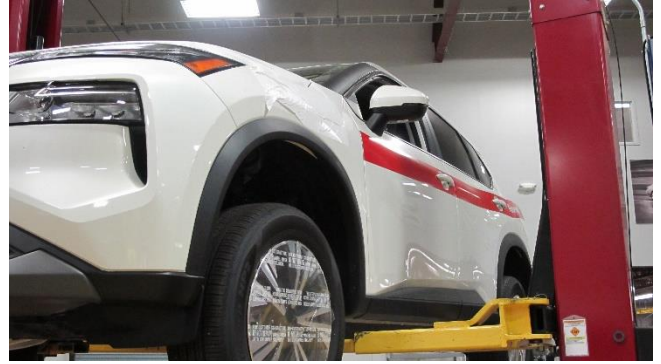
Figure 1

1. Place the vehicle on a suitable lift and raise it up (Figure 1).

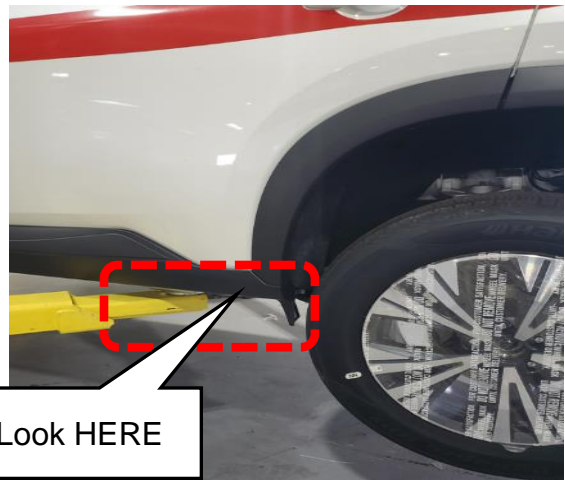
Figure 2

2. Find the front left corner of the fuel tank (Figure 2).

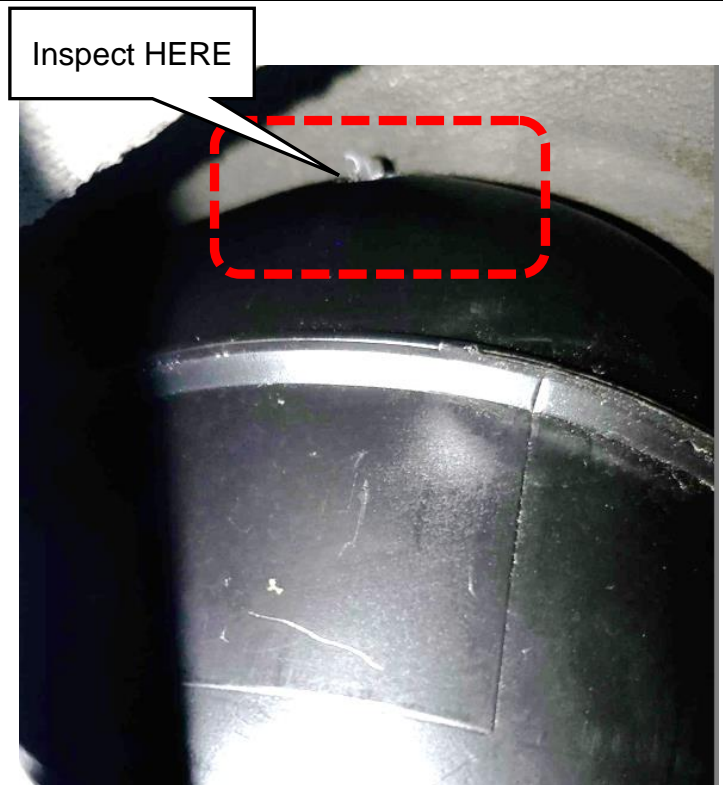
Figure 4

- Using a light source, find the area to be inspected on the top left front corner of the fuel tank (Figure 4).

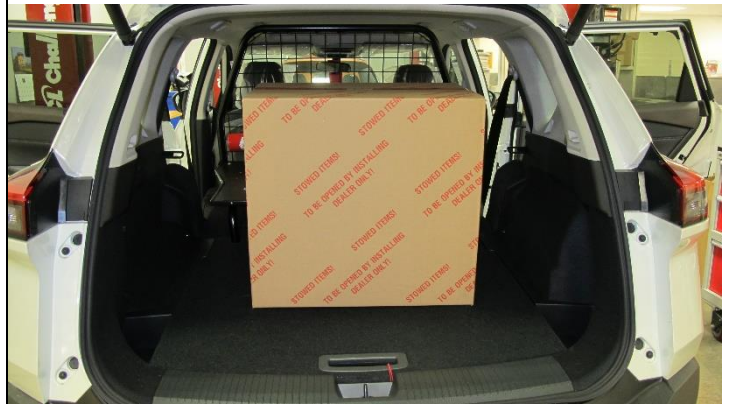
Figure 7

7. Open both rear doors and the back door (Figure 7).

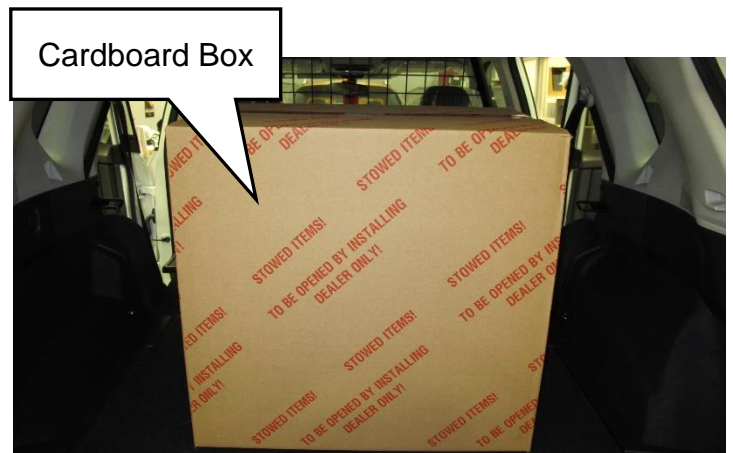
Figure 8

8. If present, remove the cardboard box labeled, "Stowed Items" (Figure 8).

**IMPORTANT: Do not open the cardboard box, it has a tamper proof seal.**

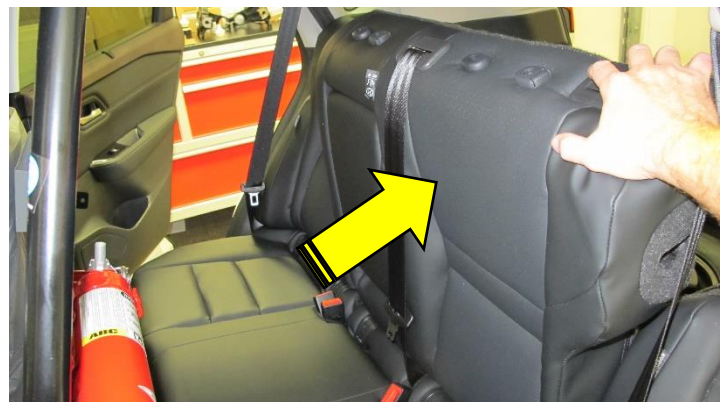
Figure 14

13. Move both the second row seat backs to the full upright position (Figure 14).

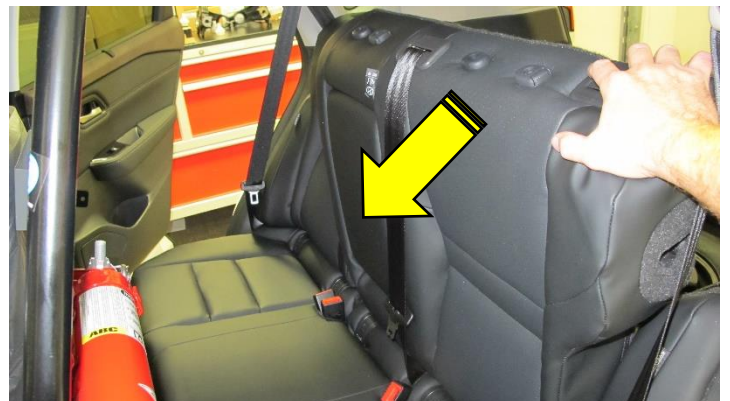
Figure 17

15. Fold both the second row seat backs to the full down position (Figure 17).

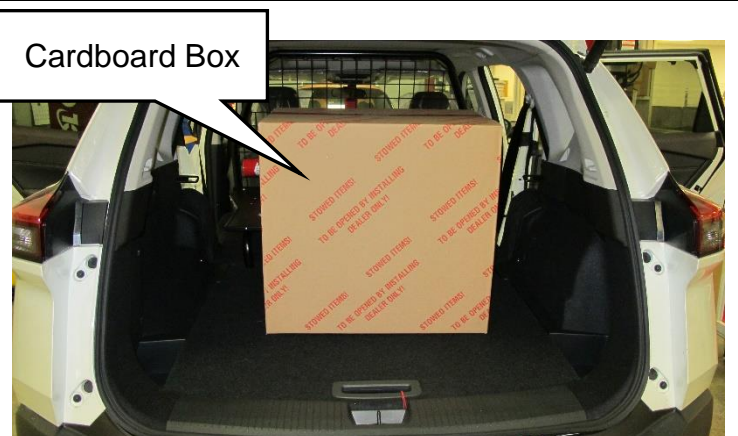
Figure 23

20. If applicable, place the cardboard box labeled, "Stowed Items" into the rear cargo area (Figure 23).

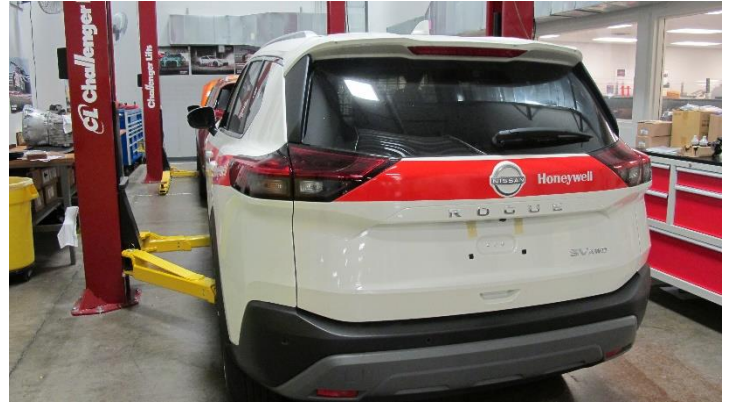
Figure 24

21. Close both rear doors and the back door (Figure 24).
