## Technical product information

<b>Topic</b>	Tailgate interior trim - Specification guidelines
<b>Market area</b>	Russische Föderation (5RU),Australia E04 Bentley rest Asia and Australia (6E04),China 796 VW Import Comp. Ltd (Vico), Beijing (6796),Germany E02 Bentley rest Europe (6E02),Japan E03 Bentley Japan (6E03),Korea, (South) E08 Bentley South Korea (6E08),United Arab Emirates E06 Bentley Middle East and Africa (6E06),United Kingdom E01 Bentley UK (6E01),United States E05 Bentley USA and rest America (6E05)
<b>Brand</b>	Bentley
<b>Transaction No.</b>	2067740/1
<b>Level</b>	EH
<b>Status</b>	Approval
<b>Release date</b>

Suspected tailgate lower trim surface damage issues

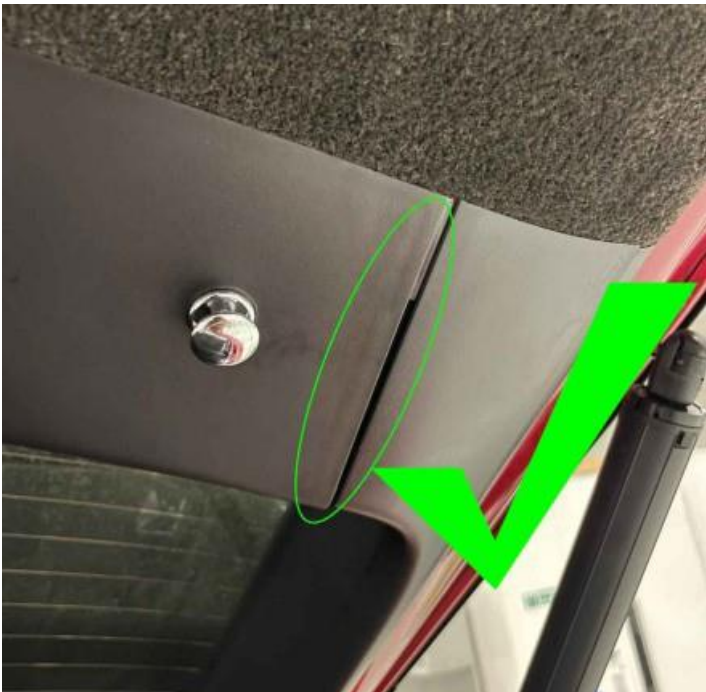
- The example shown in Figure 1 (shiny section) is to correct specification, therefore no further action is required

NOTE: Parts replacement or repair attempts to improve the surface condition is not required

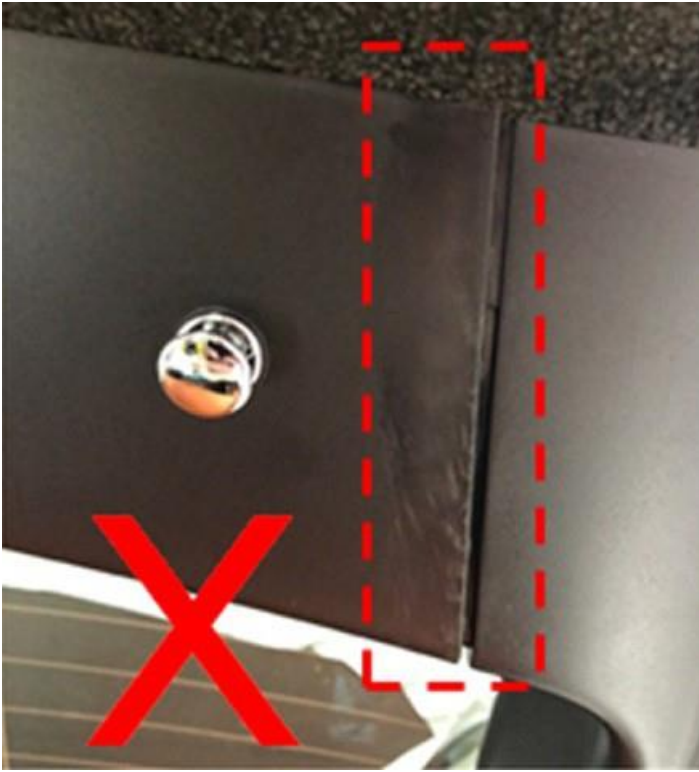
- The example shown in Figure 2 is not to specification due to damage/scratches

In the event the issue is as shown in Figure 2, the operative MUST raise a Technical DISS query, requesting permission to replace the applicable tailgate trim panel

IMPORTANT: Do Not replace any parts unless permission has been given via the open Technical DISS query

Parts replacement is not required unless the tailgate trim is damaged as shown in Figure 2

- Permission must have also been given via a Technical DISS query otherwise warranty payments will not be considered under any circumstances
