Technical product information

Topic	Air spring fault finding
Market area	Bentley: worldwide (2WBE)
Brand	Bentley
Transaction No.	2053492/8
Level	EH
Status	Approval
Release date

Customer statement / workshop findings

The front and/or rear suspension appears to have dropped

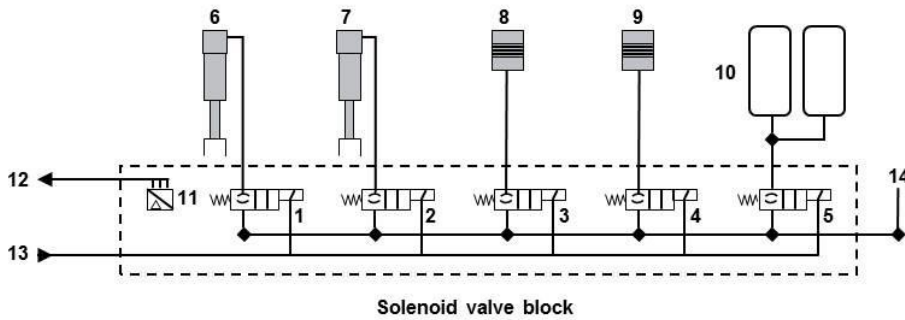
Figure 4

Please use this generic “Reference Chart” (Figure 4) in conjunction with the customer description of the fault and the “Standard Ambient Conditions” of the DTC’s if present, to focus on the relevant area (ie: if a DTC is pointing out to the accumulator and the event data from the DTC and the customer description explains that the issue appear while the vehicle was driving, then the potential source of the leak well might be in between reservoir, valve unit or compressor as these three components are active in these particular conditions).

Component	Description
1 - 5	Solenoid valves
6 & 7	Front axle suspension struts
8 & 9	Rear axle suspension units
10	Pressure accumulator
11	Pressure sensor
12	Pressure reading
13	Electrical activation of solenoid valves
14	Compressor connection

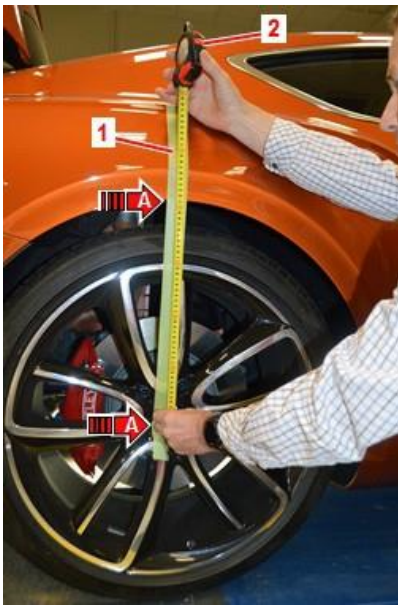
Figure 5

Apply strips of masking tape (1) from the centre of each wheel to the highest part of the wheel arch as shown, making sure the masking tape is applied ‘taut’

Using a tape measure (2), measure and take note of the ride heights (A-A) at all four corners of the vehicle. See Figure 5.

Leave the vehicle overnight and again measure the ride heights (A-A) at all four corners of the vehicle. Compare these values with those taken previously.

If there is **NO** difference in ride heights, and the strips of masking tape are still 'taut' then no air leak is present. Please explain to the customer the long term storage or changing climate conditions would cause a drop in ride height which is normal. As soon as the vehicle is started, the compressor will level the vehicle automatically. No further action is required.

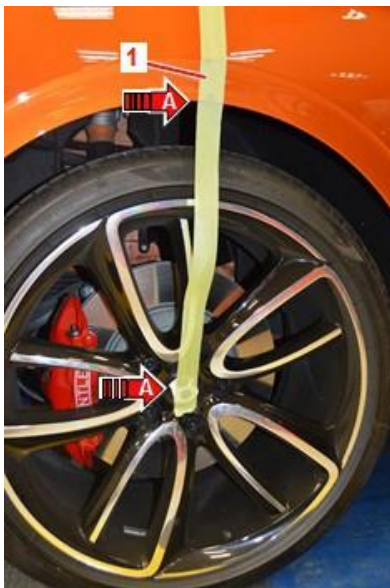
Figure 6

If there **IS** a difference in ride heights, and the strips of masking tape (1) have 'sagged' (shown in Figure 6), then refer to the following leak finding procedures below.

It should be noted that if these checks involve a claim through warranty then photographic evidence of the vehicle sagging and air leak should be included.

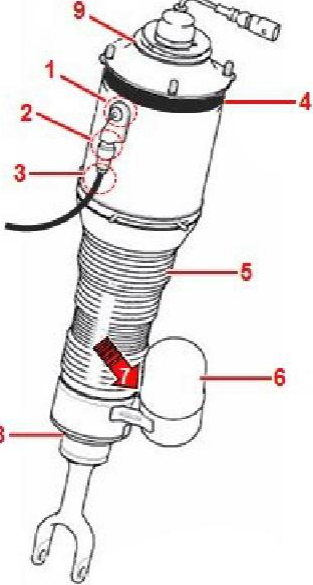
Front air spring check points - Continental series (pre 2018) and Flying Spur

Check	Yes	No	Comments
Brass fitting to air spring (1) Brass intermediate connection (2) Air feed pipe connection (3) Top of air spring (4) Air spring gaiter condition (5) Air canister and canister to air spring (6 & 7) Bottom of the air spring (8) Top of the air spring (9). Within engine compartment, pull dust seal back to inspect!

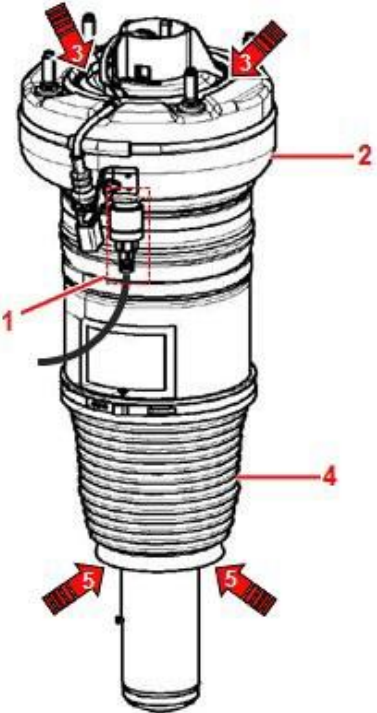
Front air spring check points – Mulsanne

Check	Yes	No	Comments
Air connection to air spring (1) Upper air spring (2) Top of air spring (3) Air spring gaiter condition (4) Bottom of the air spring (5)

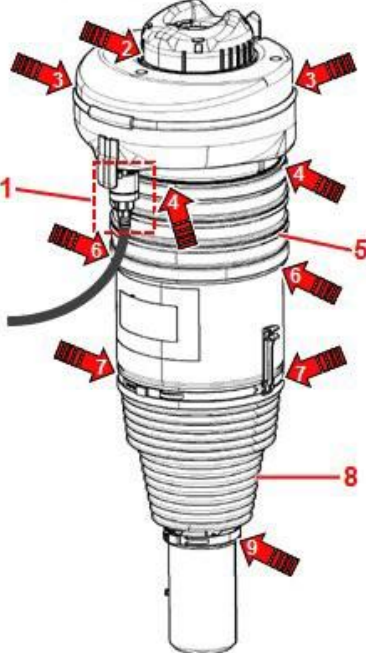
Front air spring check points – Bentayga

Check	Yes	No	Comments
Air connection to air spring (1) Top of air spring (2 & 3) Upper areas of air spring gaiter (4 & 6) Air spring upper gaiter condition (5) Lower areas of air spring gaiter (7 & 9) Air spring upper gaiter condition (8)

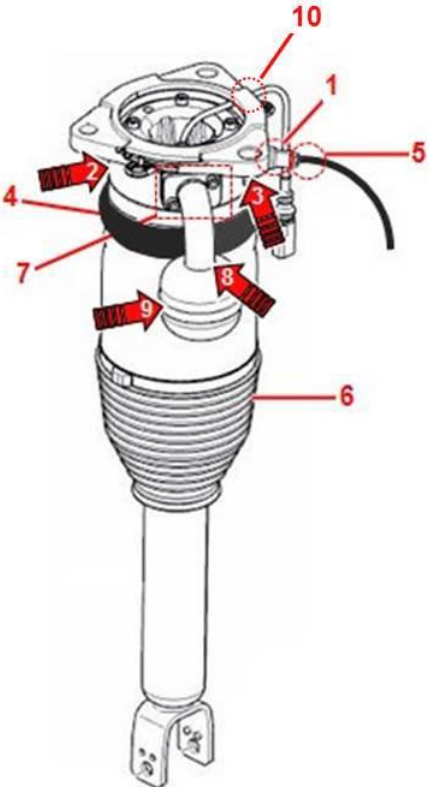
Rear air spring check points - Continental series (pre 2018) and Flying Spur

Check	Yes	No	Comments
Brass fitting to air spring (1) Top of air spring (2 & 3) Air spring bellows (4) Air feed pipe connection (5) Air spring gaiter condition (6) Air canister and canister to air spring (7, 8 & 9) Electrical cable route for air escaping (10)

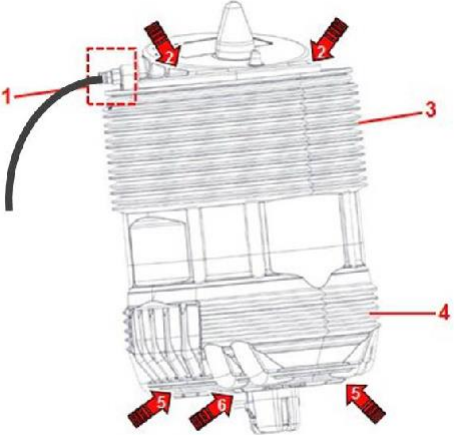
Rear air spring check points – Mulsanne

Check	Yes	No	Comments
Air feed pipe connection (1) Top of air spring (2 & 3) Upper air spring bellows (4 & 5) Lower air spring bellows (6 & 7) Airspring gaiter condition (8 & 9)

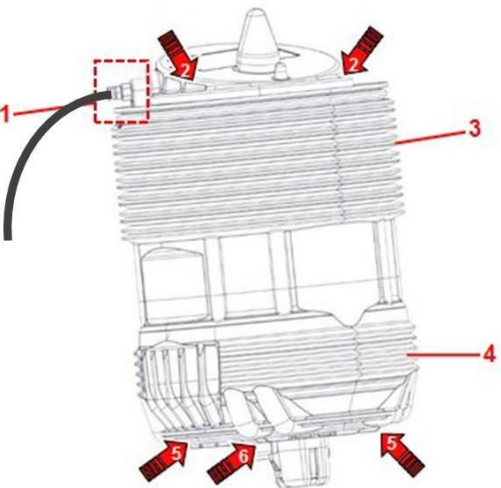
Rear air spring check points – Bentayga

Check	Yes	No	Comments
Air feed pipe connection (1) Top of air spring (2) Airspring gaiter condition (3 & 4) Lower areas of air spring (5 & 6)

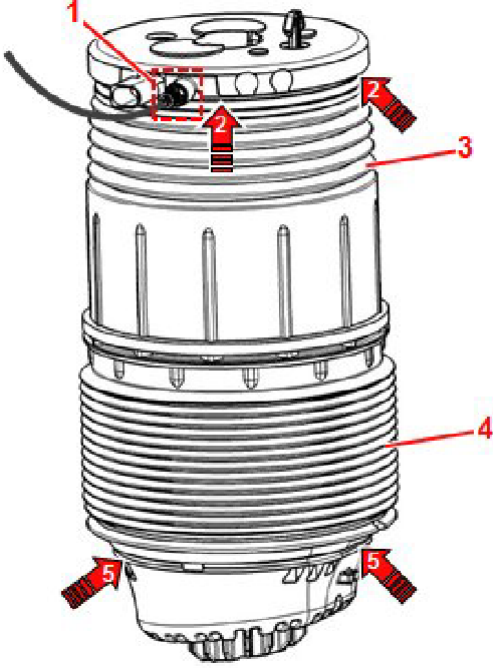
Rear air spring check points – New Continental GT/C and New Flying Spur

Check	Yes	No	Comments
Air feed pipe connection (1) Top of air spring (2) Air spring gaiter condition (3 & 4) Lower area of air spring (5)

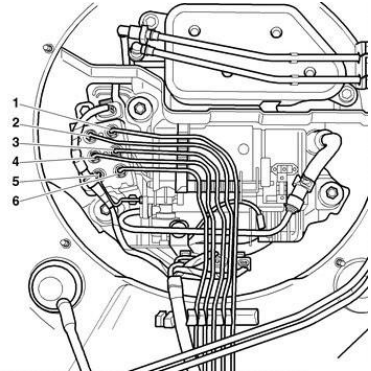
Air supply check points - Continental series (pre 2018) and Flying Spur

Check	Yes	No	Comments
Air pipe connections (1 to 6)

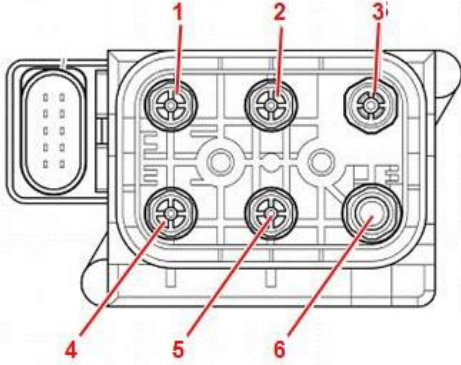
Air supply check points - Mulsanne

Check	Yes	No	Comments
Air pipe connections (1 to 6)

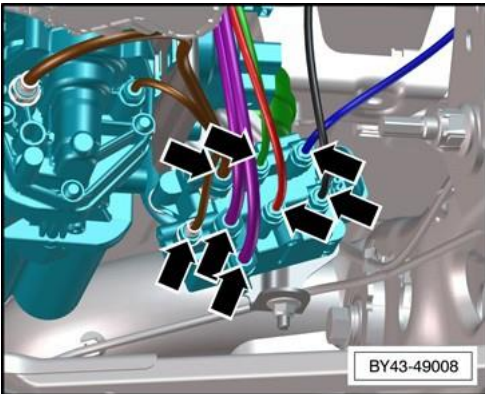
Air supply check points – Bentayga

Check	Yes	No	Comments
Air pipe connections (arrows)

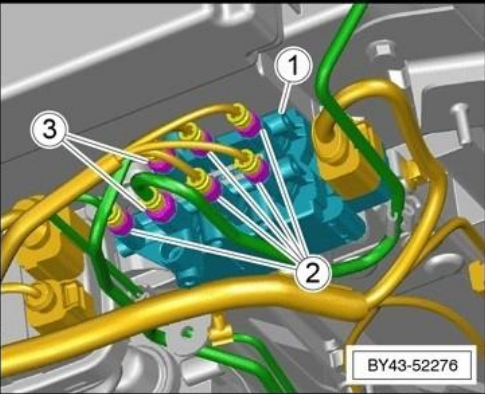
Air supply check points – New Continental GT/C and New Flying Spur

Check	Yes	No	Comments
Air pipe connections (2 & 3)

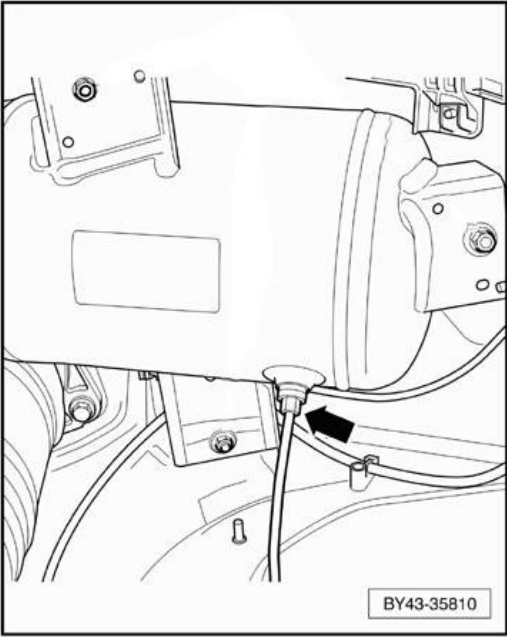
Air supply check points - Continental series (pre 2018) and Flying Spur

Check	Yes	No	Comments
<p>Air pipe connection (arrow)</p> <p>Location - GT & Flying Spur: LH rear wheel arch</p> <p>Location - GTC: Behind backboard trim panel</p>

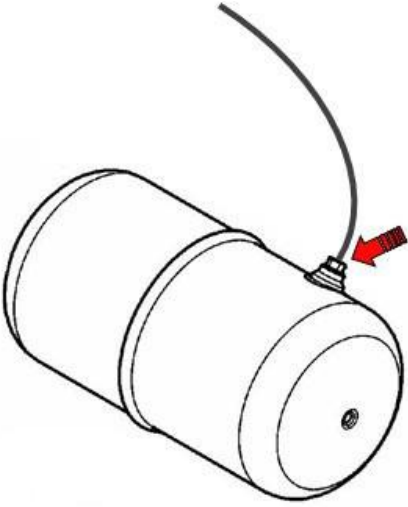
Air supply check points - Mulsanne

Check	Yes	No	Comments
<p>Air pipe connection (arrow)</p> <p>Location - Boot floor</p>

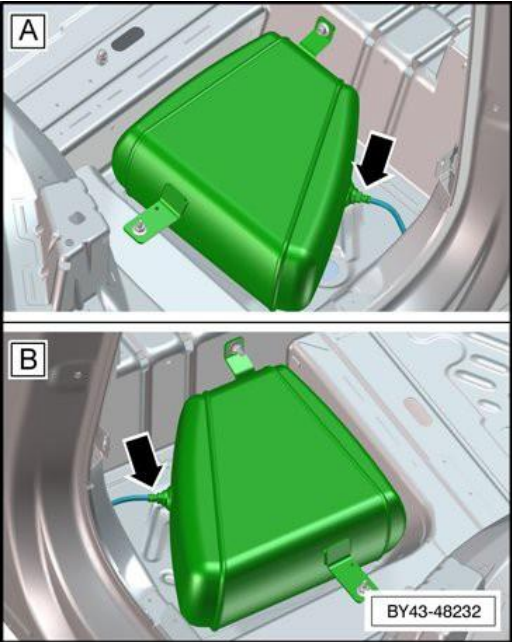
Air supply check points - Bentayga

Check	Yes	No	Comments
Air pipe connections on the twin tanks (arrows) Location – Rear footwells beneath carpets

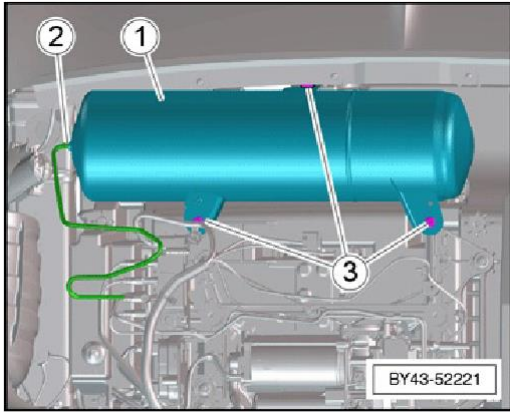
Air supply check points – New Continental GT/C and New Flying Spur

Check	Yes	No	Comments
Air pipe connection (2) Location – Refer to the repair manual depending on model
