TECHNICAL SERVICE INFORMATION BULLETIN

TSIB 22-07 Rev A		August 23, 2022
TO:	All Operators	
TITLE:	Powerex Air Compressor Field Maintenance Updates	
APPLICABILITY:	All New Flyer Xcelsior Buses Equipped with Powerex Direct Drive Electric Scroll Type Air Compressors.

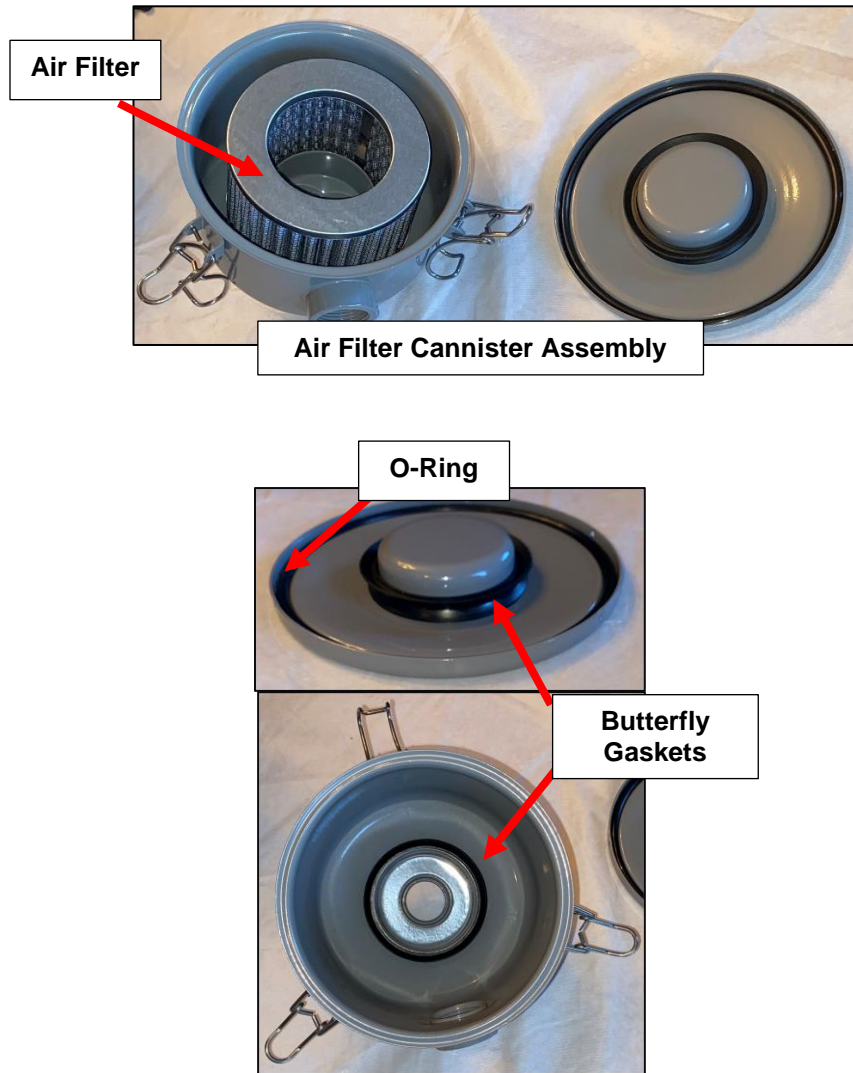
Figure A – Air Filter Parts Kit Components Inside Cannister Assembly

New Flyer has worked with our supplier Powerex to provide a new kit that provides butterfly gaskets, an O-ring and the air filter element together as a kit. This new kit provides your technicians with everything that is needed to ensure a proper seal, protecting your compressor from damage due to dirt ingestion. To facilitate this change, both New Flyer and Powerex have implemented a new **Air Filter Parts Kit P/N 6490265** (includes filter element, butterfly gaskets x2 and O-ring). Air Filter Parts Kit P/N 6490265 has fully superseded previous Air

Filter P/N 6475034 and will be automatically provided when an order is placed through NFI Parts. Refer to Figure A.

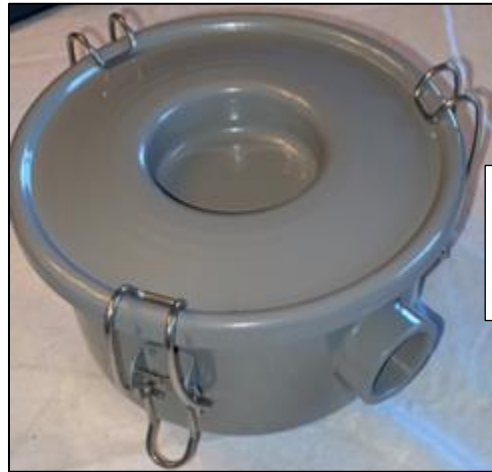
Figure B – “Bowl Style” and “Hat Style” filter cannister assemblies

☞ **NOTE:** The new Air Filter Parts Kit P/N 6490265 is ONLY compatible with Powerex air compressors which feature the “Bowl Style” filter cannister assemblies. Air Filter Parts Kit P/N 6490265 is NOT applicable to the alternative “Hat Style” filter assemblies and ONLY the filter element needs to be changed out for this specific filter cannister design. Refer to Figure B.

“Bowl Style” air filter assembly – Install new Air Filter Parts Kit P/N 6490265.

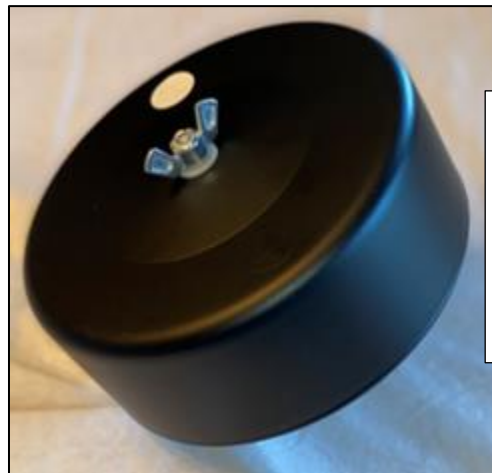
“Hat Style” air filter assembly – NOT COMPATIBLE with new Air Filter Parts Kit P/N 6490265 and ONLY the filter element needs to be changed.

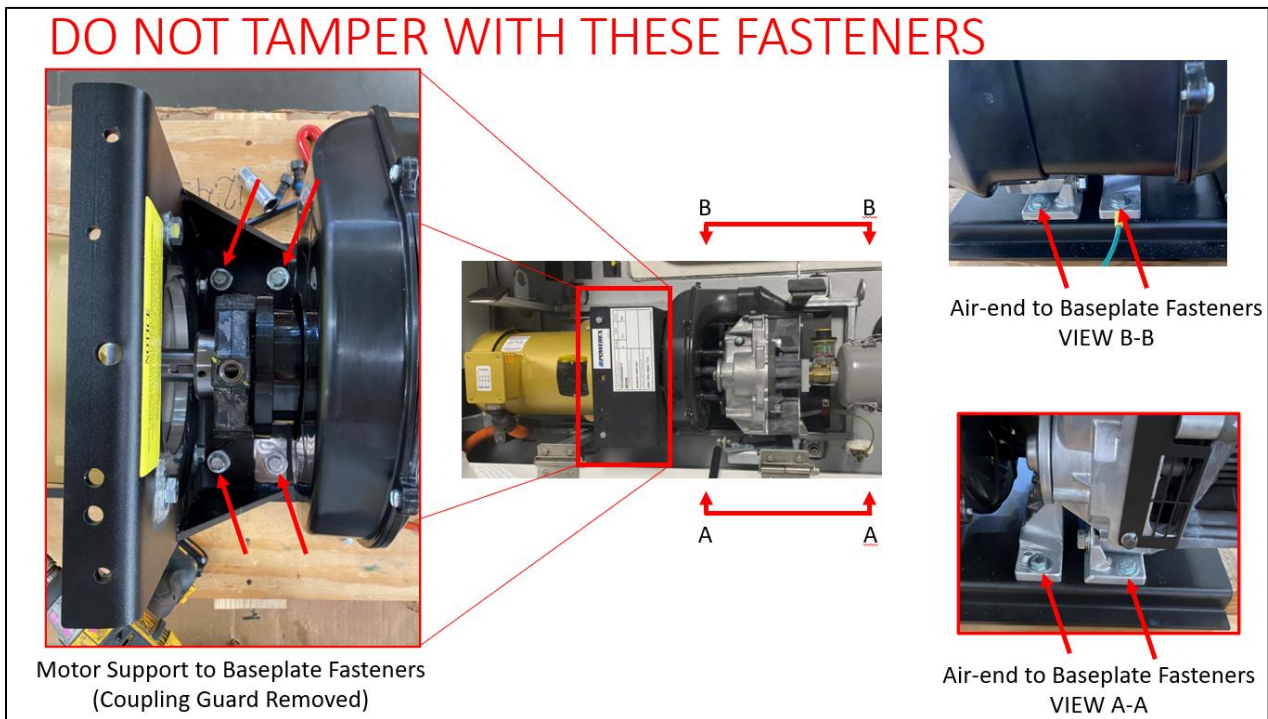
Figure C – Do NOT remove motor support bracket hardware during PM operations

It has come to New Flyer’s attention that some customers are removing the four bolts securing the Powerex air-end and motor support brackets from the baseplate. These bolts should NOT be removed at any time during preventative maintenance operations. Separating the air-end and/or motor support from the baseplate can potentially damage the flex coupling/bearings and can lead to compressor alignment issues. Additionally, the four (4) bolts that secure the motor support bracket to the motor adapter ring should NOT be removed during preventative maintenance operations. Refer to both Figures C and D. Removal of any of these fasteners could lead to damage of the compressor which will not be covered by warranty.

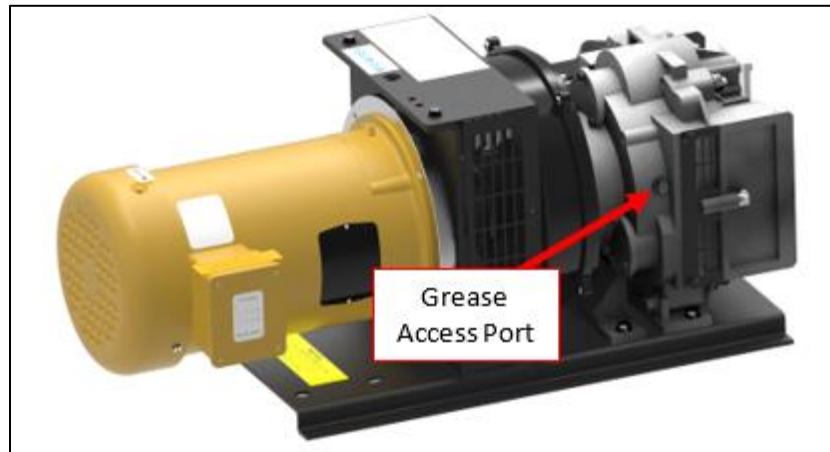
Figure E – Existing Curb Side Grease Port Location

🔧 **NOTE:** Visually confirm that the Powerex air compressor DOES NOT already feature a curb side grease access port before starting procedure. Refer to Figure E for curb side grease port location.

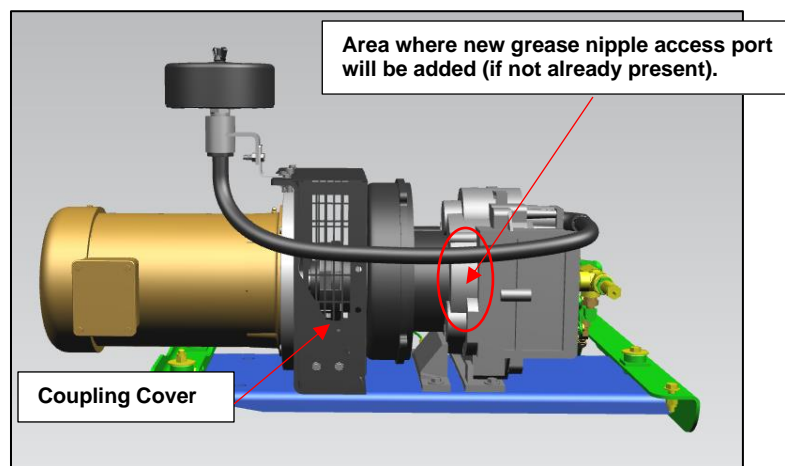
Figure 1: Air Compressor Curb Side Grease Port Position

1. Turn the main battery disconnect switch to the “OFF” position.
2. Open the engine compartment curbside access door.
3. Locate the air compressor.
4. Locate the area on the scroll compressor body shown in Figure 1 and wipe it free of dirt and debris.
5. Remove the bracket that supports the intake hose between the air filter and compressor intake. Disconnect the intake hose at the filter and plug the opening to prevent entry of debris. Carefully reposition the intake hose to allow room for drilling.

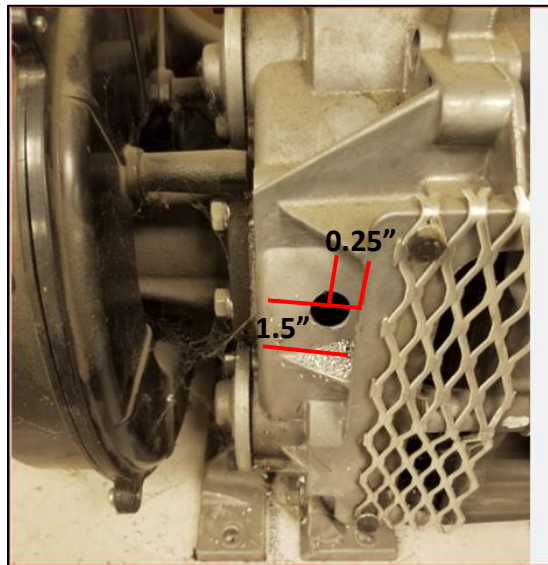
Figure 2: Air Compressor Grease Port Drilling Location

6. Measure 1.5 inches up from the reinforcing rib on the compressor housing and 0.25 inches (to the left) from the edge of the ventilation opening flange. Mark the drilling location. Refer to Figure 2.

7. Use a center punch to locate the drill start point.
8. Using a 1/8 inch diameter drill bit, drill through the aluminum casting. Casting is approx. 1/8 inch thick.
 - a. Enlarge the hole to ¼ inch dia and then finish the hole to ½ inch diameter.

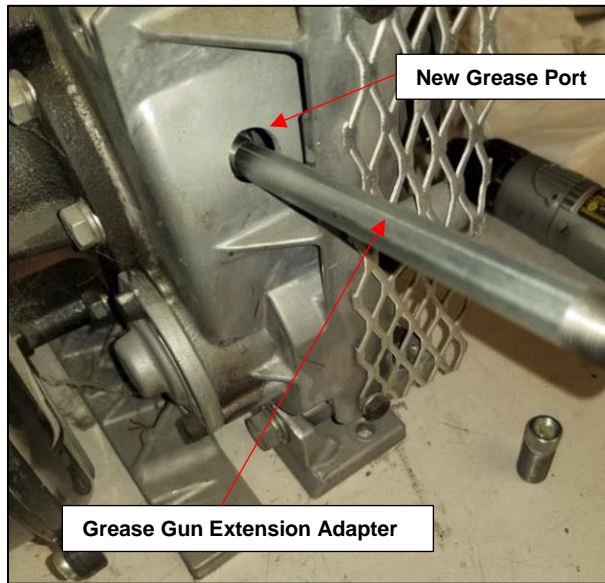
Figure 3: Air Compressor Grease Port Drilling Location.

9. Using an OSHA approved blow gun, blow air into the hole just created; this will expel the bulk of any chips that fell inward during the drilling process. The chips and debris will come out the ventilation opening.
10. Clean up the area around the new opening.
11. Remove the coupling cover Figure 1 and turn the shaft to align the grease fitting with the newly drilled port.
 - a. Using a Powerex grease gun (Special Tool P/N 6403621) and extension adaptor (Special Tool P/N 92583130), engage the grease fitting, then use an Allen key to loosen the nut on the gun to start pumping. Apply the correct amount (three strokes of the grease gun handle) of Powerex grease NF P/N 6403622. Refer to Figure 3.

👉 NOTE: Use only Powerex genuine grease. Pump grease gun before feeding. This eliminates air from the grease passage of the extension adapter.

12. Reinstall the coupling cover and torque the mounting hardware to 76 In-Lbs.
13. Install an expanding plug NF P/N 6465413 with bolt NF P/N 20B04012 and washer NF P/N 10W02000 to seal the new grease port opening. Torque bolt to 15 In-Lbs.
14. Remove all tools and debris and return the bus to service condition.
15. Close and secure the curbside access door.
16. Turn the main battery disconnect switch to the "ON" position.
