Technical product information

Topic	New Continental GT(C) - Door/window seals damaged/worn and/or water ingress at the front door/window seals
Market area	Russische Föderation (5RU),Australia E04 Bentley rest Asia and Australia (6E04),China 796 VW Import Comp. Ltd (Vico), Beijing (6796),Germany E02 Bentley rest Europe (6E02),Japan E03 Bentley Japan (6E03),Korea, (South) E08 Bentley South Korea (6E08),United Arab Emirates E06 Bentley Middle East and Africa (6E06),United Kingdom E01 Bentley UK (6E01),United States E05 Bentley USA and rest America (6E05)
Brand	Bentley
Transaction No.	2067820/1
Level	EH
Status	Approval
Release date

New Continental GT and GTC

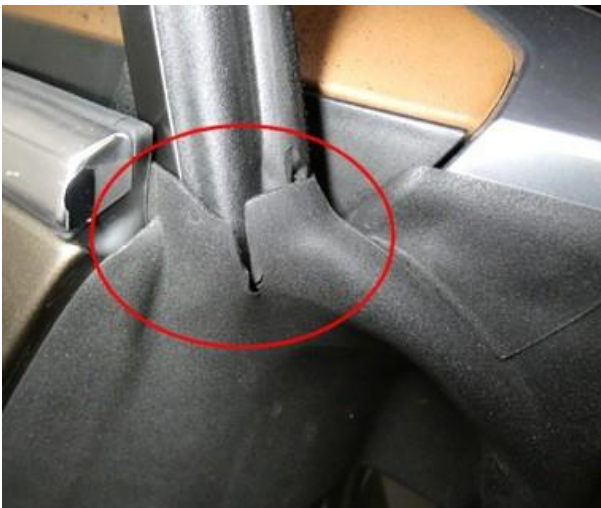
Figure 1 (Door seal split and division bar seal worn)

1) Raise a technical DISS query and await feedback via the open DISS query before conducting any further work

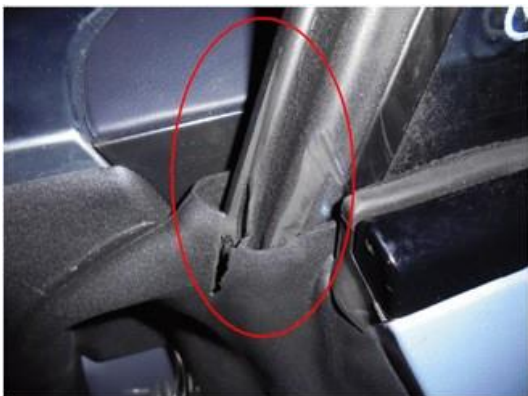
Figure 2 (Seal split and division bar seal worn)

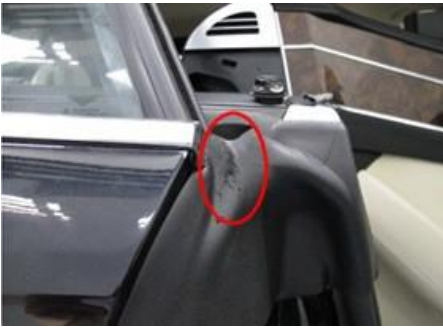
Figure 3 (Door seal worn)

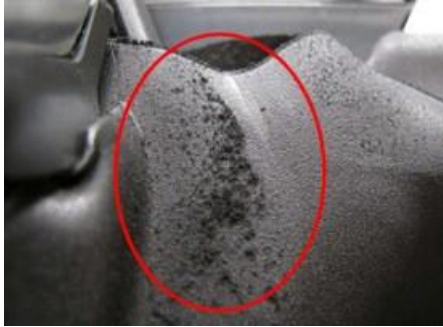
Figure 4 (Door seal worn)

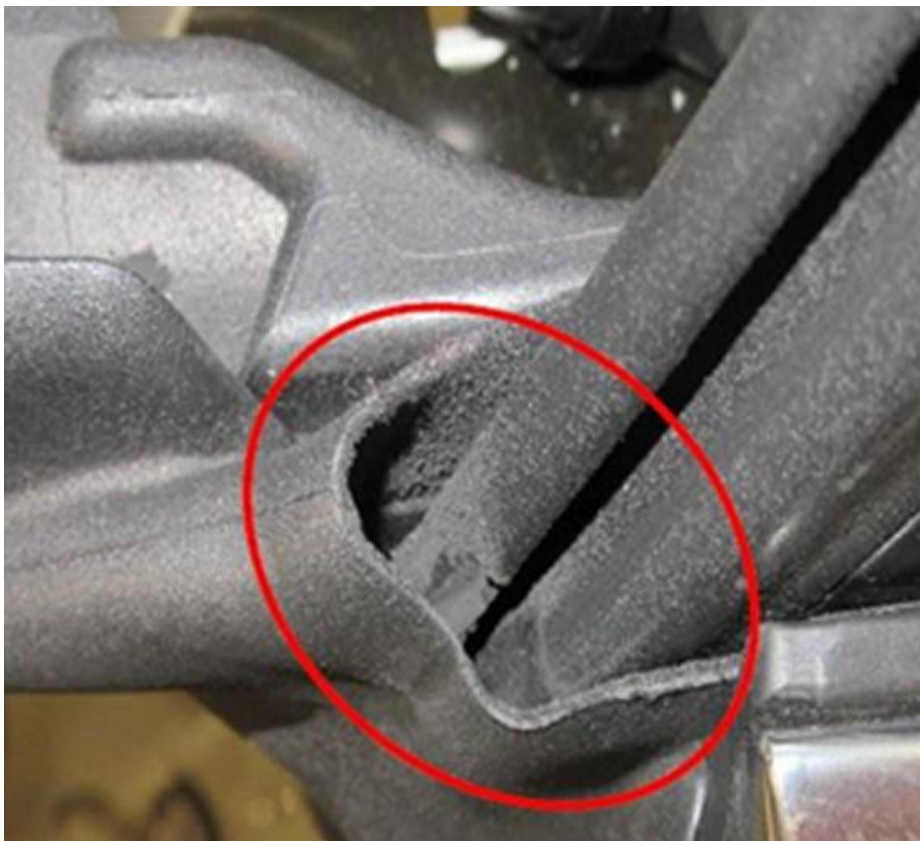
Figure 5 (Door seal worn and division bar seal worn/split)
