TO: Mercedes-Benz Dealer Principals, General Managers, Sales Managers, Service Managers, Parts Managers	FROM: Gregory Gunther, Department Manager, Vehicle Compliance and Analysis, Engineering Services
RE: Emission Service Campaign 2022070004 Launch Notification Replace Braided Hose of Low-Pressure Fuel Line	DATE: August 11, 2022

Campaign No. 2022070004, August 2022

SUBJECT: **Model S-Class (217 and 222 platform)**
Model Year 2018 - 2021

Replace Braided Hose of Low-Pressure Fuel Line

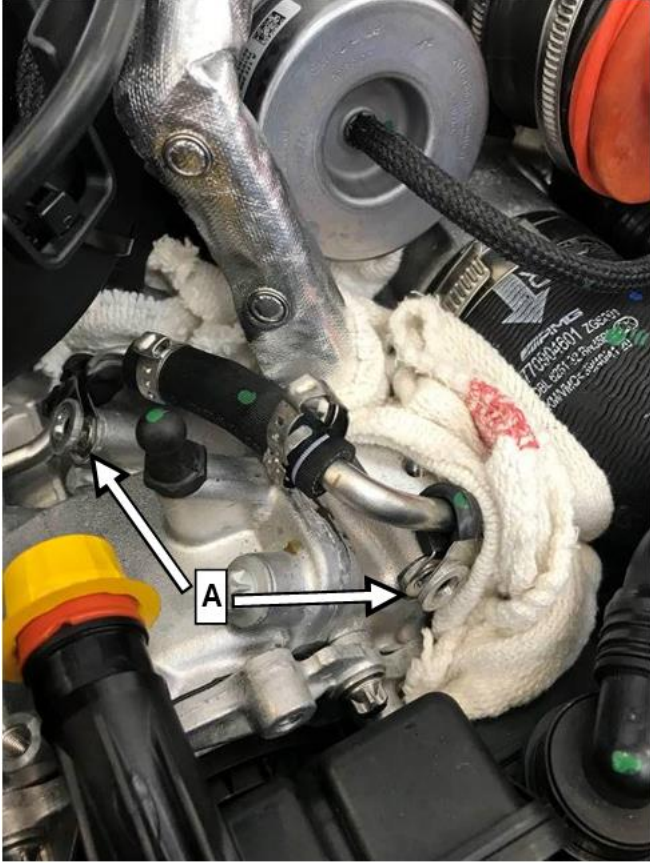
Figure 2

4. Unscrew fastening clamps of low-pressure line (**A, Figure 2**) upstream and downstream of the braided hose.

i The fastening clamps (**A, Figure 2**) should not be removed.

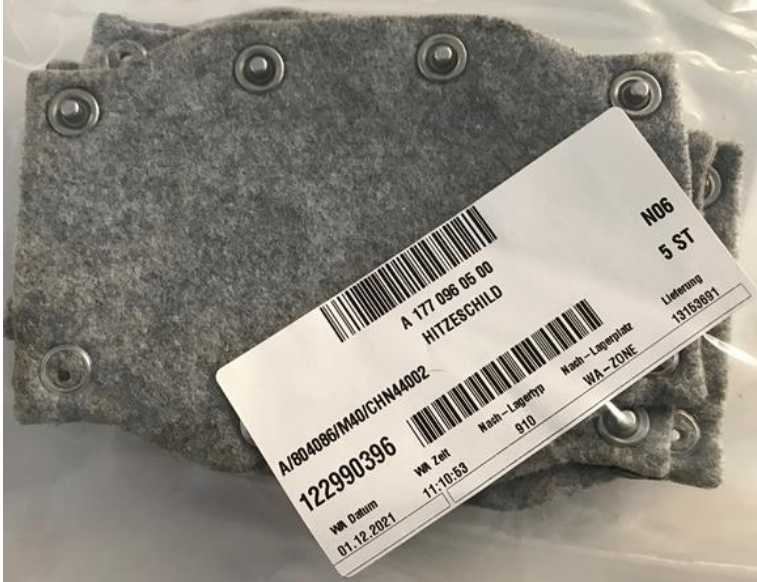
Figure 5

7. Install heat shield over the new braided hose.

i Close snap fasteners.
