Service Bulletin

Bulletin No.: 20-NA-105

Subject: 360 Camera Views go Blank with Tailgate Removed

Brand:	Model:	Model Year:		VIN:		Engine:	Transmission:
		from	to	from	to		
Chevrolet	Silverado 2500HD/3500HD	2020	2023			All	All
GMC	Sierra 2500HD/3500HD

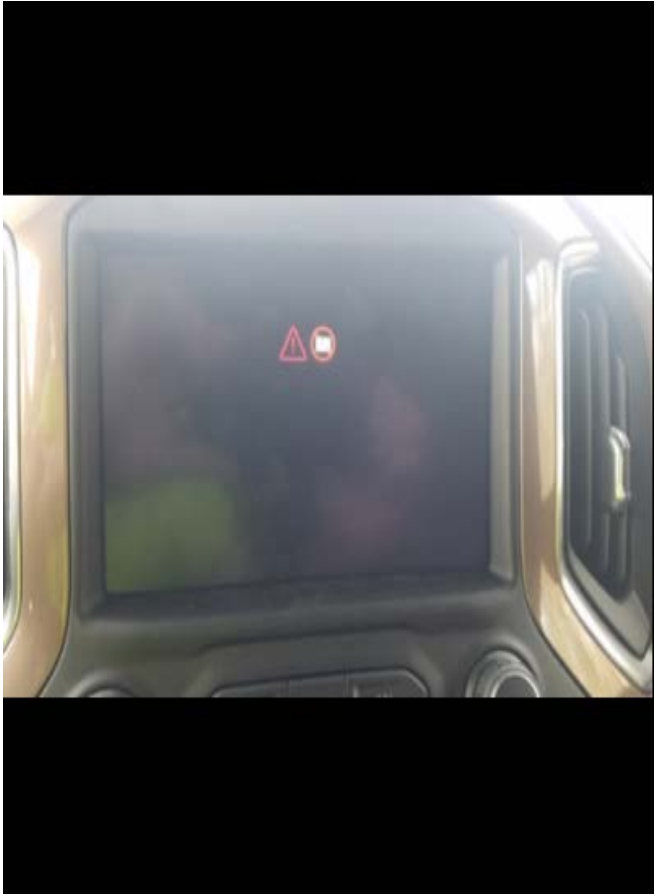
Involved Region or Country	United States, Canada, Mexico, Middle East, Israel.
Additional Options (RPOs)	Equipped with RPO UVS
Condition	<p>Some customers may comment that the 360° camera option (RPO UVS) will lose all camera views when the tailgate is removed.</p> <div style="text-align: center;">

Correction	Important: This repair is a costumer pay alteration. All work and payment, authorization must come from the customer. For customers who remove the rear tailgate for use with a slide in camper or for clearance for a 5th wheel trailer, a jumper can be installed that will provide usage of the side and front camera. The rear camera view will be blacked out. The following steps must be performed to re-enable the remaining camera views without the tailgate/camera being presently installed.
-------------------	---

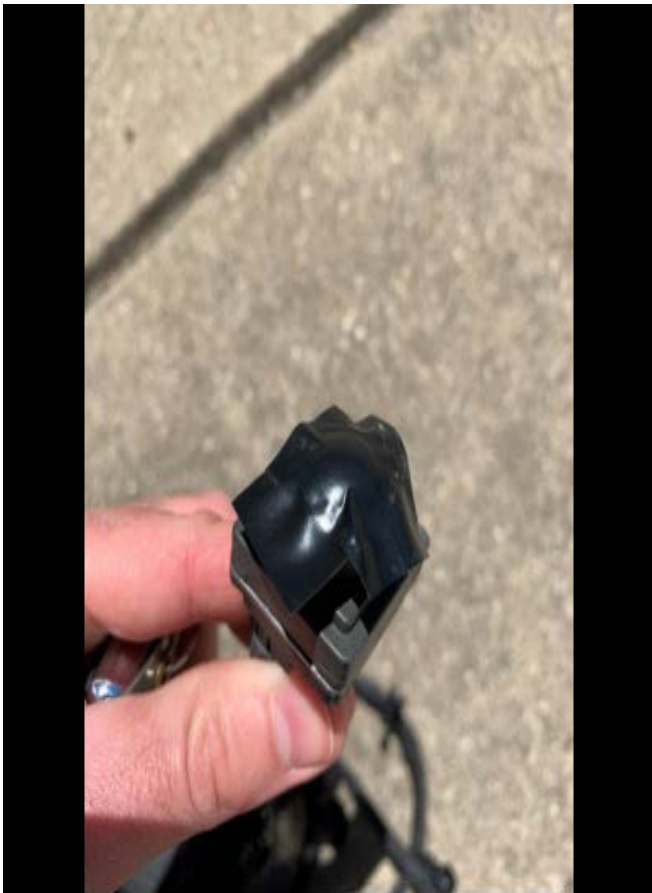
5608081

The camera on the jumper harness will need to have the lens blocked by black paint and electrical tape so the view will not provide a false image to the driver (see pictures).

Dealers can order a tailgate harness (P/N 84679989) and camera (P/N 84676845) that plug into the vehicle harness. This will provide the rear camera input that the system needs to activate the front and side cameras

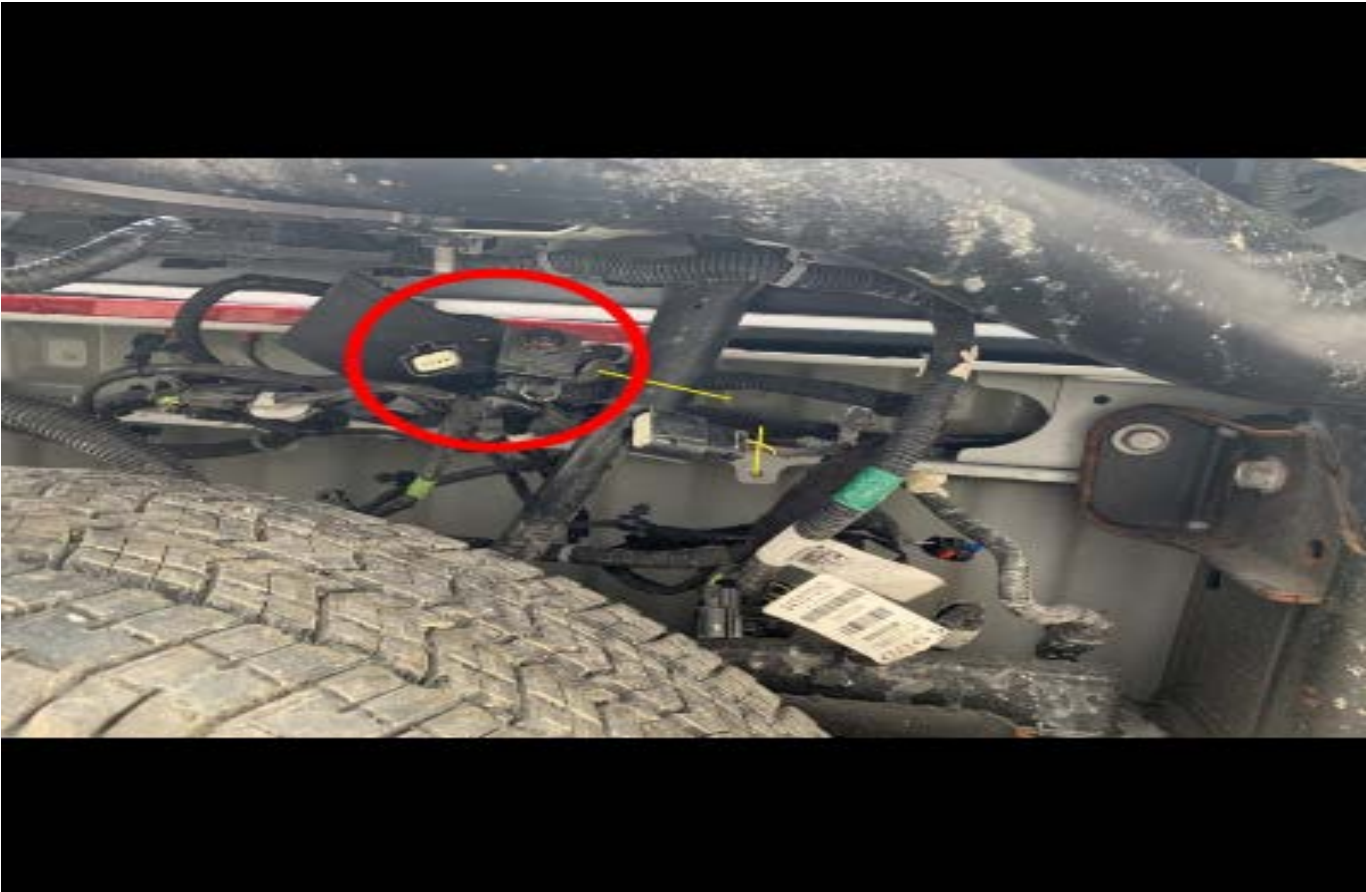
The harness will need to be plugged into the vehicle harness, bundled and stowed under the bed with zip ties and electrical tape (see picture).

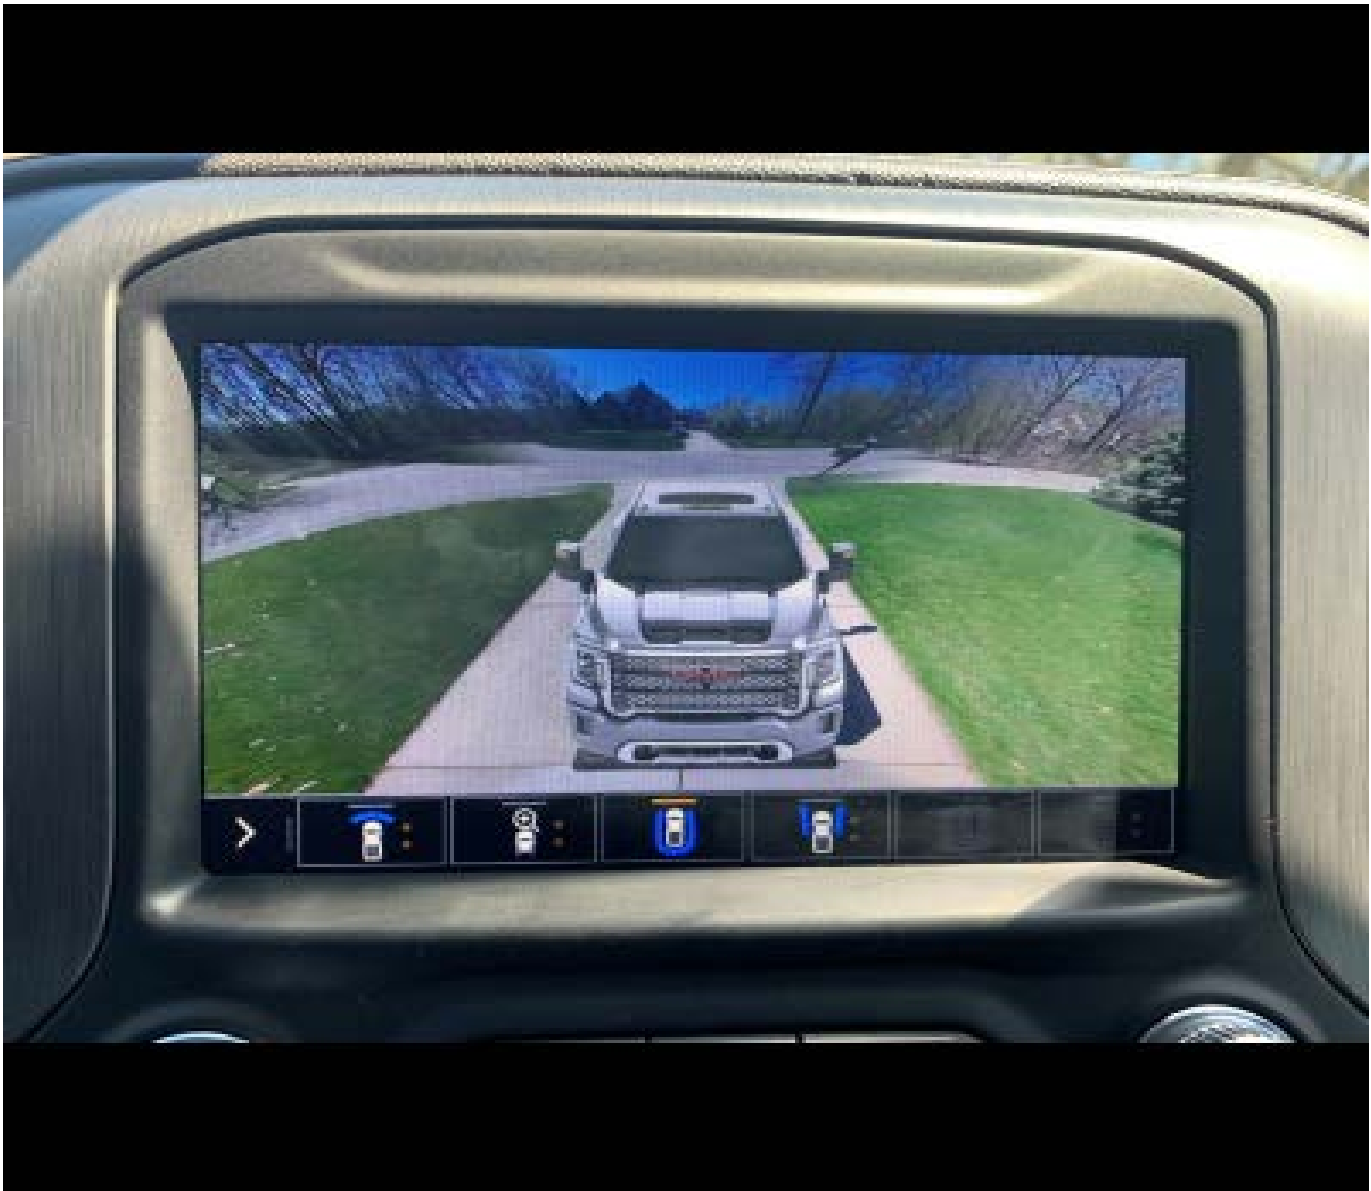
Frontend view, Tailgate equipped

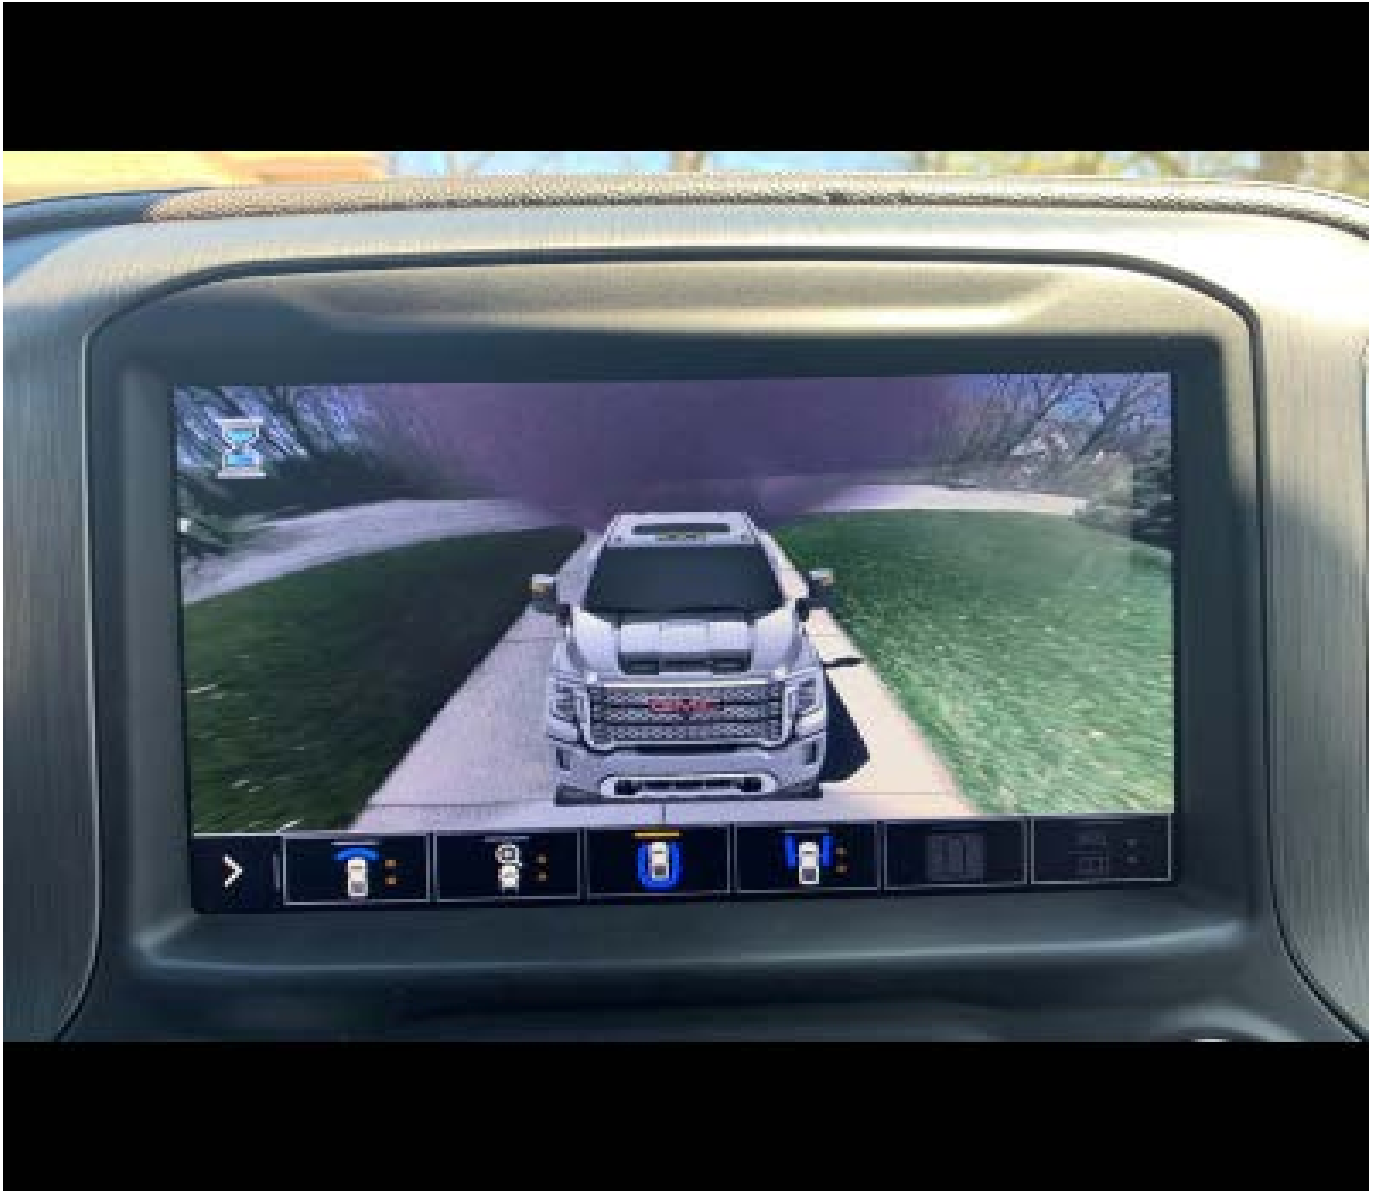
Frontend view, Tailgate removed

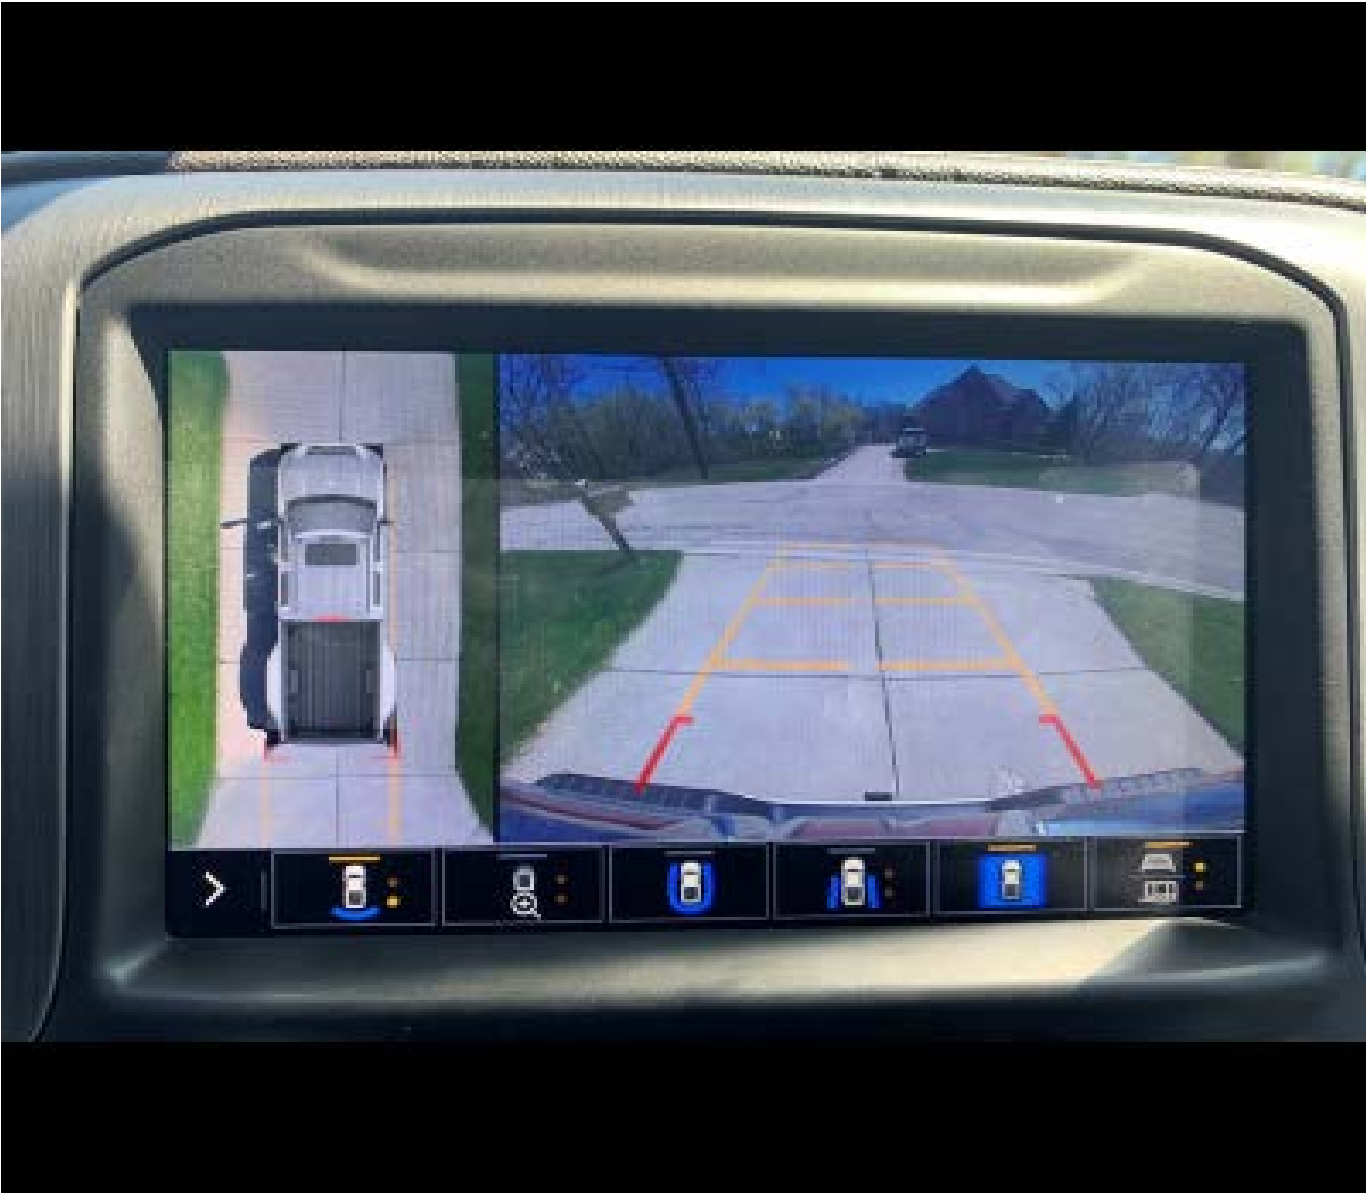
Tailgate backup camera, Tailgate equipped

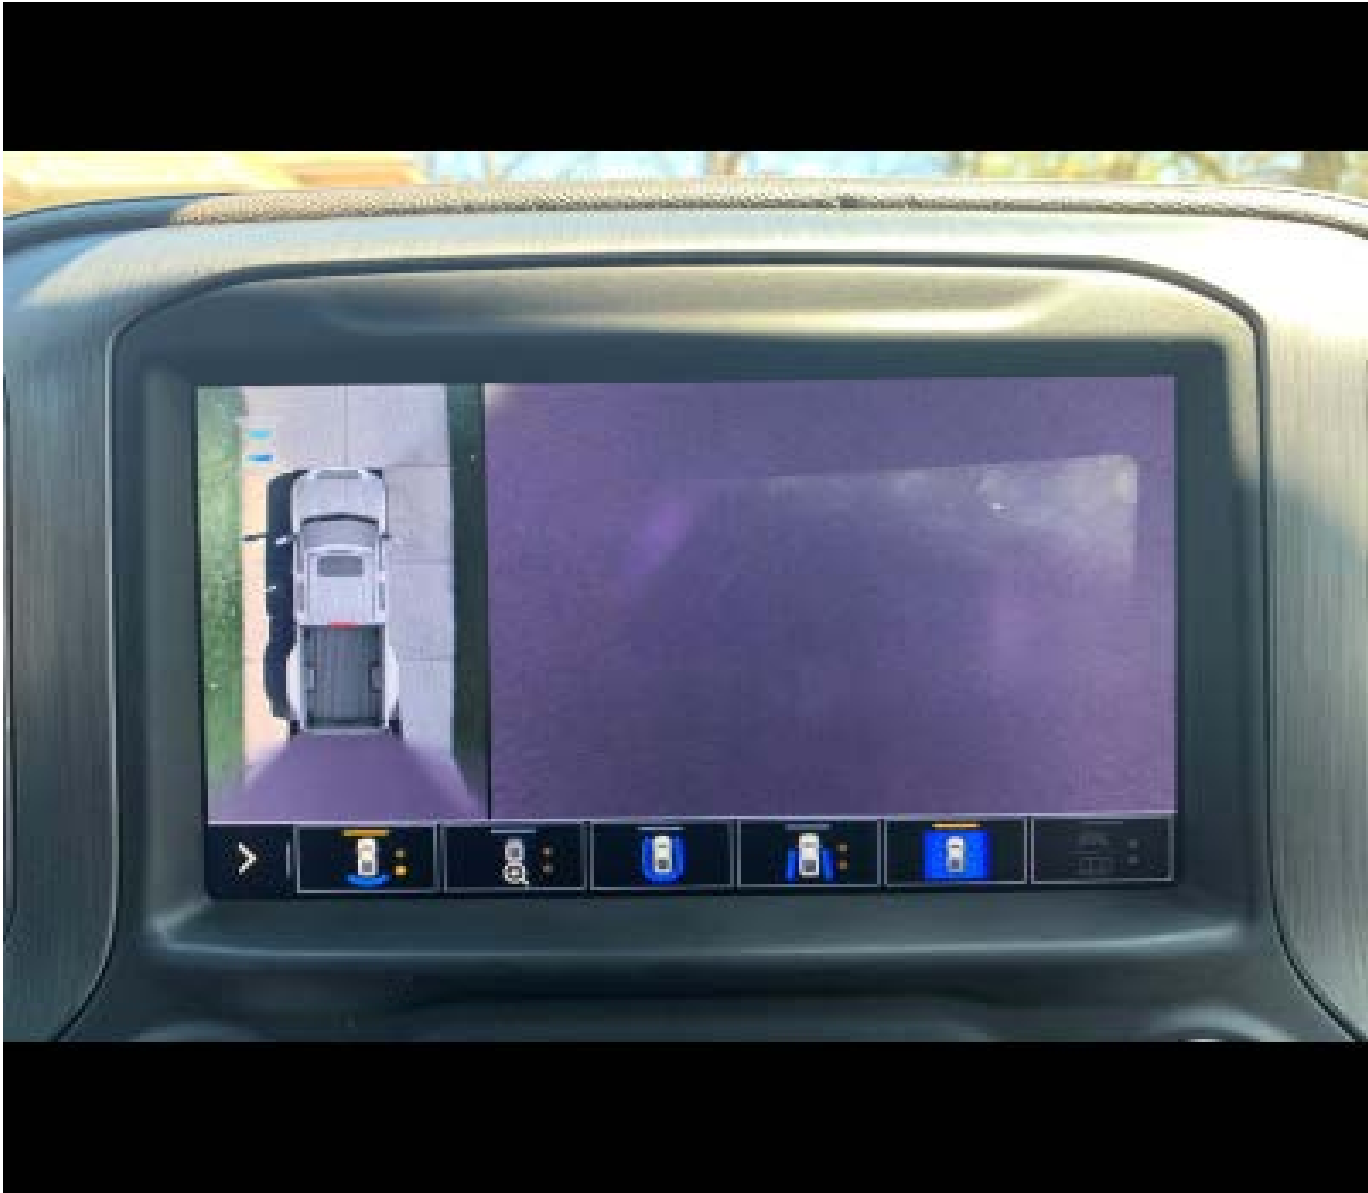
Tailgate backup camera, Tailgate removed

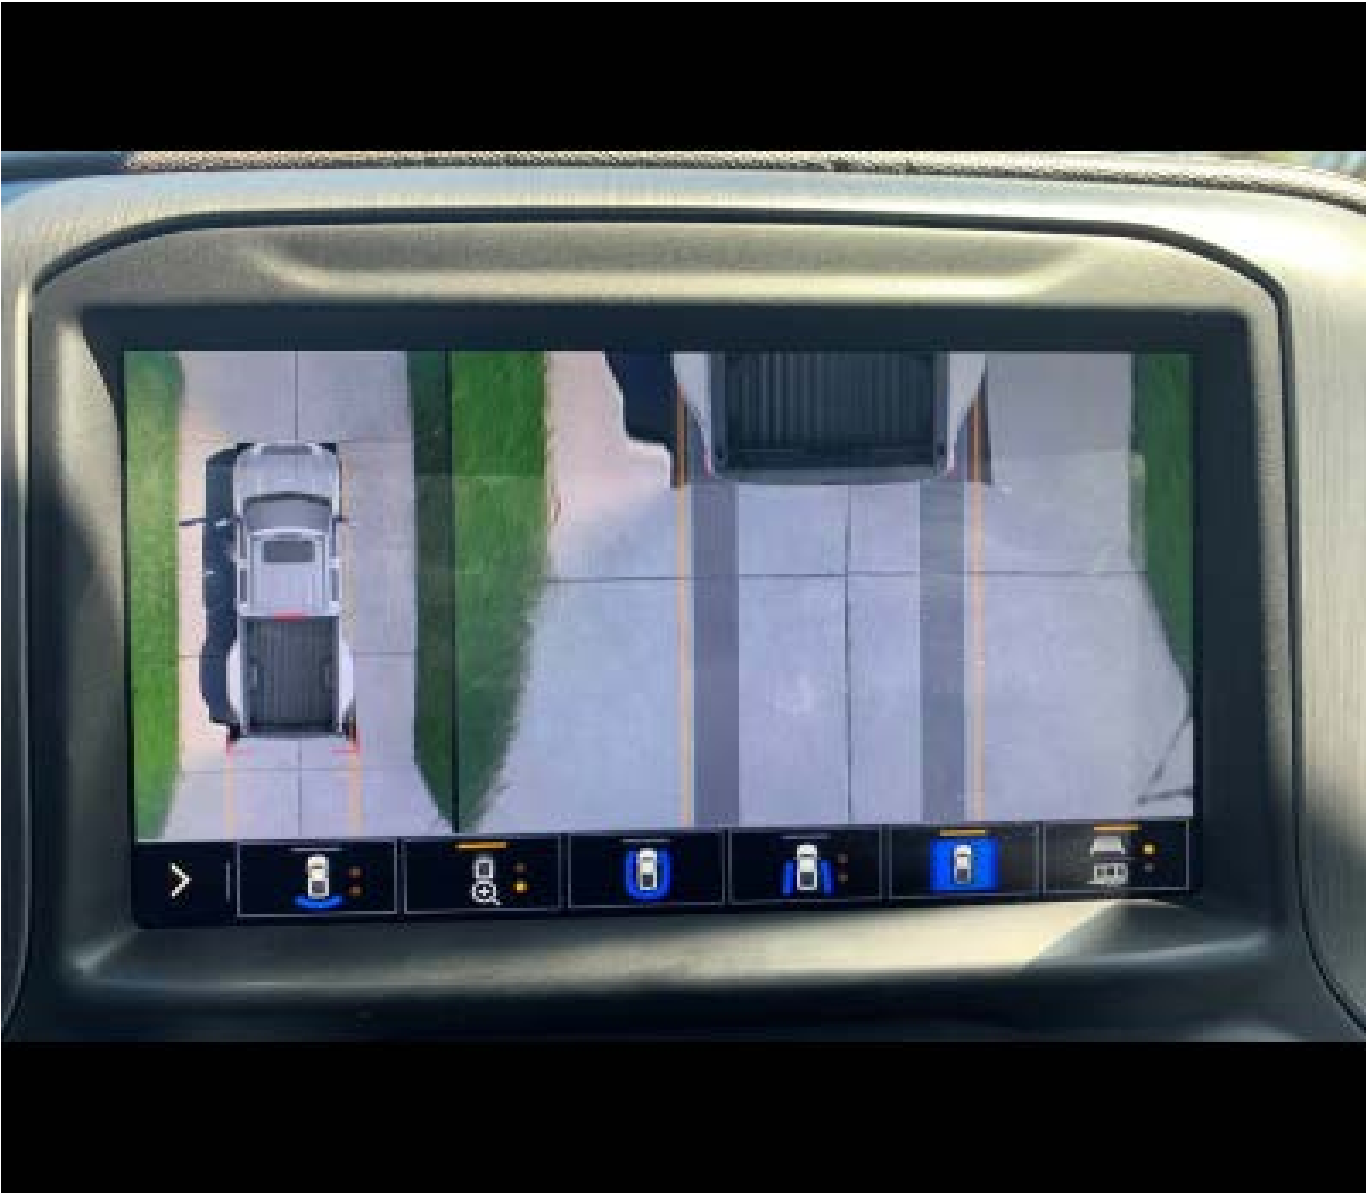
Tailgate overhead camera, Tailgate equipped

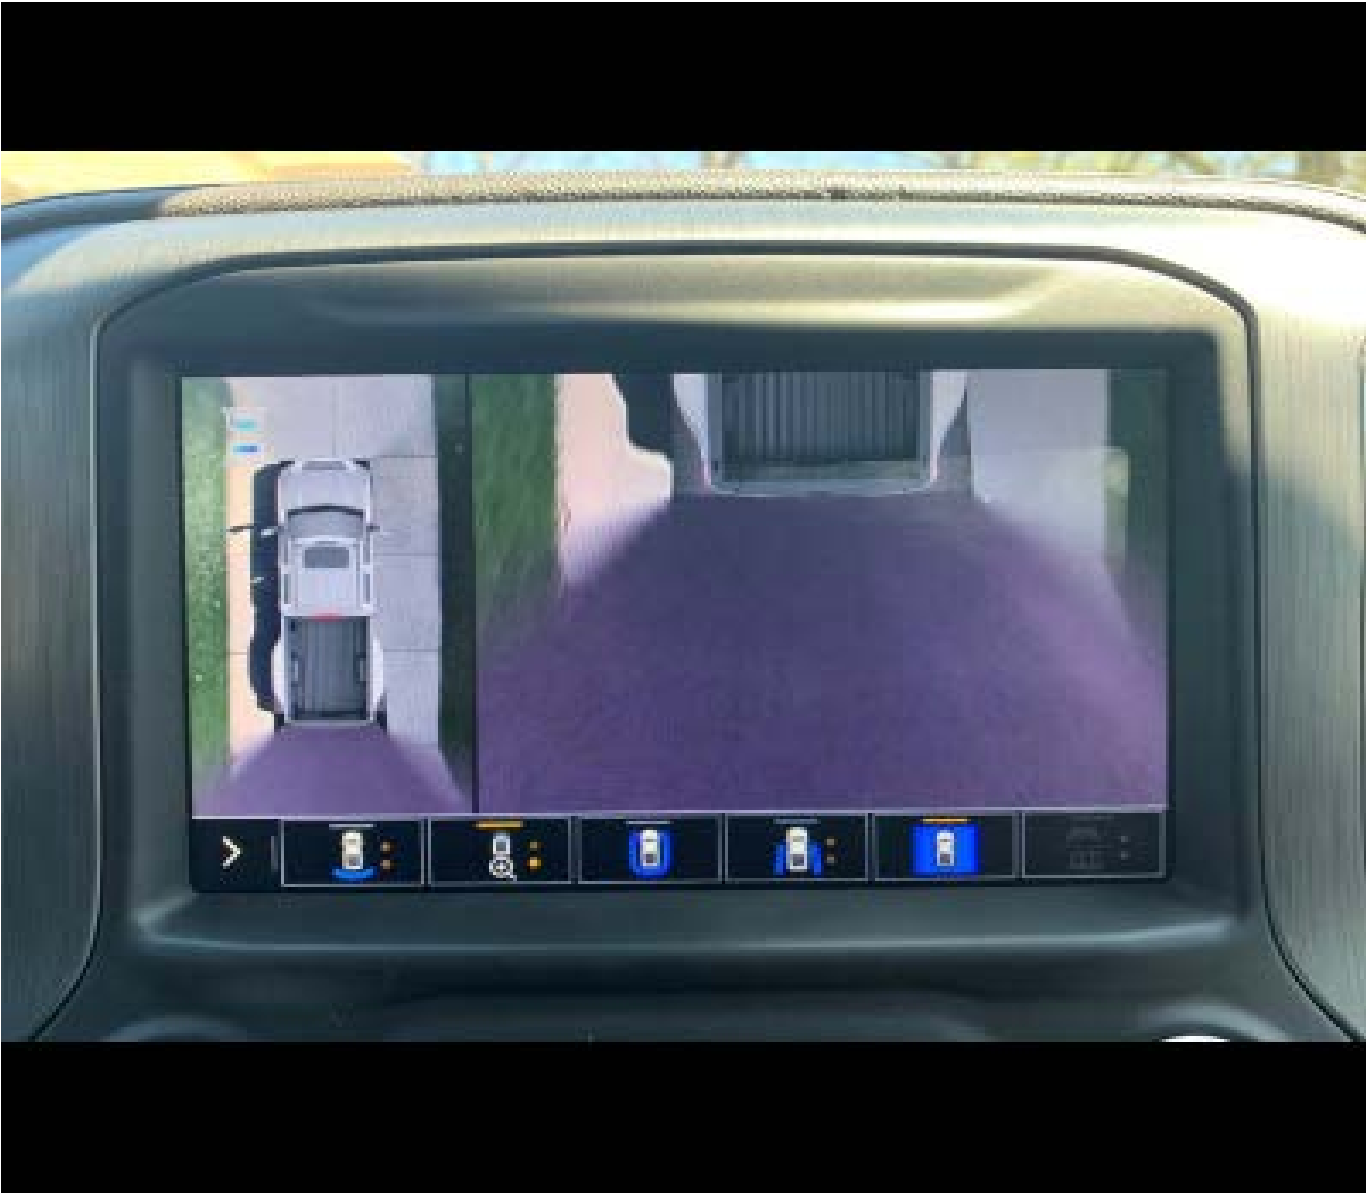
Tailgate overhead camera, Tailgate removed

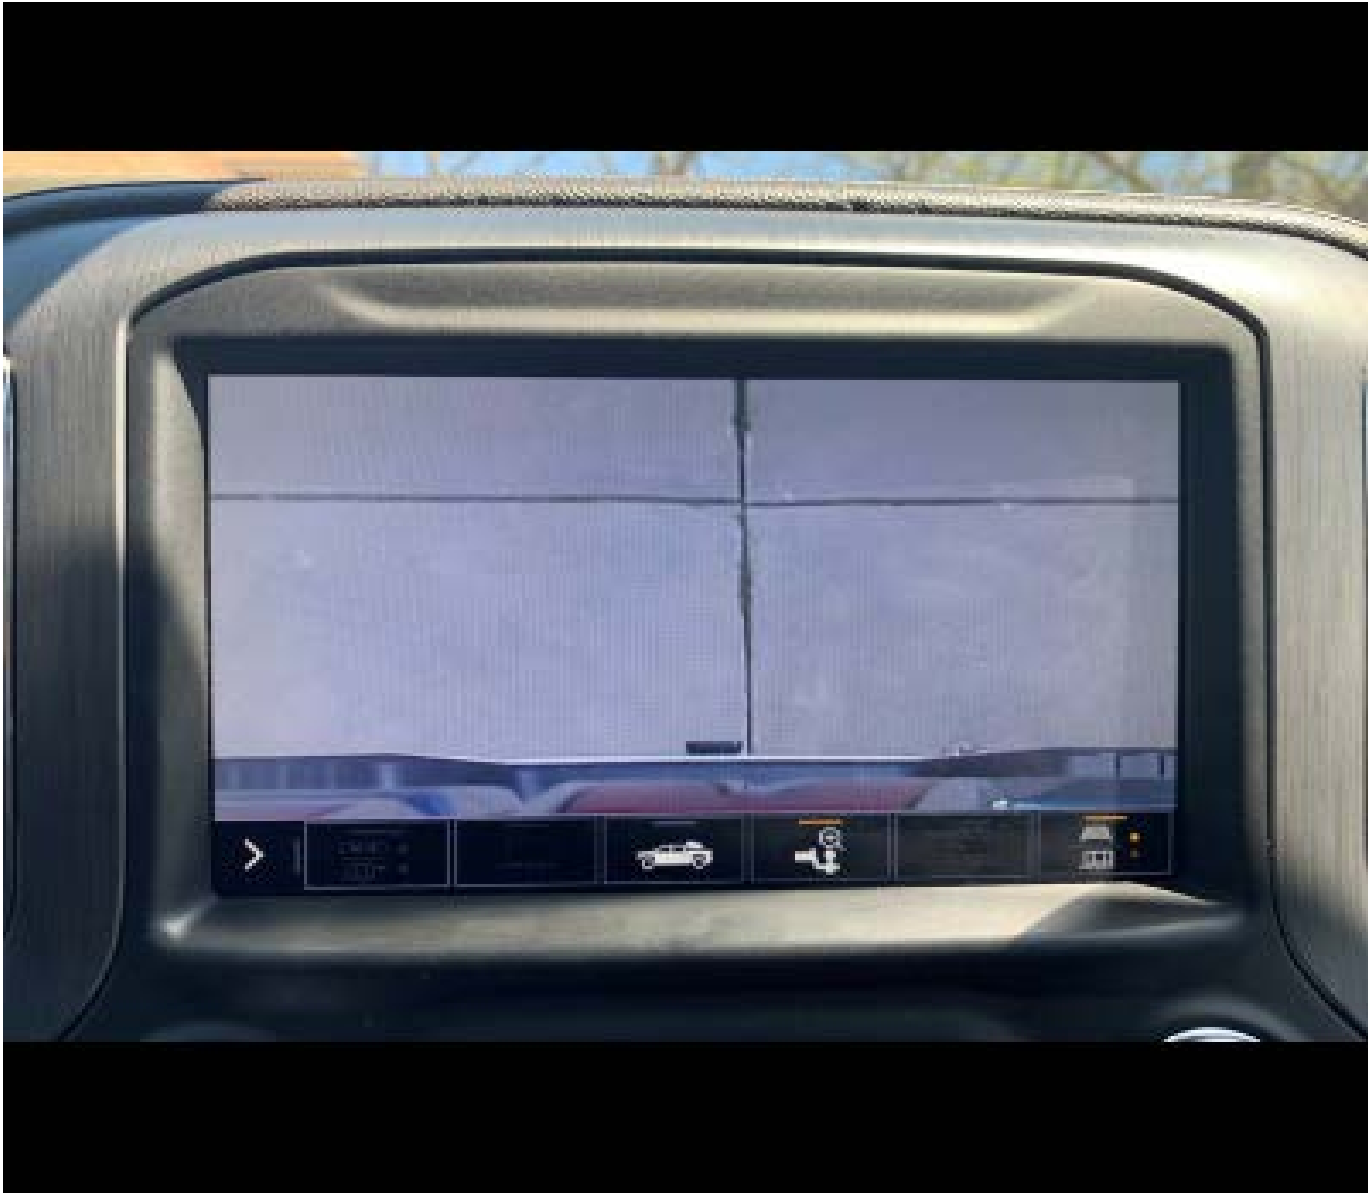
Trailer hitch camera, Tailgate equipped

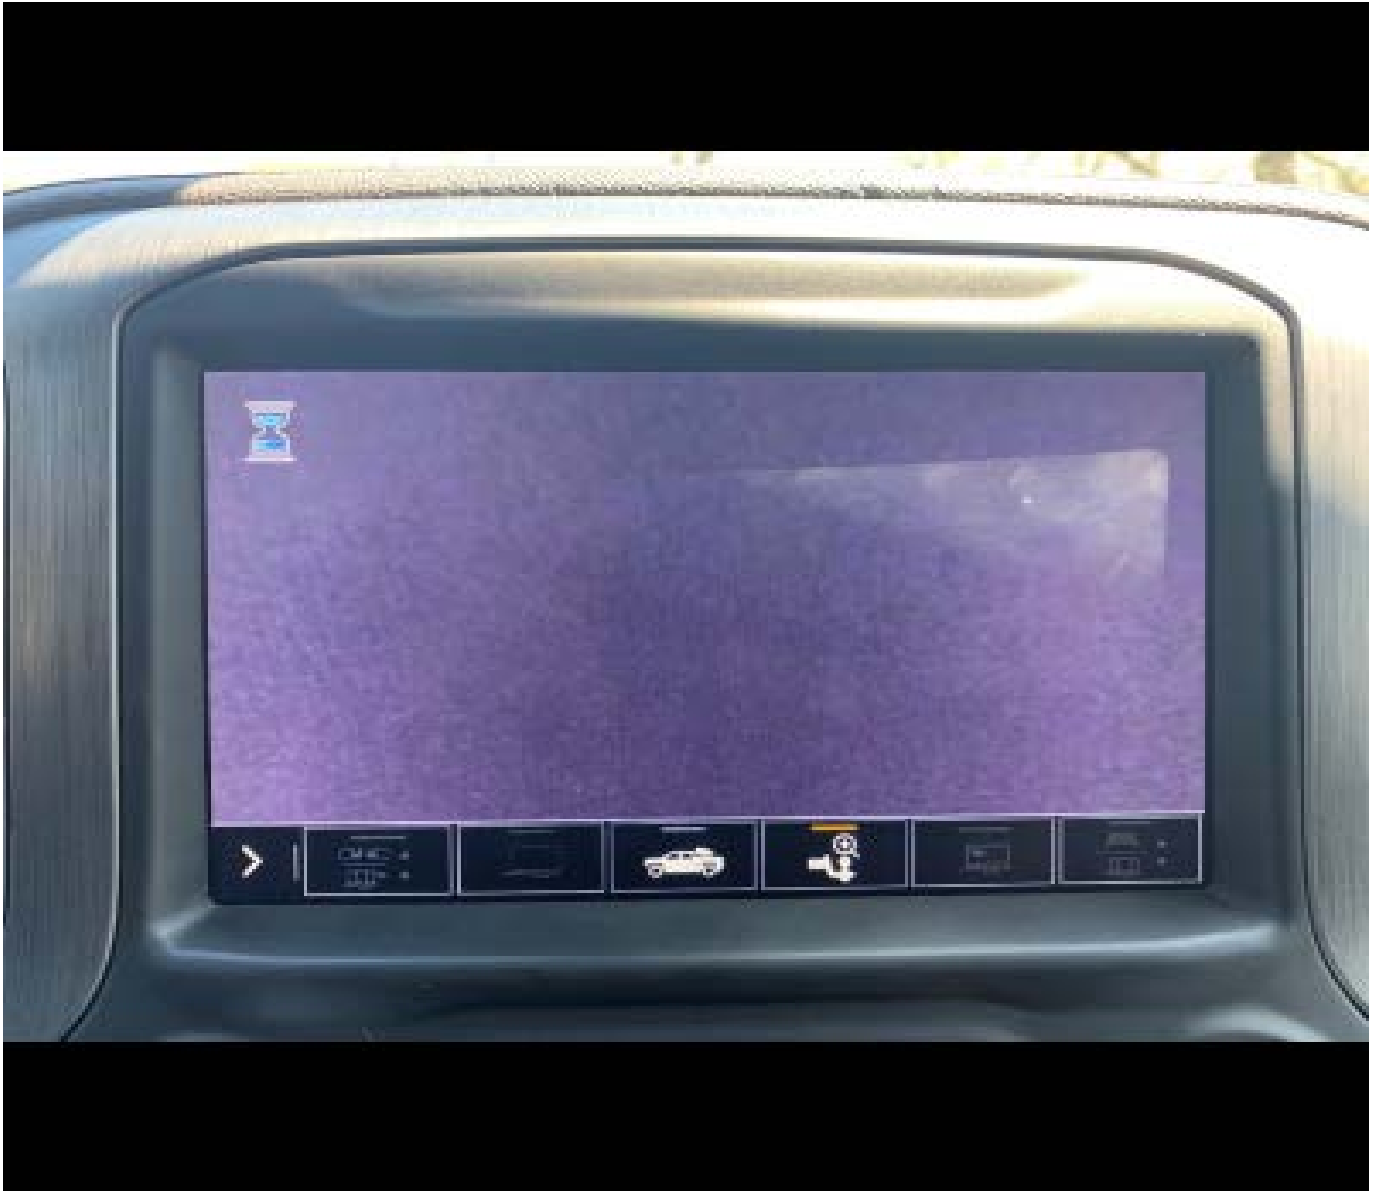
5608160

Trailer hitch camera, Tailgate removed
