HYUNDAI Technical Service Bulletin	GROUP CAMPAIGN	NUMBER 22-01-069H
	DATE AUGUST, 2022	MODEL(S) PALISADE (LX2)
SUBJECT: TRAILER TOW HITCH HARNESS FUSE REMOVAL (CAMPAIGN P31)

Description: This bulletin provides the procedure to remove the 40A fuse as an interim action relating to Recall 235 (TSB 22-01-070H or latest version) for vehicles equipped with a Genuine Hyundai Accessory trailer tow hitch and wire harness installed.

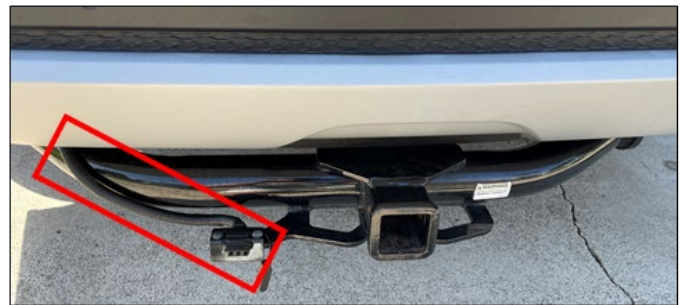
1. Confirm the vehicle is equipped with the Genuine Hyundai Accessory trailer tow hitch and wire harness installed.

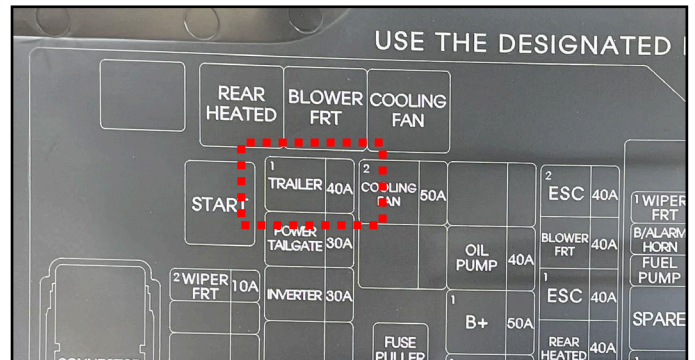
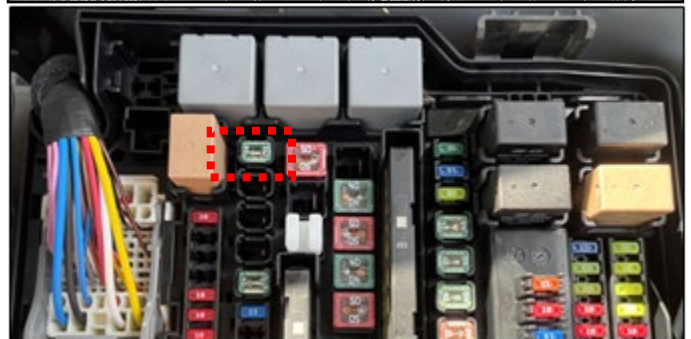
2. Open the hood and locate the fuse box in the engine bay.

Remove the "TRAILER" 40A fuse.

This is an interim action relating to Recall 235. The trailer lights will be rendered inoperative until the final Recall remedy has been implemented.

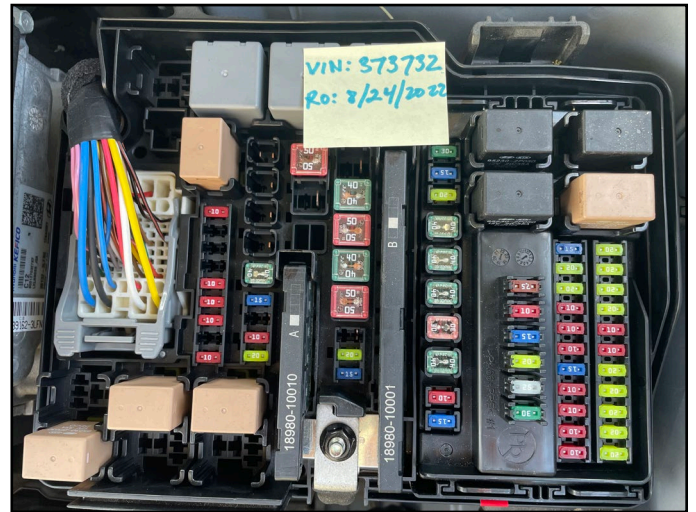
3. Write the last six digits of the VIN and date of repair onto a piece of paper and place it near the engine bay fuse box.

Using STUI, take a picture of the engine fuse box with the “TRAILER” 40A fuse removed. Upload the photo to STUI.
