SERVICE ACTION

Global Service Action
Number: H394v2

Subject: Front EDU Link Harness	Publication No.: H394v2
	Model: I-PACE (X590)
	Model Year: 2021
	Date of Issue: 11 August 2022
	Expiry Date: 31 March 2024

Front EDU Link Harness

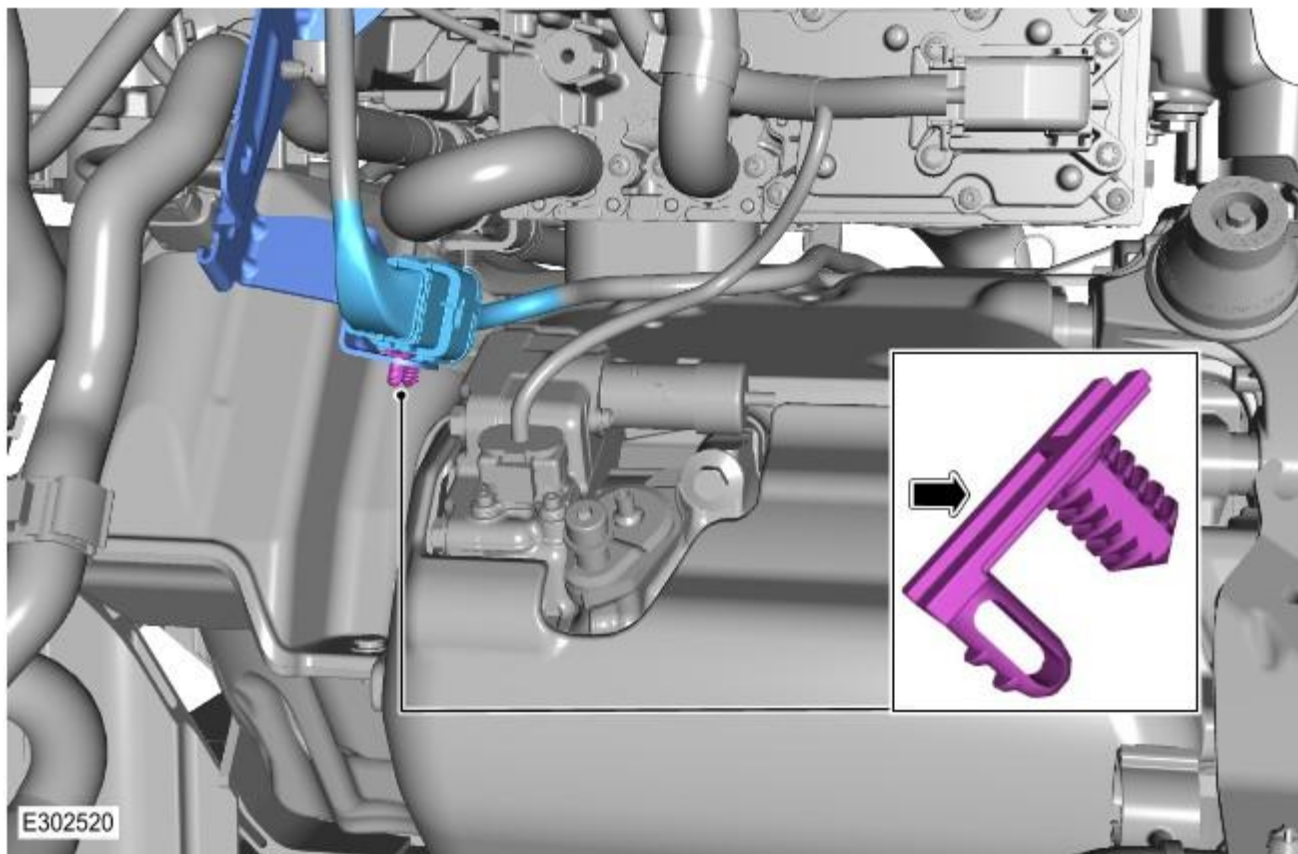
1. During the installation of the new front [EDU](#) link wiring harness, the front [EDU](#) link harness retaining clip **must** be renewed. (T4K16162)

1. Renew the front [EDU](#) link wiring harness, (see TOPlx Workshop Manual section 418-02: Wiring Harnesses - Removal and Installation - Front Electric Drive Unit Link Wiring Harness).
