Various Error Messages in the Instrument Cluster: Checking Splices in the Fuse Box (25/22)

Vehicle Type: **Macan (95B) / Macan S (95B) / Macan Turbo (95B)**

Model Year: **As of 2019 up to 2021**

Concerns: **Engine wire harness body**

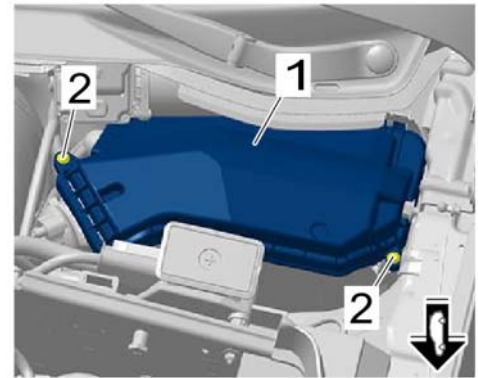
*Fuse box cover*

- 5 Remove fuse box cover ⇒ *Fuse box cover -1-*.
For this, unscrew screws ⇒ *Fuse box cover -2-* and
remove fuse box cover ⇒ *Fuse box cover -1-*.
- 6 Disconnect relay carrier ⇒ *Relay carrier -1-* from
fuse box.

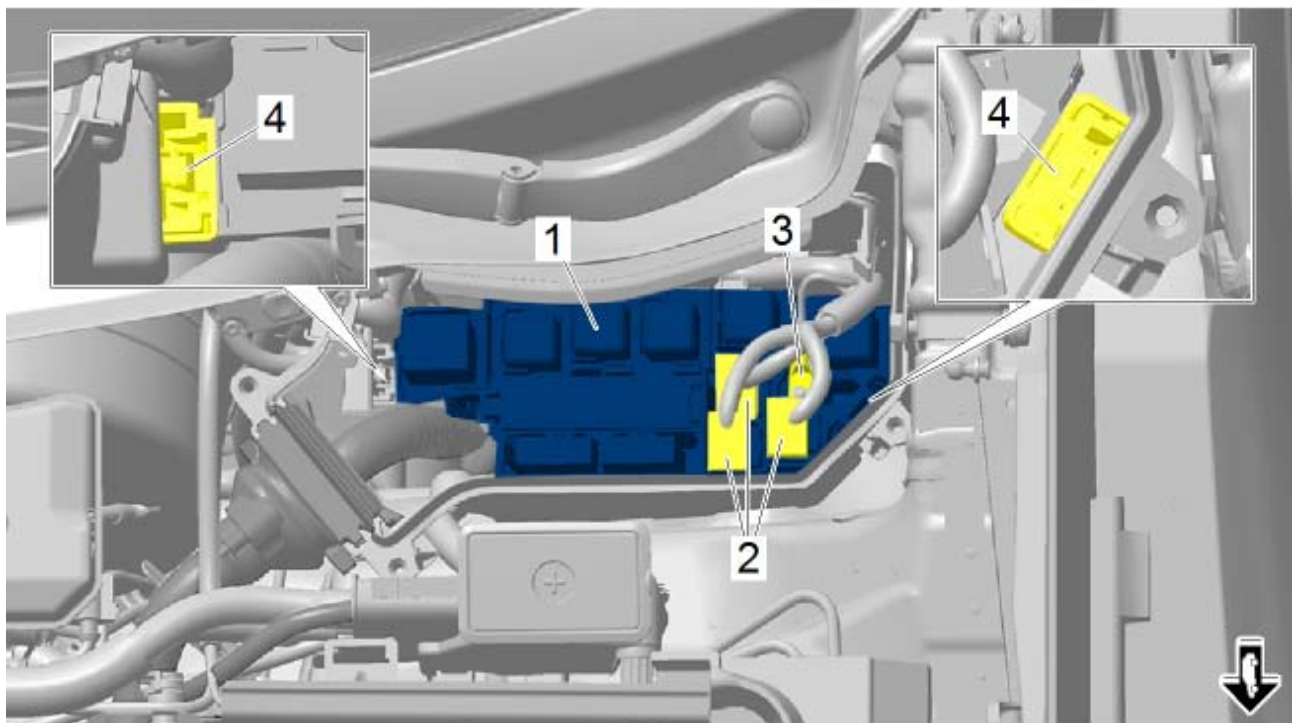
*Relay carrier*

- 6.1 Release electric plug connections ⇒ *Relay carrier -2-* and disconnect them.
 - 6.2 Unscrew nut ⇒ *Relay carrier -3-*.
 - 6.3 Press locking lugs ⇒ *Relay carrier -4-* and remove relay carrier ⇒ *Relay carrier -1-* by
pulling it upwards.
- 7 Checking fuse box for water leaking in.

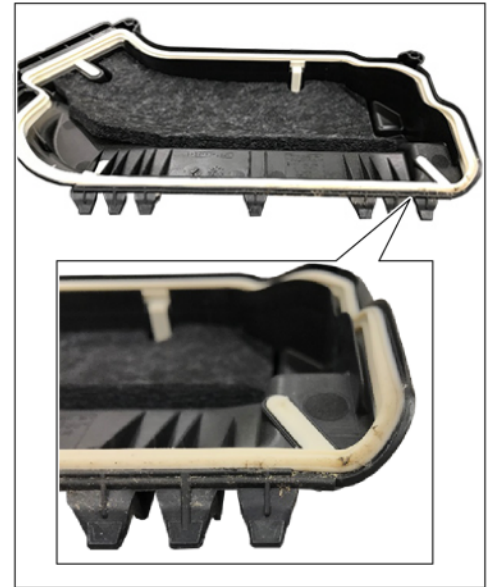
Checking fuse box cover

- 7.1 Check the seal on the fuse box cover
⇒ *Checking fuse box cover* for dirt and any deformations.
- 7.2 Check the fuse box in areas ⇒ *Water leak in fuse box -5 and 6-* for traces of water leaking in.

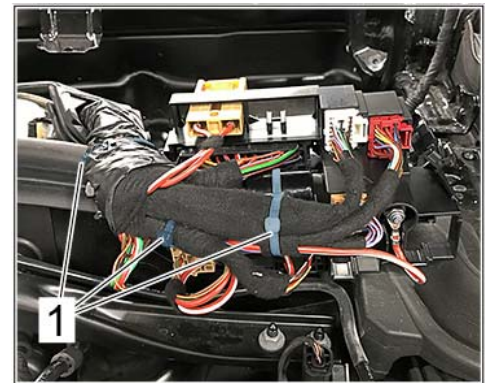
Lower relay carrier

Work Procedure: 1 Cut three tie-wraps ⇒ *Lower relay carrier -1-* on the wire harness using a suitable tool.

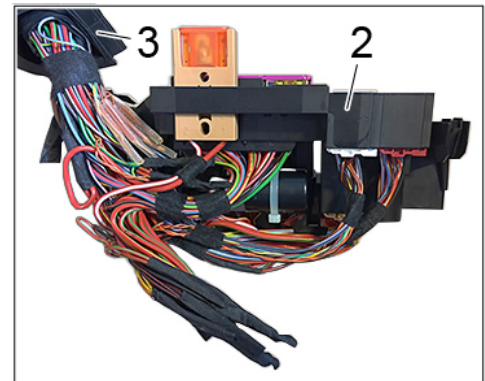
Wire harness exposed

- 2 Remove insulating tape and fabric tape on the engine body wire harness between the relay carrier ⇒ *Wire harness exposed -2-* and rubber sleeve ⇒ *Wire harness exposed -3-*.
- 3 Remove fabric tape on the splice connections in areas ⇒ *Installation position of splice connections -A, B-* and ⇒ *Installation position of splice connections -C-* for a visual inspection and check the splice points for corrosion.
Start with Segment C.

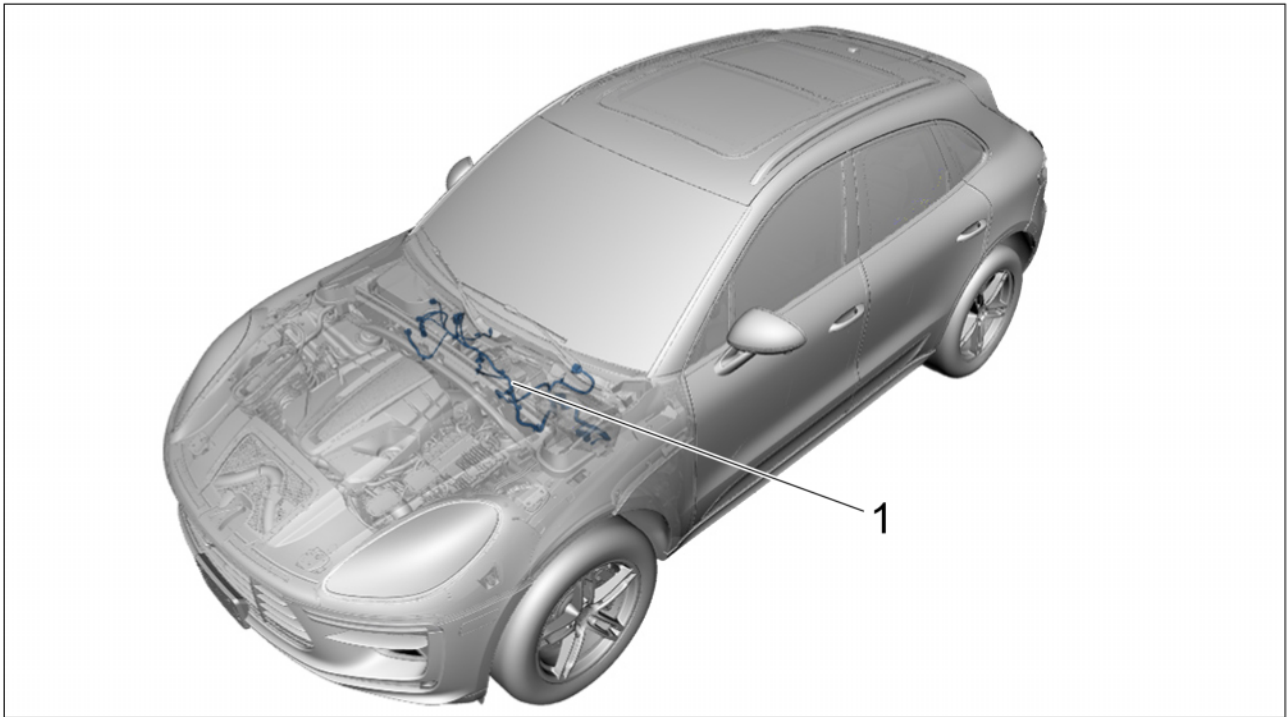
Installation position of wire harness for plenum panel

- Work Procedure: 1 Removing engine wire harness body.
For instructions, see:
⇒ *Workshop Manual '975219 Removing and installing engine wire harness body (R4)'*
or
⇒ *Workshop Manual '975219 Removing and installing engine wire harness body'*
- 2 Loosen wire harness in plenum panel.
To do this, disconnect all electric plug connections on the plenum panel wire harness ⇒ *Installation position of wire harness for plenum panel -1-* as far as the fuse box section and remove the plenum panel wire harness as far as the fuse box section.

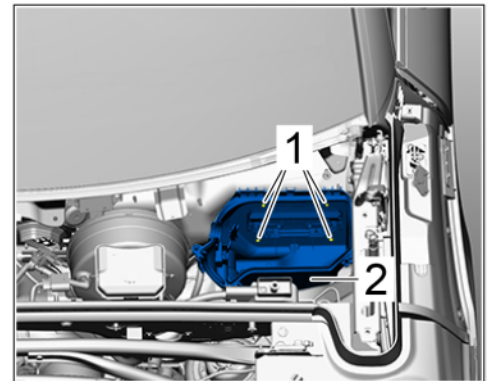
Remove fuse box

- 3 Remove old fuse box.
 - 3.1 Loosen and unscrew screws ⇒ *Remove fuse box -1-* on the fuse box ⇒ *Remove fuse box -2-*.

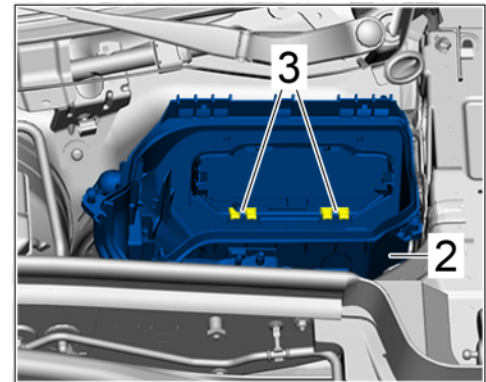
Loosening fuse box

- 3.2 Press locking lugs ⇒ *Loosening fuse box -3-* upward, release and remove the fuse box ⇒ *Loosening fuse box -2-*. Guide the plenum panel wire harness out of the fuse box.

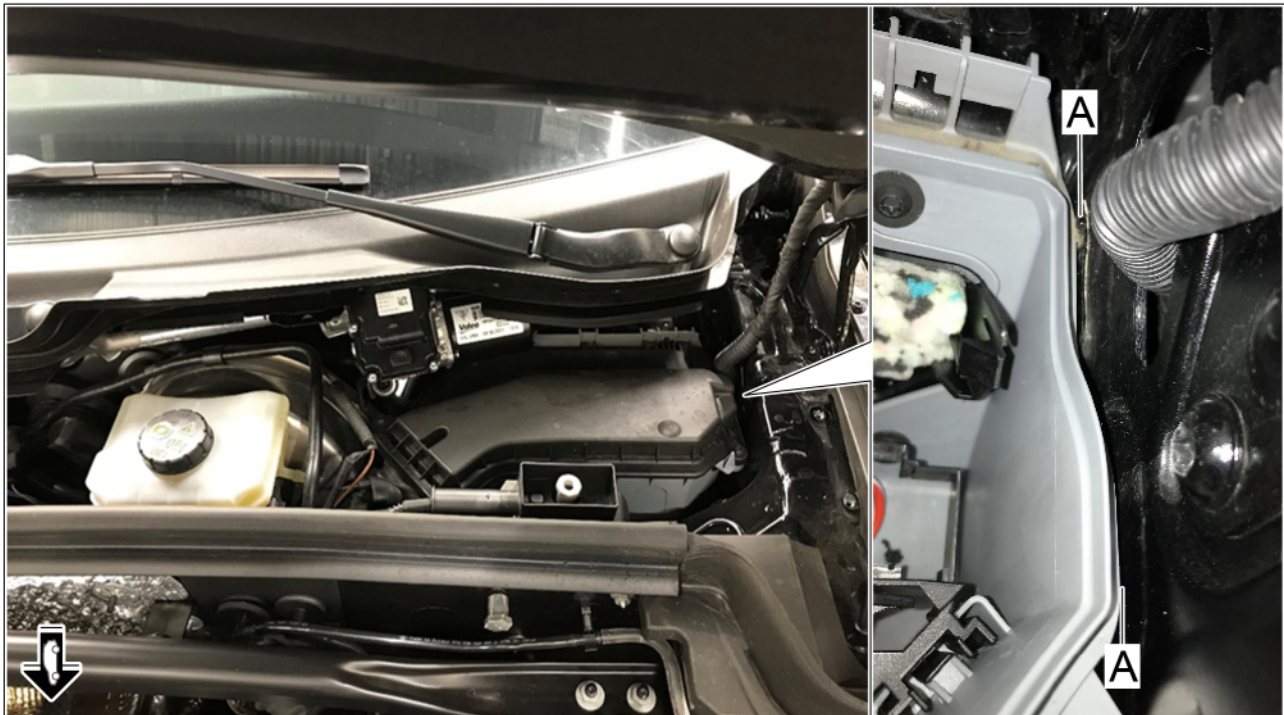
Gap from fuse box to unpainted bodyshell with PVC seam

The water leaking into the fuse box is caused by possible contact between the fuse box housing and a PVC seam on the vehicle body. ⇒ *Gap from fuse box to unpainted bodyshell with PVC seam -A-*

This contact can cause the fuse box to become deformed and result in a leak on the fuse box cover.

To prevent future water leaks, the fuse box must be replaced, and the PVC seam between the fuse box and unpainted bodyshell must be reworked.

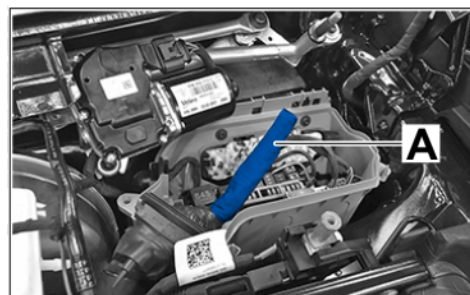
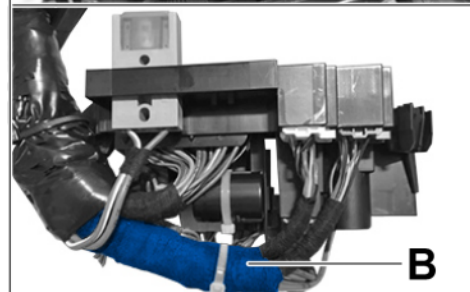
Installation position of splice node

- If the splice node is already moved upwards ⇒ *Installation position of splice node -A-*, the wire harness can be installed.
- If the splice junction is not routed upwards as on the previous wire harness ⇒ *Installation position of splice node -B-*, it must be reworked before installation in the vehicle.

For instructions, see: ⇒ *Technical Information '975219 Reworking new engine wire harness on body'*

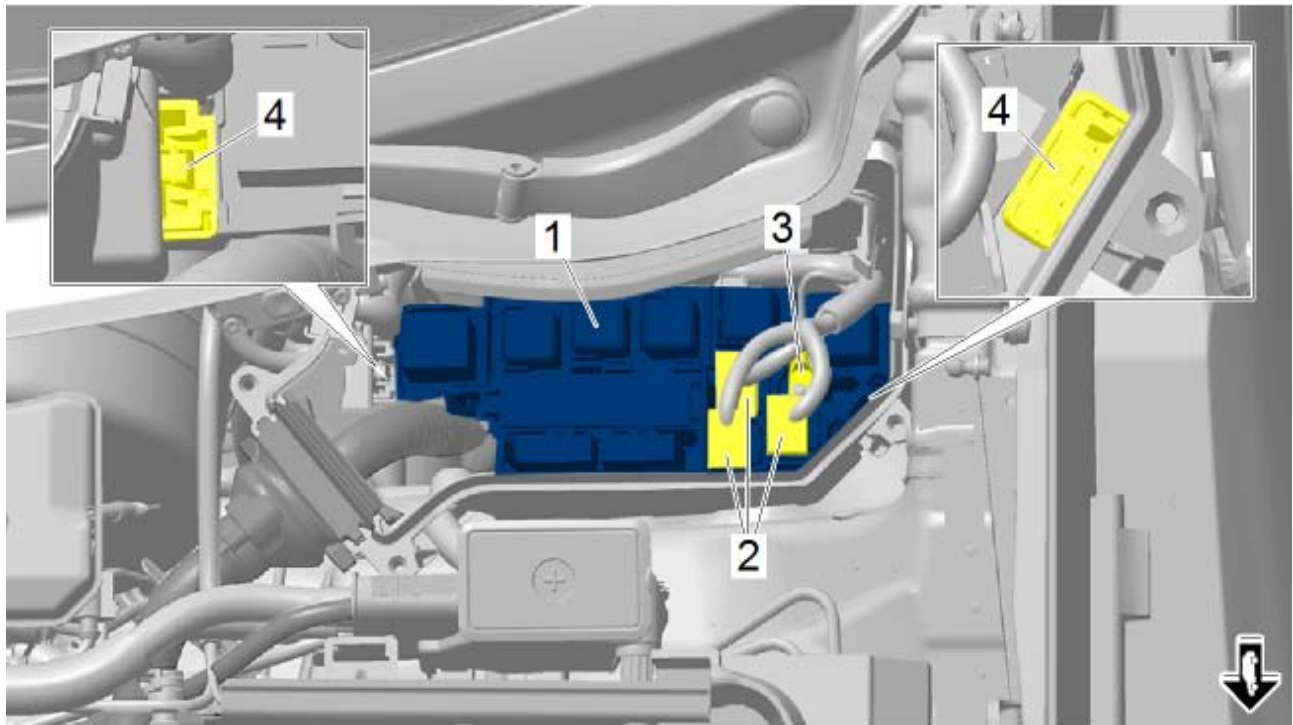
Relay carrier

- 7 Install wiper link. ⇒ *Workshop Manual '921919 Removing and installing wiper link'*
- 8 Fasten relay carrier ⇒ *Relay carrier -1-* on the fuse box.

8.1 Push in relay carrier ⇒ *Relay carrier -1-* until the locking lugs ⇒ *Relay carrier -4-* engage securely.

8.2 Screw on and tighten nut ⇒ *Relay carrier -3-*.

Tightening torque 9 Nm

8.3 Connect and lock electric plug connections ⇒ *Relay carrier -2-*.

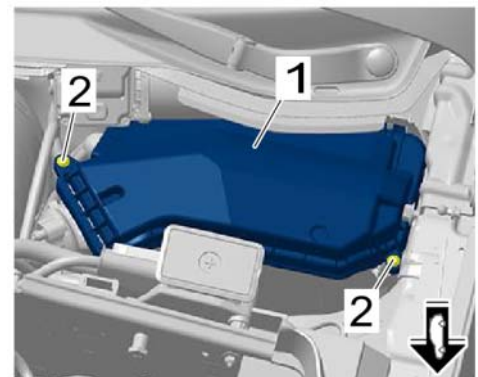
Fuse box cover

9 Install **new** fuse box cover ⇒ *Fuse box cover -1-*.

9.1 Install cover on fuse box ⇒ *Fuse box cover -1-*.

9.2 Install and tighten screws ⇒ *Fuse box cover -2-*.

Tightening torque 3 Nm

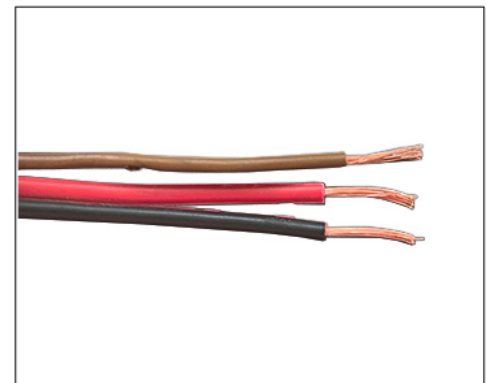
Insulated lines

- 1 Cut back electric lines at the affected splice point until no more corrosion is visible.
 - 1.1 To do this, cut out the corroded area of the electric lines.
 - 1.2 Slide shrink-fit hose onto the lines.
 - 1.3 Strip 10 mm of insulation off electrical lines.

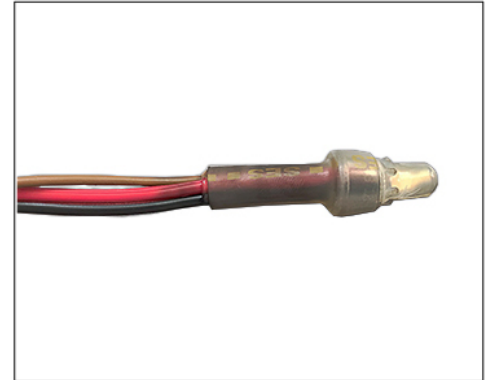
Repaired splice point (example)

- 1.4 Crimp electric lines with **crimping pliers** using crimping sleeves or a combination of crimp and shrink-fit hose.
- 1.5 Slide shrink-fit hose over the crimp connections and carefully shrink it to make it watertight using the **hot-air blower**.
- 1.6 Wrap commercially available PVC adhesive tape all around the joints.

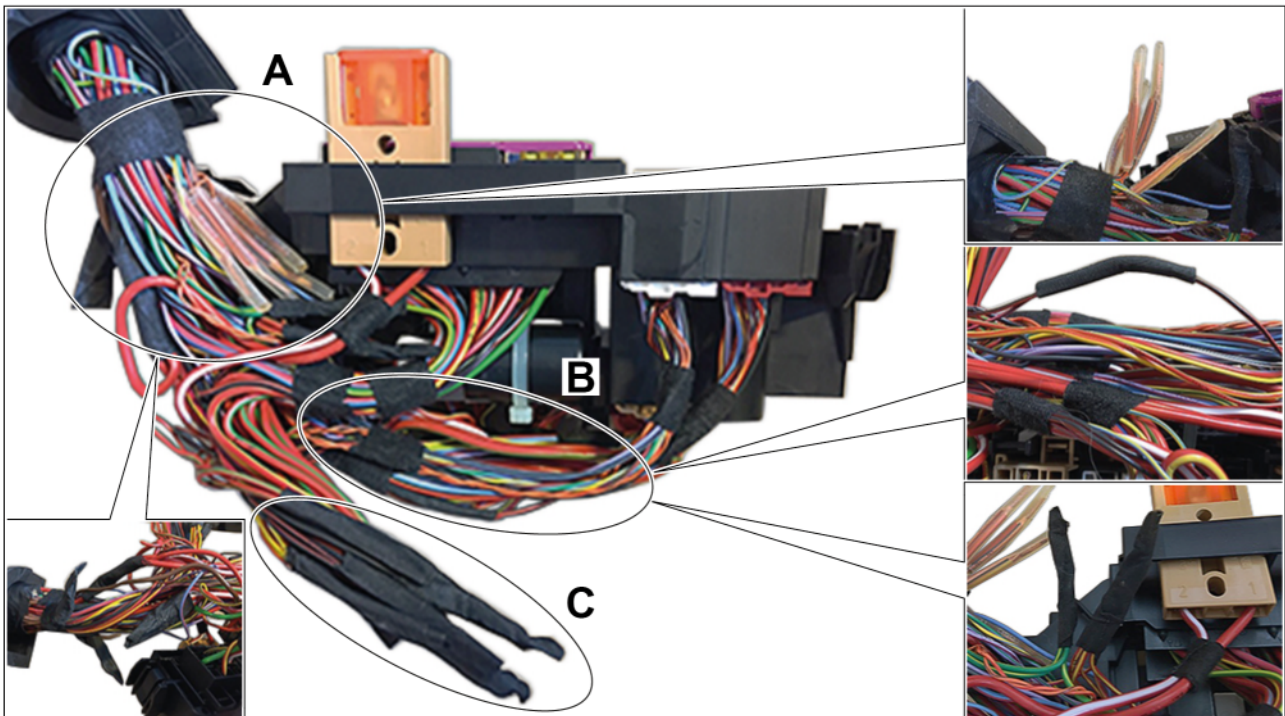
- 2 Insulate splice connections in the area \Rightarrow *Splices exposed -B-* using a water-resistant heat shrink hose. Insulation with PVC adhesive tape is sufficient on splice connections in the area \Rightarrow *Splices exposed -A- and \Rightarrow Splices exposed -C-*.

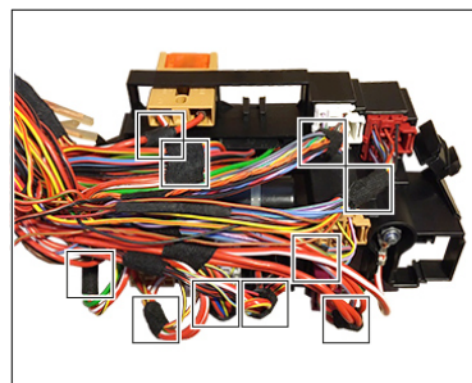
Securing individual lines

- 3 Secure engine wire harness body to the relay carrier.
 - 3.1 Wrap ⇒ *Securing individual lines* with fleece adhesive tape around the individual lines at the marked areas.

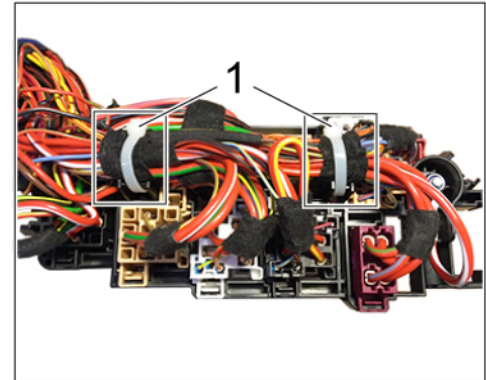
Securing lines

- 3.2 Wrap with fleece adhesive tape around the lines in the marked area and fasten ⇒ *Securing lines -1-* to the relay carrier each with a tie-wrap.

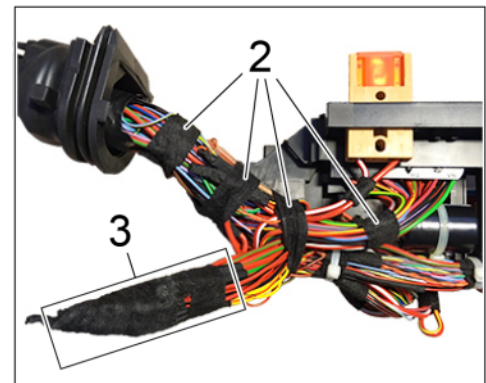
Wrapping engine wire harness body

- 3.3 Wrap the engine wire harness body at the positions ⇒ *Wrapping engine wire harness body -2-* and at the splice node ⇒ *Wrapping engine wire harness body -3-* with fleece adhesive tape.

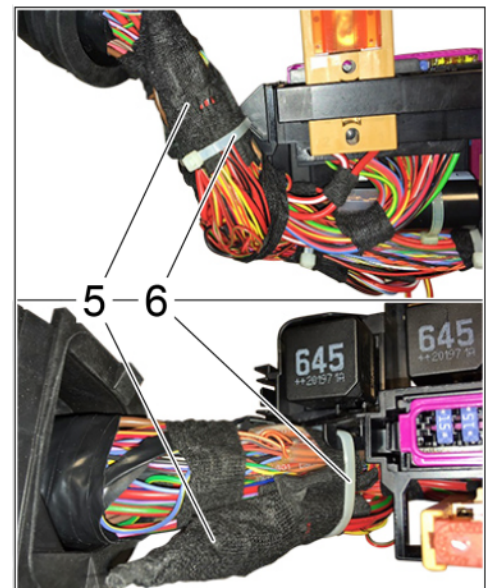
Securing splice node

- 3.4 Route splice node ⇒ *Securing splice node -5-* upwards and fasten ⇒ *Securing splice node -6-* to the relay carrier together using the remaining wire harness and a tie-wrap.

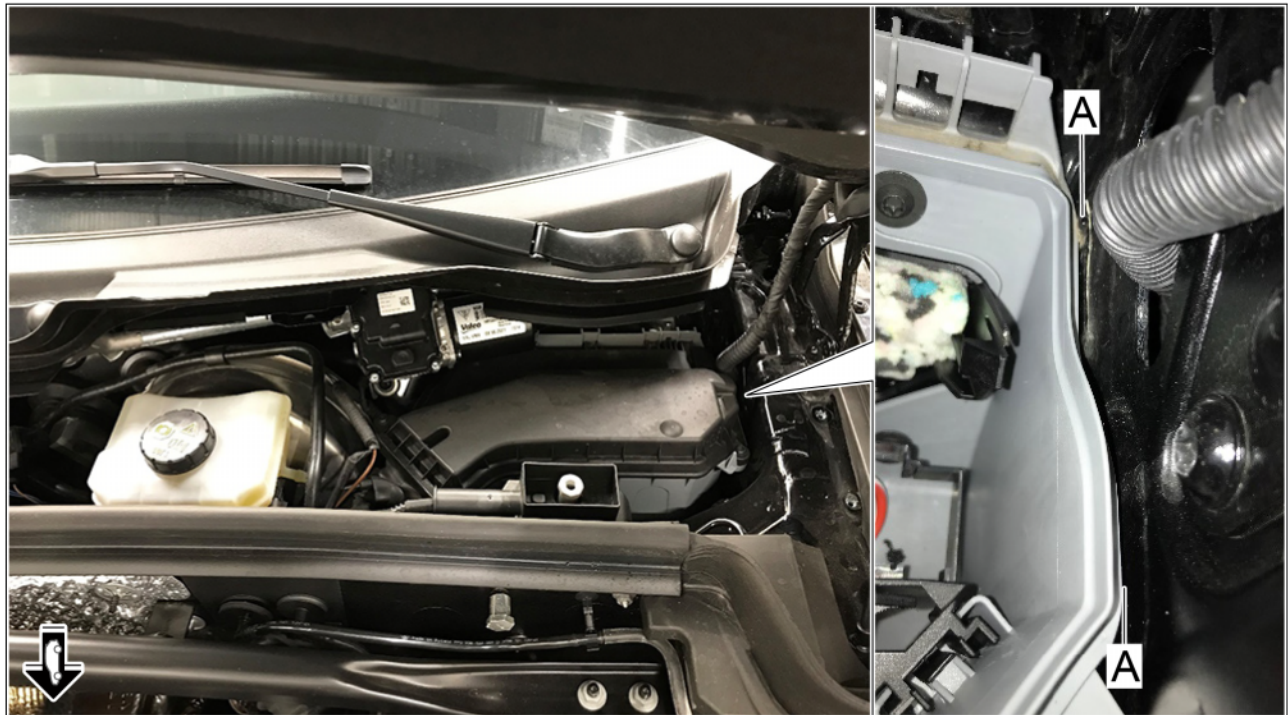
Gap from fuse box to unpainted bodyshell with PVC seam

The water leaking into the fuse box is caused by possible contact between the fuse box housing and a PVC seam on the vehicle body.

This contact can cause the fuse box to become deformed and result in a leak on the fuse box cover.

To prevent future water leaks, the fuse box cover must be replaced, and the PVC seam between the fuse box and unpainted bodyshell must be reworked.

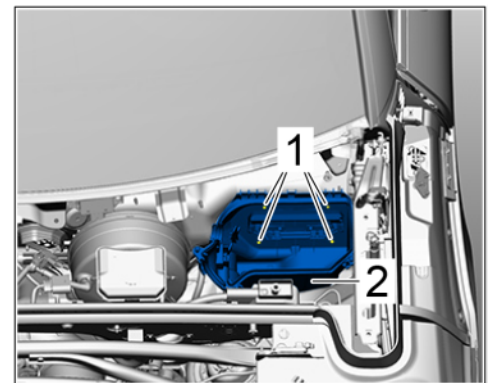
Remove fuse box

- 4 Removing wiper link. ⇒ *Workshop Manual '921919 Removing and installing wiper link'*
- 5 Loosen fuse box to allow access to the PVC seam.
 - 5.1 Loosen and unscrew screws ⇒ *Remove fuse box -1-* on the fuse box ⇒ *Remove fuse box -2-*.

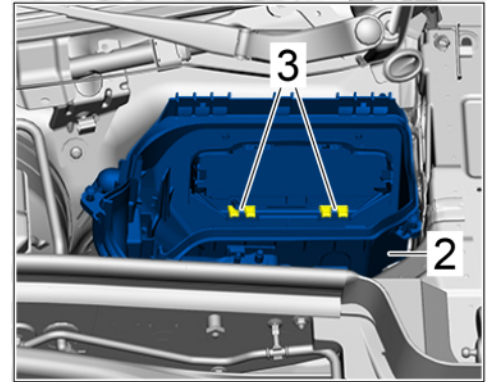
Loosening fuse box

- 5.2 Press locking lugs ⇒ *Loosening fuse box -3-* up and release them. Remove the fuse box as far as required as the existing plenum panel wire harness can be used. ⇒ *Rework position of fuse box for PVC seam*

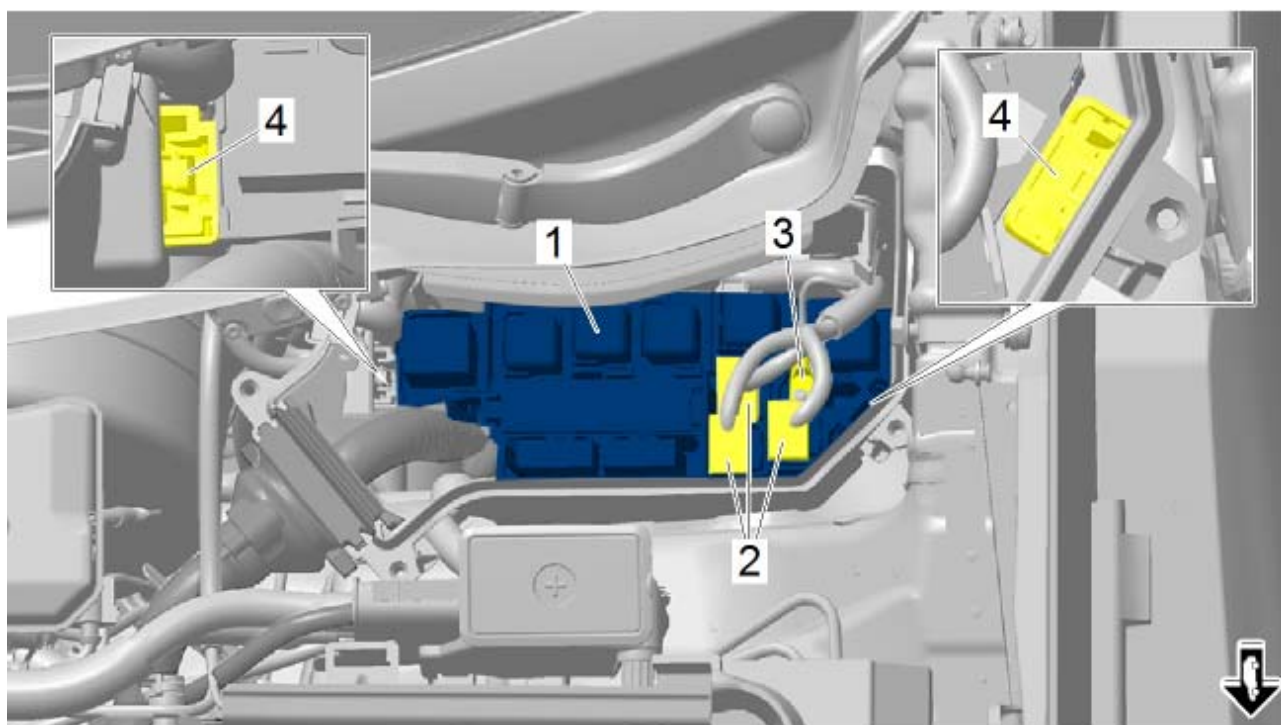
Relay carrier

- 6 Install wiper link. ⇒ *Workshop Manual '921919 Removing and installing wiper link'*
- 7 Fasten relay carrier ⇒ *Relay carrier -1-* to the fuse box.

- 7.1 Push in relay carrier ⇒ *Relay carrier -1-* until the locking lugs ⇒ *Relay carrier -4-* engage securely.
- 7.2 Screw on and tighten nut ⇒ *Relay carrier -3-*.
- Tightening torque 9 Nm**
- 7.3 Connect and lock electric plug connections ⇒ *Relay carrier -2-*.

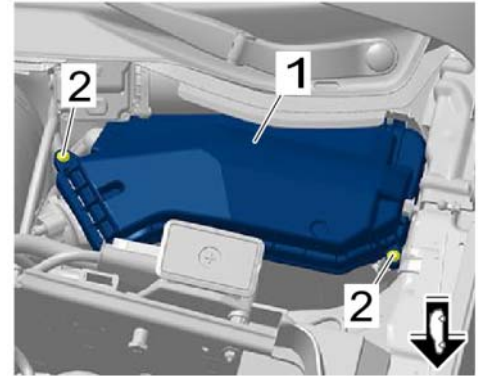
Fuse box cover

- 8 Install **new** fuse box cover ⇒ *Fuse box cover -1-*.
 - 8.1 Install cover on fuse box ⇒ *Fuse box cover -1-*.
 - 8.2 Install and tighten screws ⇒ *Fuse box cover -2-*.

Tightening torque 3 Nm

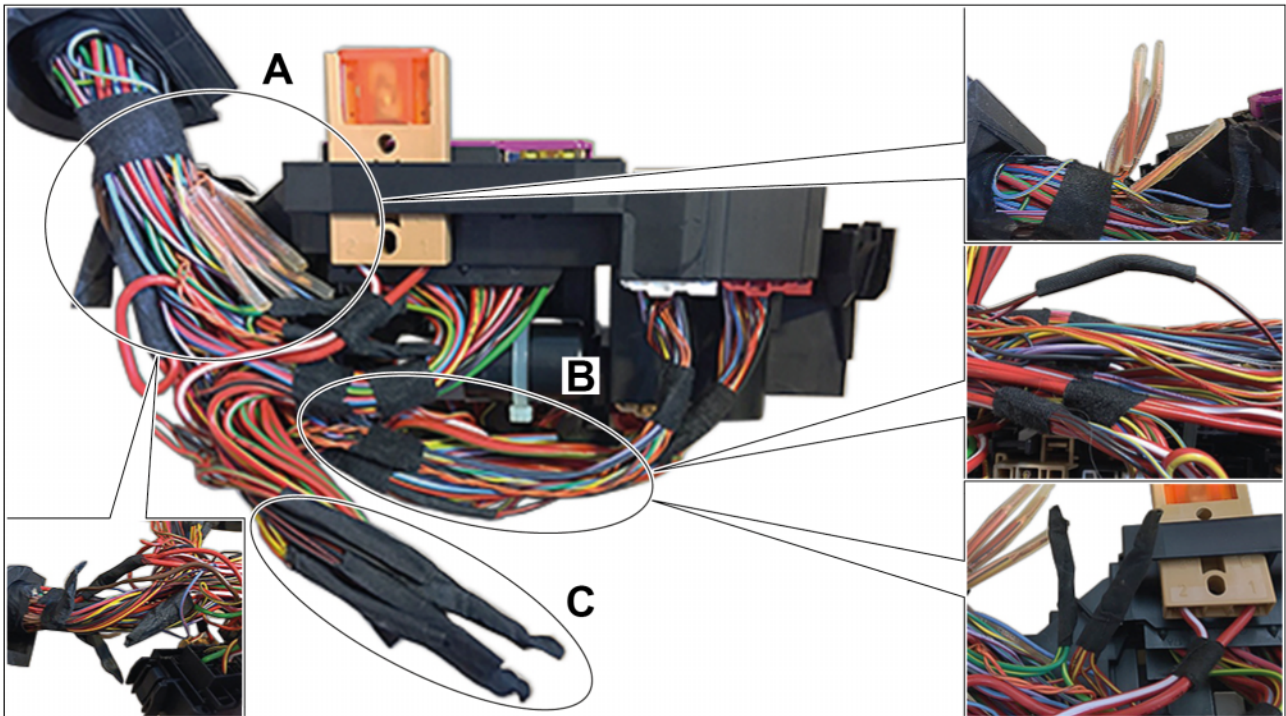
- 1 Insulate splice connections in the area \Rightarrow *Splices exposed -B-* using a water-resistant heat shrink-fit hose.
Insulation with PVC adhesive tape is sufficient on splice connections in the area \Rightarrow *Splices exposed -A- and \Rightarrow Splices exposed -C-*.

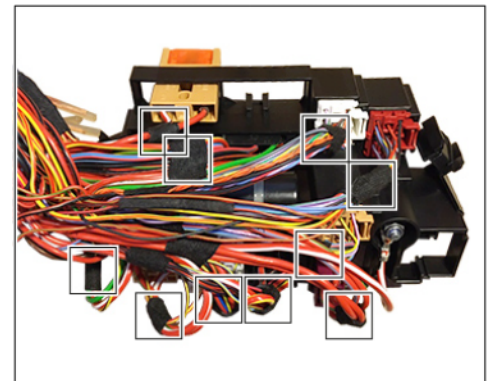
Securing individual lines

2.1 Wrap with fleece adhesive tape around the individual lines at the marked areas.
 ⇒ *Securing individual lines*

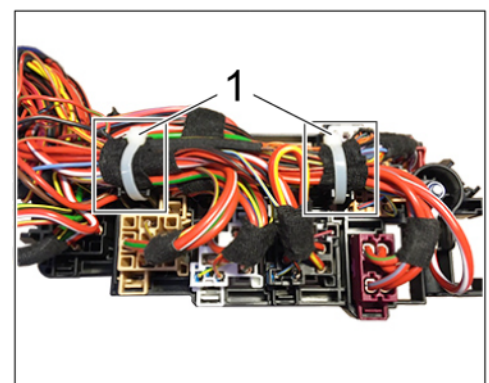
Securing lines

2.2 Wrap with fleece adhesive tape around the lines in the marked area and fasten ⇒ *Securing lines -1-* on the relay carrier each with a tie-wrap.

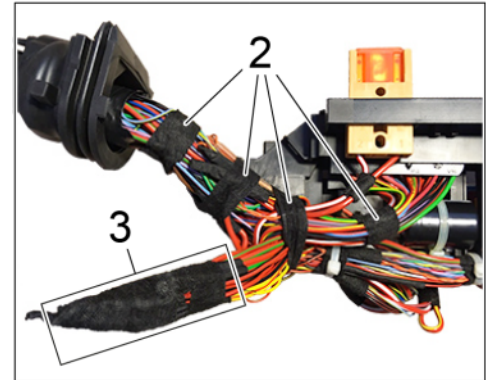
Wrapping engine wire harness body

- 2.3 Wrap the engine wire harness body at the positions ⇒ *Wrapping engine wire harness body-2-* and at the splice node ⇒ *Wrapping engine wire harness body-3-* with fleece adhesive tape.

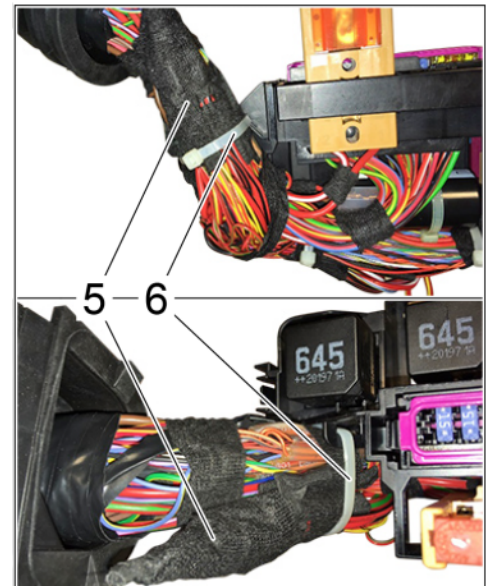
Securing splice node

- 2.4 Route splice node ⇒ *Securing splice node -5-* upwards and fasten ⇒ *Securing splice node -6-* to the relay carrier together using the remaining wire harness and the tie-wrap.

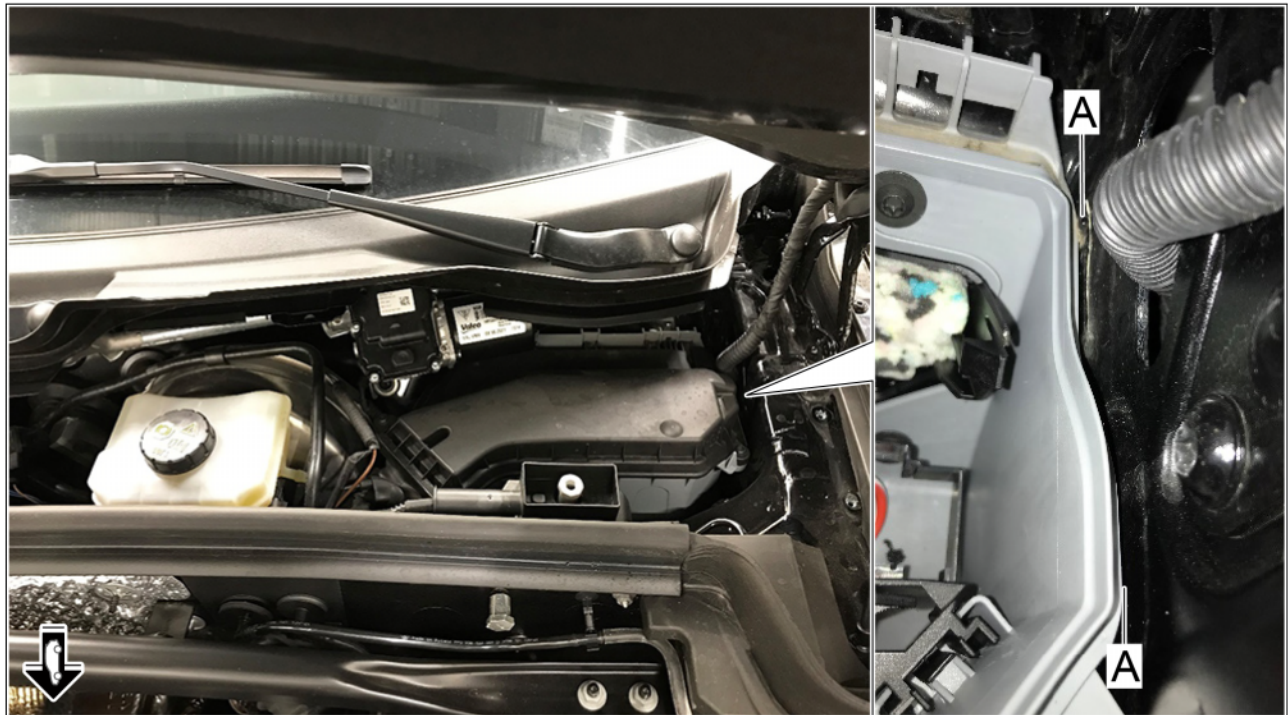
Gap from fuse box to unpainted bodyshell with PVC seam

The water leaking into the fuse box is caused by possible contact between the fuse box housing and a PVC seam on the vehicle body.

This contact can cause the fuse box to become deformed and result in a leak on the fuse box cover.

To prevent future water leaks, the fuse box cover must be replaced, and the PVC seam between the fuse box and unpainted bodyshell must be reworked.

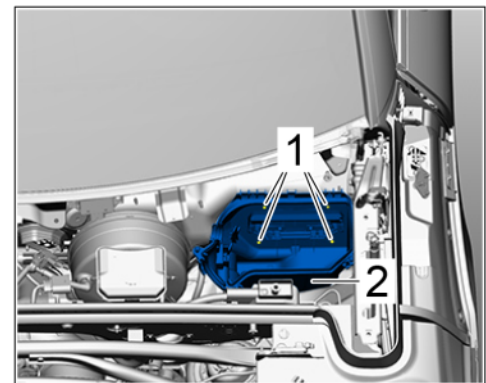
Remove fuse box

- 3 Removing wiper link. ⇒ *Workshop Manual '921919 Removing and installing wiper link'*
- 4 Loosen fuse box to allow access to the PVC seam.
 - 4.1 Loosen and unscrew screws ⇒ *Remove fuse box -1-* on the fuse box ⇒ *Remove fuse box -2-*.

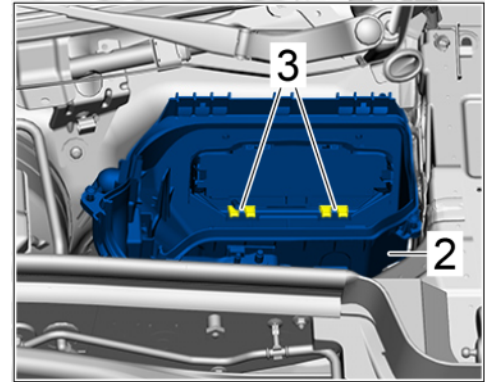
Loosening fuse box

- 4.2 Press locking lugs \Rightarrow *Loosening fuse box -3-* up and release them. Remove the fuse box as far as required as the existing plenum panel wire harness can be used. \Rightarrow *Rework position of fuse box for PVC seam*

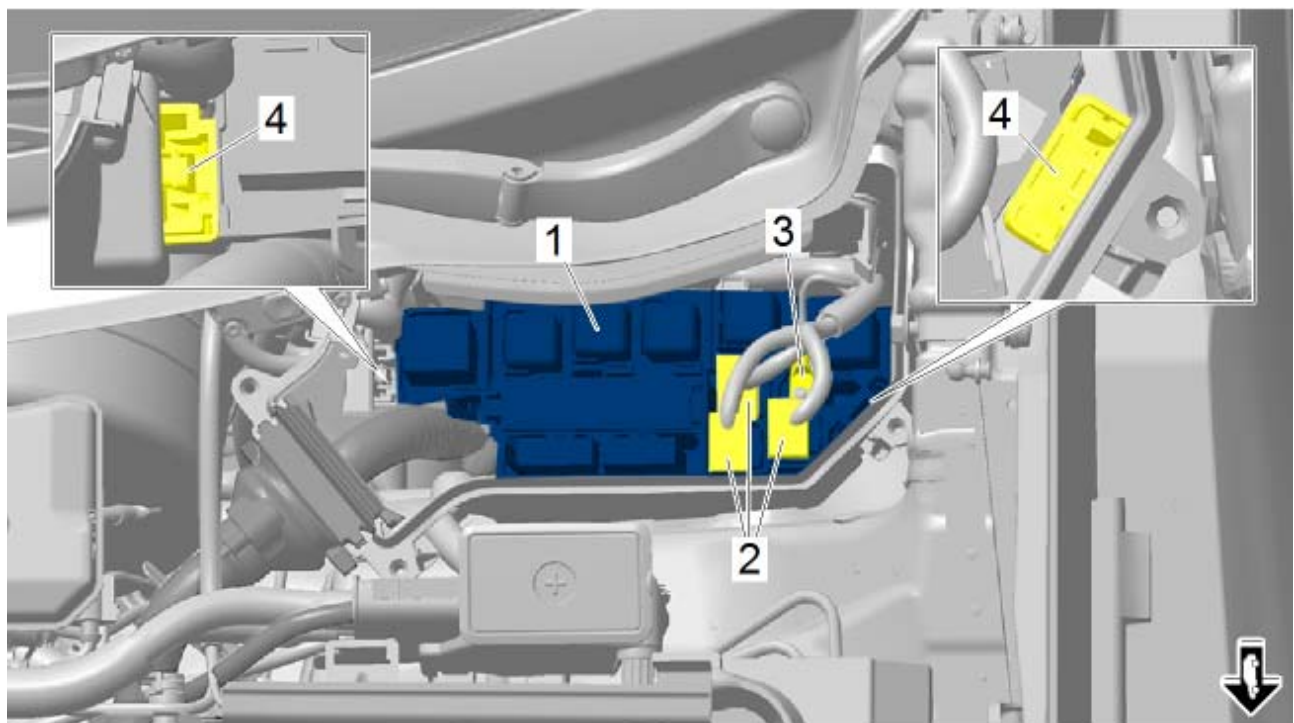
Relay carrier

- 5 Install wiper link. ⇒ *Workshop Manual '921919 Removing and installing wiper link'*
- 6 Fasten relay carrier ⇒ *Relay carrier -1-* to the fuse box.

- 6.1 Push in relay carrier ⇒ *Relay carrier -1-* until the locking lugs ⇒ *Relay carrier -4-* engage securely.
- 6.2 Screw on and tighten nut ⇒ *Relay carrier -3-*.
- Tightening torque 9 Nm**
- 6.3 Connect and lock electric plug connections ⇒ *Relay carrier -2-*.

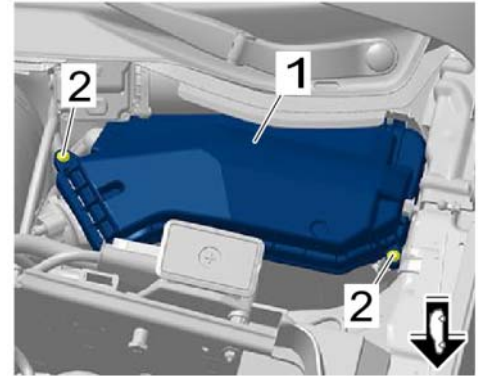
Fuse box cover

- 7 Install **new** fuse box cover ⇒ *Fuse box cover -1-*.
 - 7.1 Install cover on fuse box ⇒ *Fuse box cover -1-*.
 - 7.2 Install and tighten screws ⇒ *Fuse box cover -2-*.

Tightening torque 3 Nm

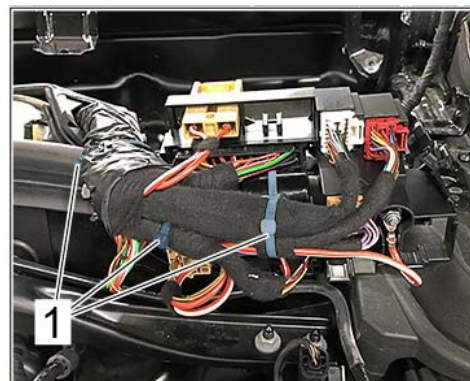
Lower relay carrier

- 1 Cut three tie-wraps ⇒ *Lower relay carrier -1-* on the wire harness using a suitable tool.

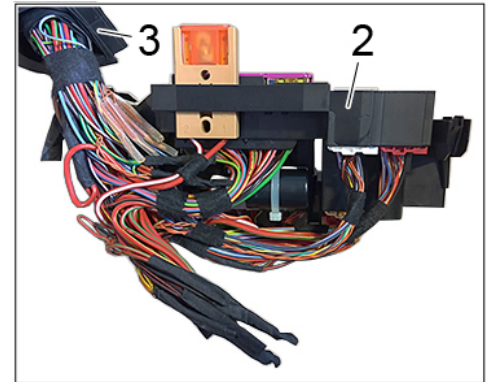
Wire harness exposed

- 2 Remove insulating tape and fabric tape on the engine body wire harness between the relay carrier ⇒ *Wire harness exposed -2-* and rubber sleeve ⇒ *Wire harness exposed -3-*.
- 3 Secure engine wire harness body to the relay carrier.

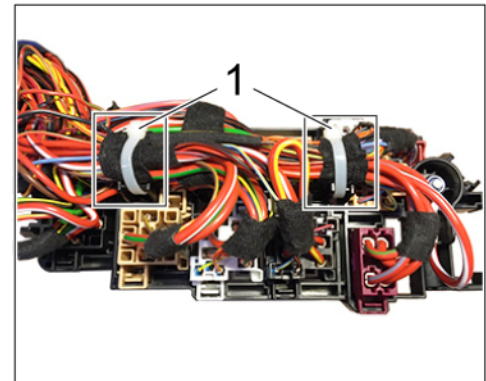
Securing lines

- 3.1 Wrap with fleece adhesive tape around the lines in the marked area and fasten ⇒ *Securing lines -1-* to the relay carrier each with a tie-wrap.

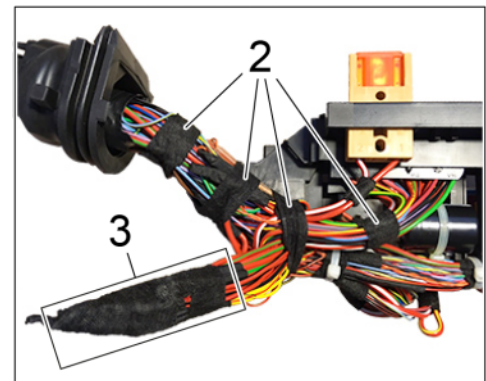
Wrapping engine wire harness body

- 3.2 Wind fleece adhesive tape around the engine wire harness body at positions ⇒ *Wrapping engine wire harness body -2-* and at the splice node ⇒ *Wrapping engine wire harness body -3-*.

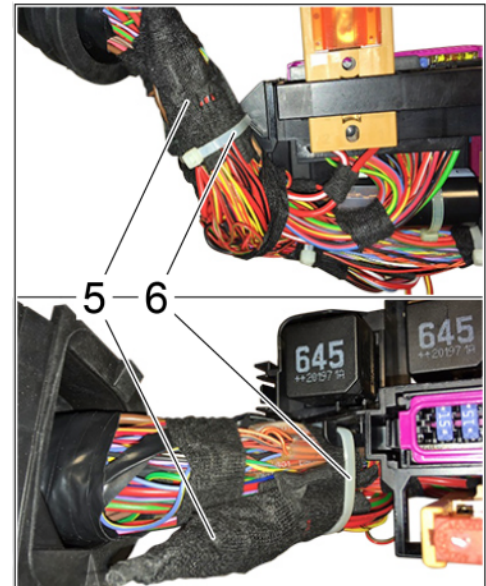
Securing splice node

- 3.3 Route splice node ⇒ *Securing splice node -5-* upwards and fasten to the relay carrier together using the remaining wire harness and a tie-wrap ⇒ *Securing splice node -6-*.
- 4 Install engine wire harness body.
Proceed as described under section ⇒ *Technical Information '926019 Replacing engine wire harness body and fuse box, reworking PVC seam on bodyshell'*, Step 7 onwards.
