MIL Comes On with DTC P2422

AFFECTED VEHICLES

Year	Model	Trim	VIN Range
2017– 22	Ridgeline	ALL	ALL

The MIL is on with DTC P2422 (EVAP canister vent shut valve stuck closed malfunction).

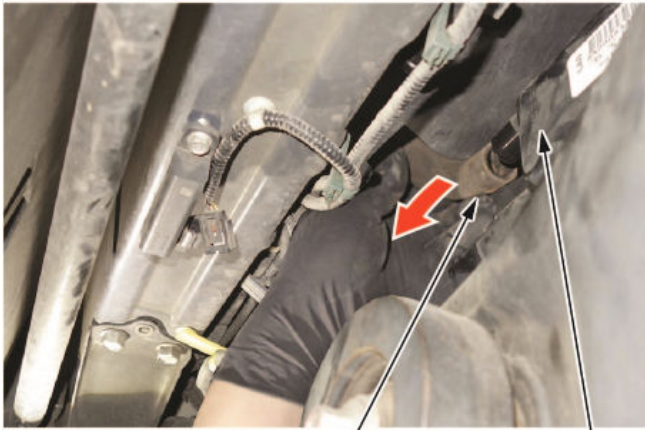
Disconnect the rubber drain tube. EVAP CANISTER

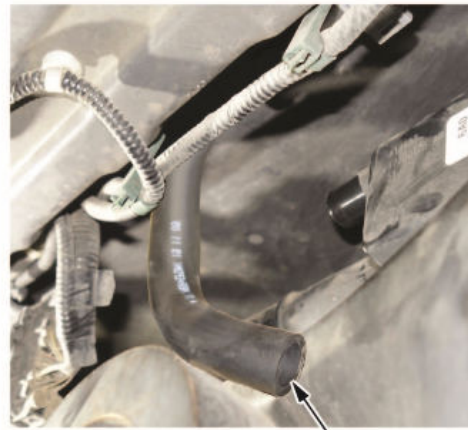
Inspect for dirt or dust.

- For 2WD vehicles, if the drain tube has any dust or dirt inside it, go to REPAIR PROCEDURE A.
- For AWD vehicles, if the drain tube has any dust or dirt inside it, go to REPAIR PROCEDURE B.

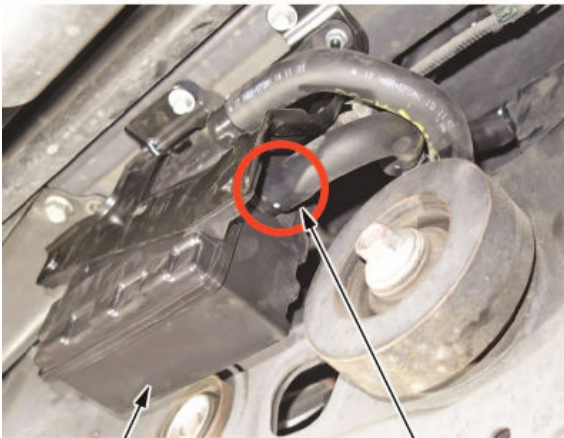
CANISTER FILTER BOX Disconnect this drain tube.

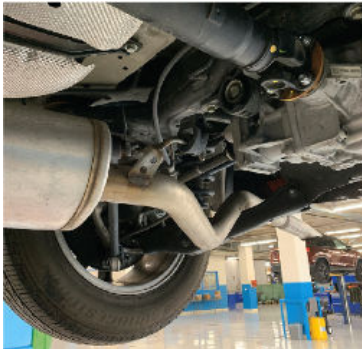
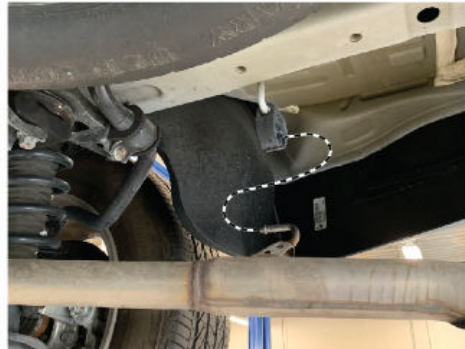
1. *2017–20 Models:* Unhook the mid-pipe and muffler from its hangers, the suspension will support it.

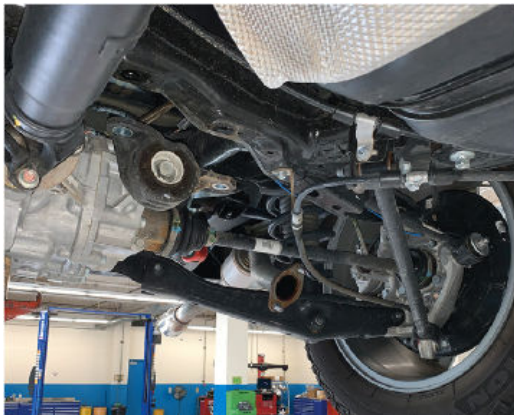
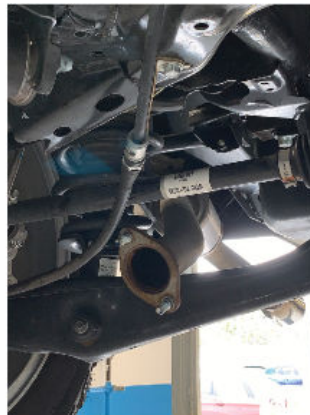
2021–22 Models: Remove the mid-pipe muffler.

NOTE: Do not reuse the exhaust nuts or gasket.

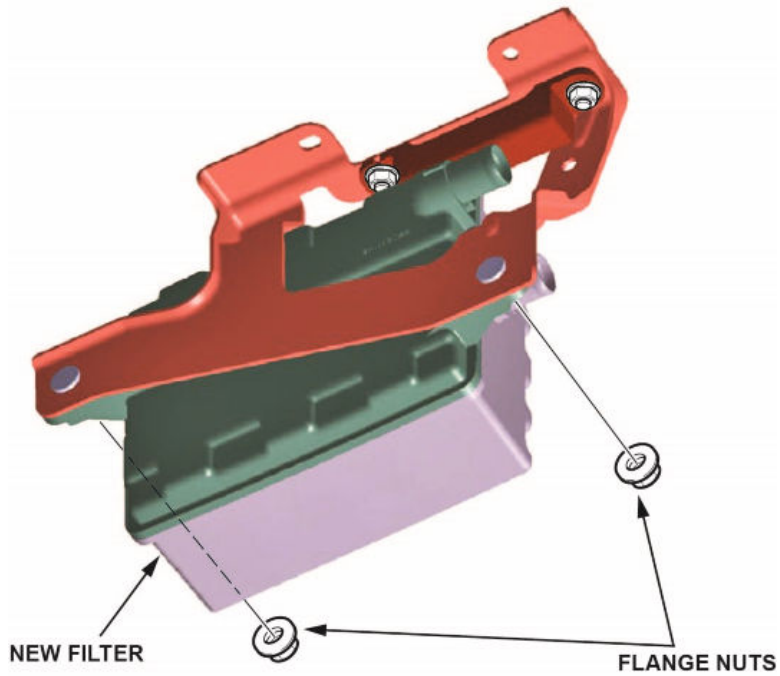
15. Install the new canister filter box to the bracket. Use the two flange nuts included in the kit, and torque them to **9.4 N•m (6.9 lb-ft)**.
