## Oil Residue on the A/C Condenser

Year	Model	Trim Level
2016–22	HR-V	ALL

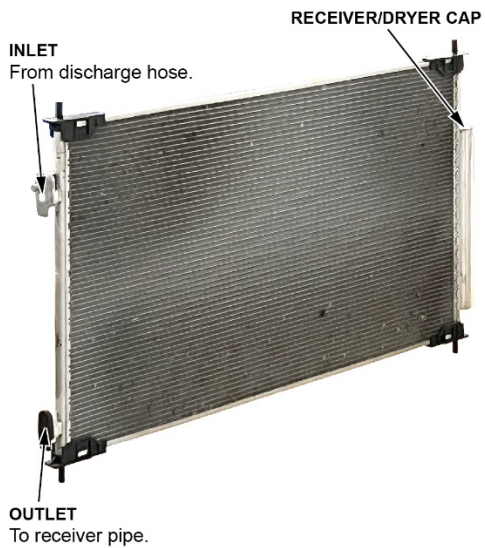
3. Check the inlet and outlet joints and the dryer cap for leaks.
