September 2, 2022

Product Update: Blower Motor Inspection

AFFECTED VEHICLES

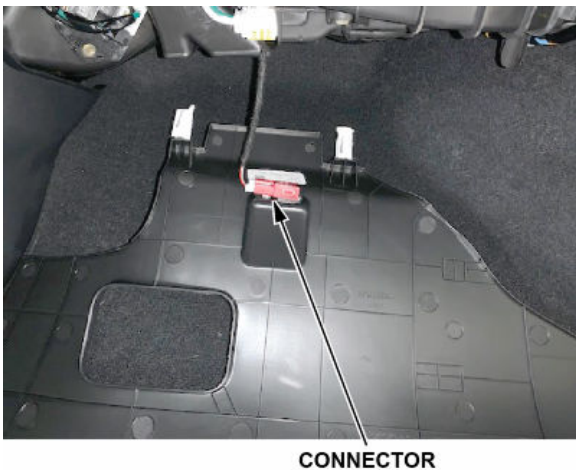
2. Disconnect the connector (if applicable).

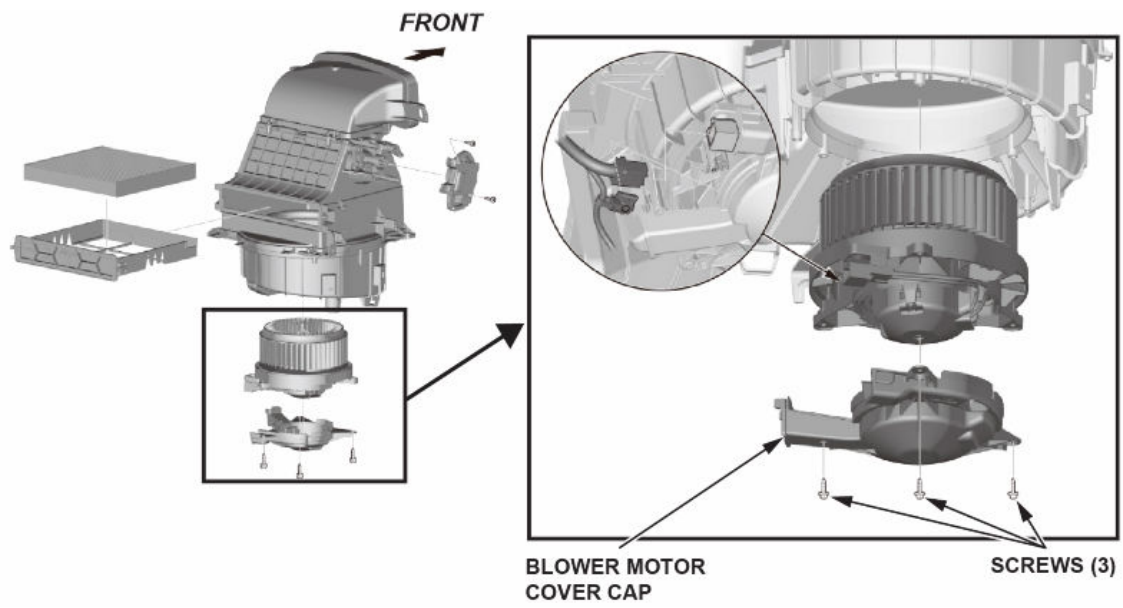
3. Remove the front blower motor cover screws (3).

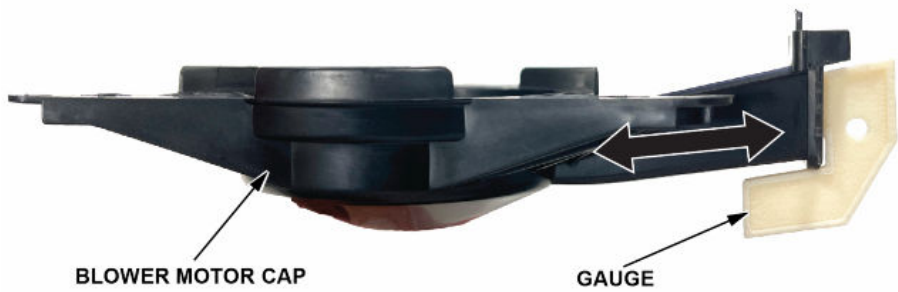
SIDE VIEW

4. Install the left and right side inspection tool one at a time into the air duct passage as shown.
- If the inspection tool goes through the opening without forcing it through, install the blower motor cover, no further action is required.
 - If the inspection tool does not go through the opening, **Do Not force it through**, go to the Repair Procedure and replace the blower motor and blower motor cover cap.

PLATE
Limits side movement and wrong hole insertion.

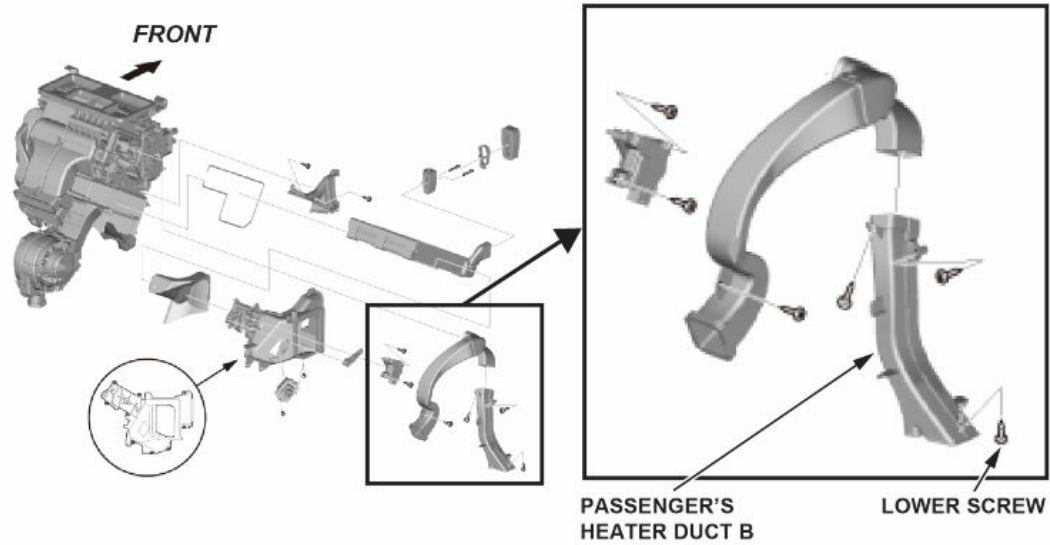
1. Remove the lower screw for passenger's heater duct B.

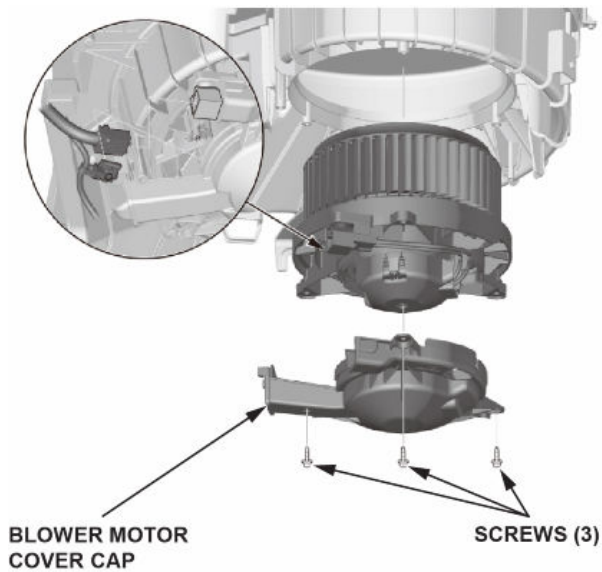
2. Push the passenger's heater duct B to give clearance for the blower motor to be removed and disconnect the motor connector.

3. Replace with new blower motor and cover cap, then torque the screws to **(14-16 in-lbs)**.
4. Connect the connectors, then install all removed parts in the reverse order of removal.

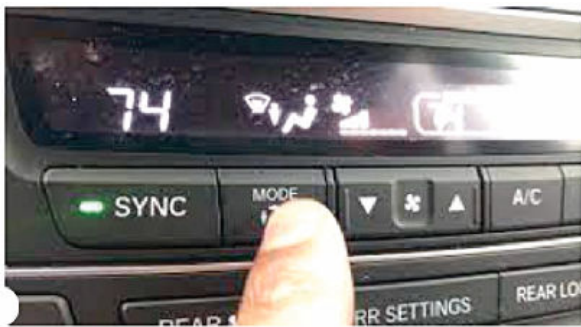
5. Turn the fan on to confirm that the blower motor works properly.
