Subject	Solitude ST390RK Rear Upper Deck Securement				Number	22-003
					Date	9/12/2022
					Model	Solitude ST390RK
					Build Date	Units offline prior to June 2022
Circulate To:	Service Manager	x	Parts Manager		Technician	x
	Warranty Admin	x	Sales Manager		Part Number (s)	961113, 960736 &

Concern:	The rear upper deck on Solitude ST390RK models produced prior to June 6, 2022 may not be properly supported. As a result, the rear upper deck floor may sag slightly at the sidewalls.
-----------------	---

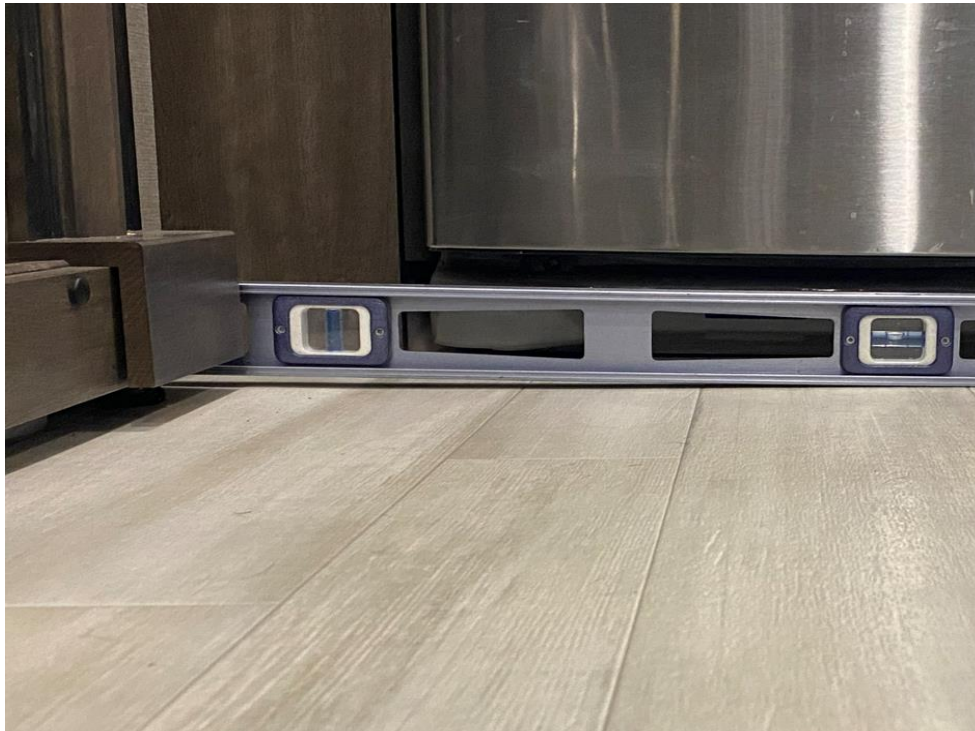
Photo example 1. Inspecting the floor for sag.

1. Visually inspect the chassis from the rear axle to the bumper. Ensure there are no bent outriggers and verify the unit has not been modified for towing.
2. Using the hydraulic system, level the unit. Inspect the floor of the rear upper deck for signs of "sag" or dropping.

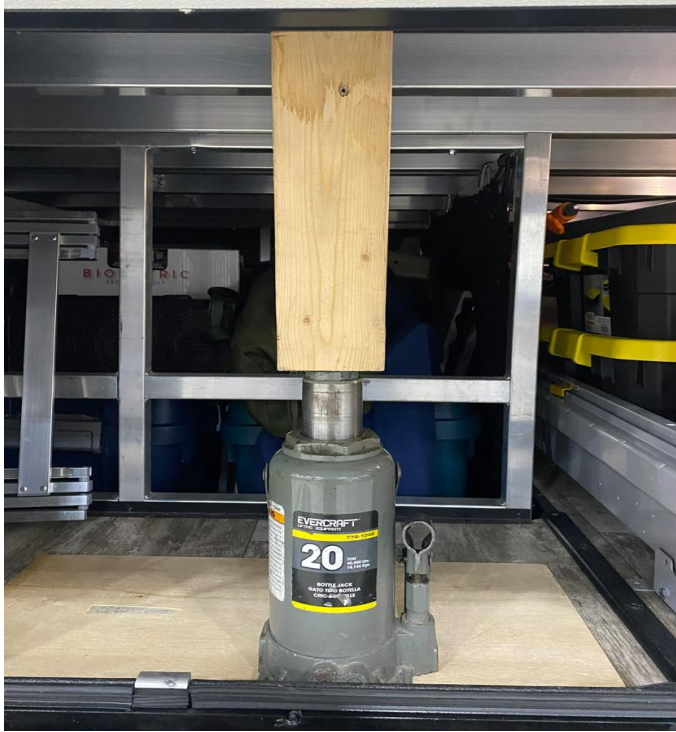
Photo example 2. Using jack to support rear upper deck.

3. Open the rear compartment doors on both sides of the unit.
4. Place a jack inside the compartment, using a small board to protect the linoleum covered subfloor. Align the jack with the P-tubing along the outside edge of the upper deck against the interior of the sidewall. Support the deck with the jack. You may need another small board to help support.

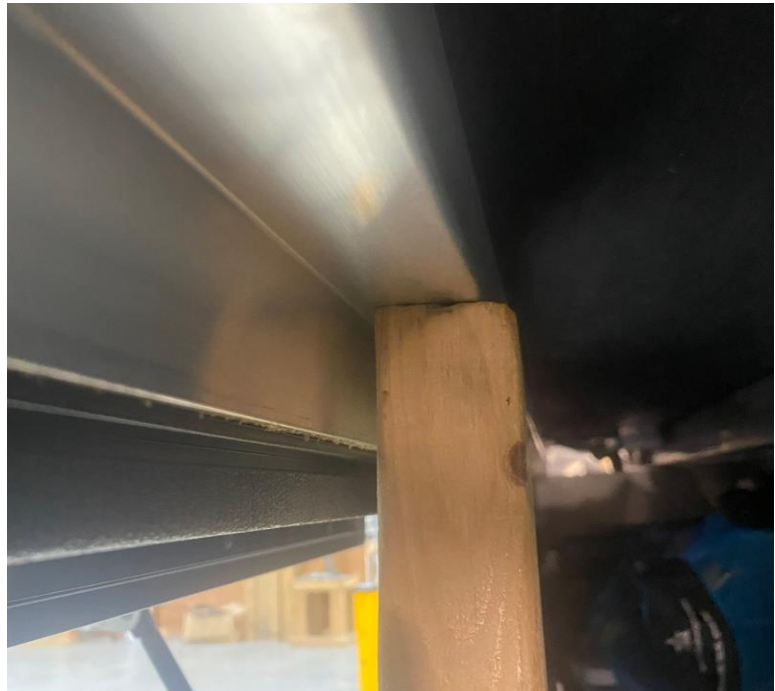
Photo example 3. Alignment of 2x4 supporting upper deck.

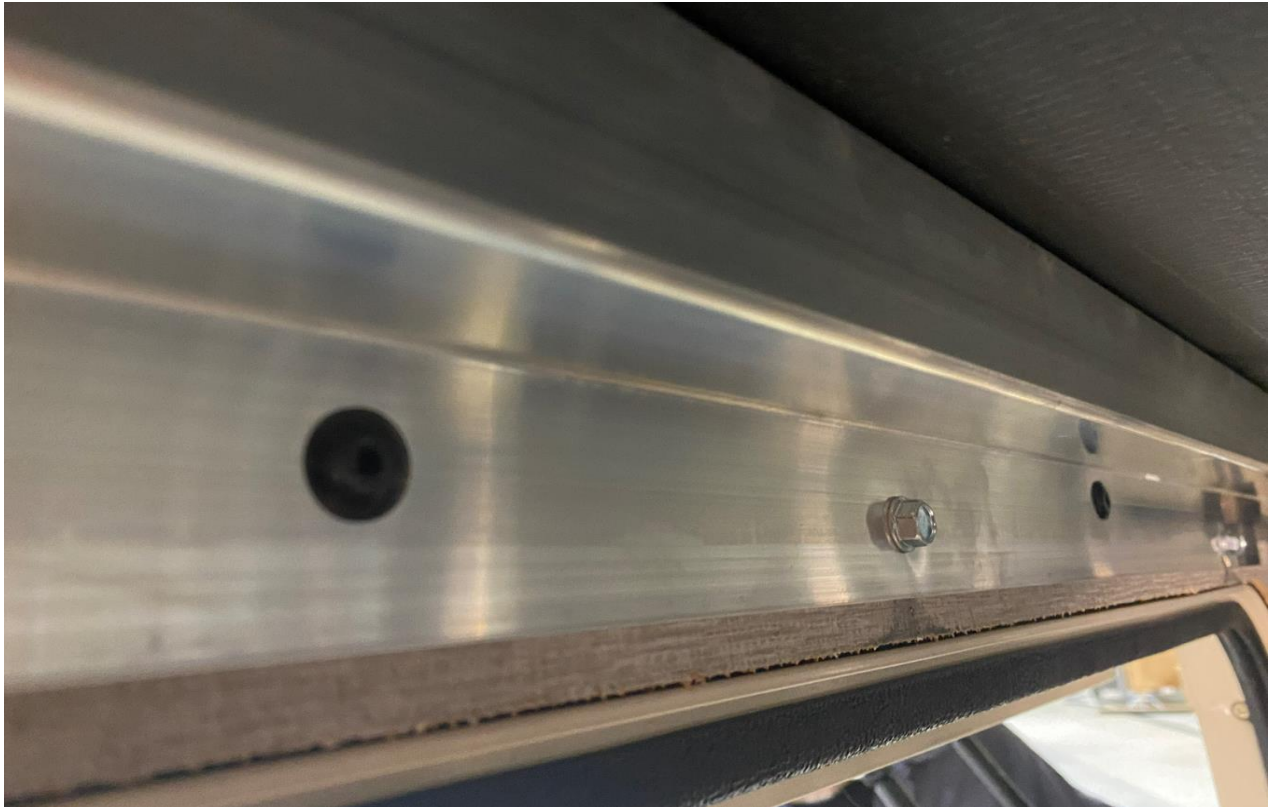
Photo example 4. Repaired P-tube with screws and rivets installed.

5. With the upper deck supported, remove the existing screws from the P-tube. Using the jack, carefully raise upper deck until level.
6. Install non-selftapping screw 14x1 Hex - *GDRV part number 961113* - every 12" to 14" apart. You may be able to use existing screw holes. This process may require you to relocate the jack several times, checking for level as you go.
7. Using a 7/32" drill, start a pilot hole equal distance between each screw and install an expandable rivet - *GDRV part number 960736*

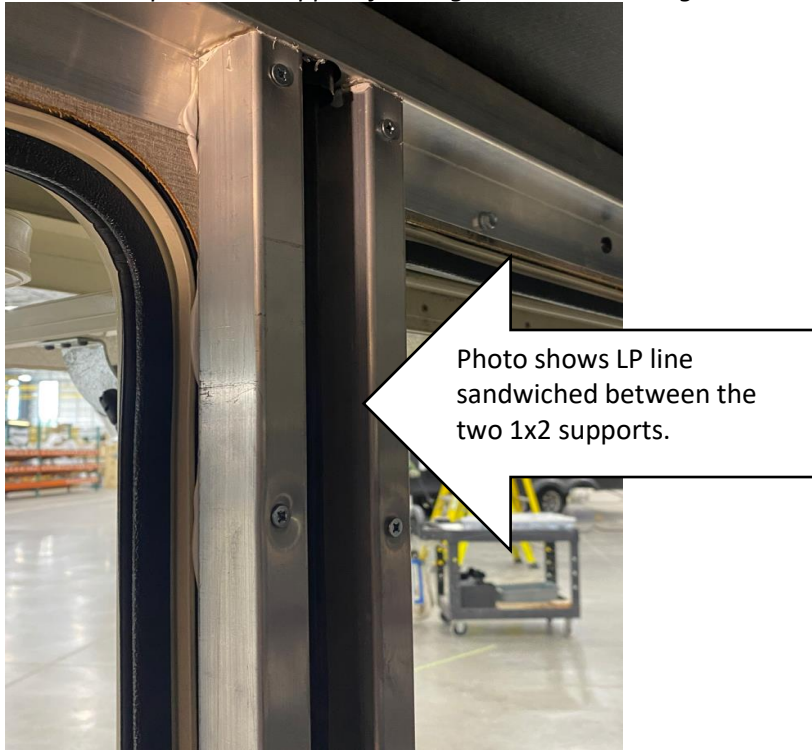
Photo example 5. 1x2 support framing between the cargo doors.

8. Remove the strut rod between the two compartment doors. Measure vertically, the distance between the floor of the cargo area and the bottom of the aluminum P-tube, between the compartment doors.
9. Cut two 1x2, aluminum (wood stuffed) tubes to the measured length and place on either side of the LP hose. Where no LP line is present, use a single 2x3 stuffed aluminum tube. Apply Sika-Flex to the wall side of the tubing and secure with 2.5" screws. Be sure to secure at the top of the support through the lip of the P-tube and at the bottom of the support into the bottom rail of the exterior wall. Add two additional screws, equal distance between the two. Reattach cargo door strut.

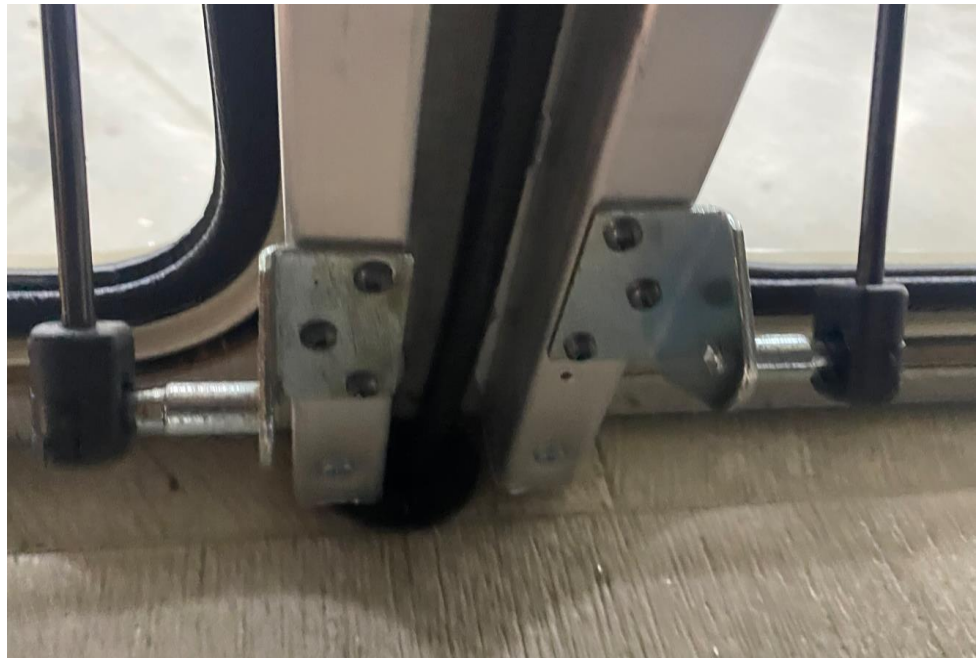
Photo example 6. Cargo door struts reattached.
