GROUP	MODEL
Emissions Service Campaign	2023MY Sportage (NQ5a)
NUMBER	DATE
SC239	September 2022

VOLUNTARY EMISSIONS SERVICE CAMPAIGN

CENTER MUFFLER INSPECTION AND REPLACEMENT (SC239)

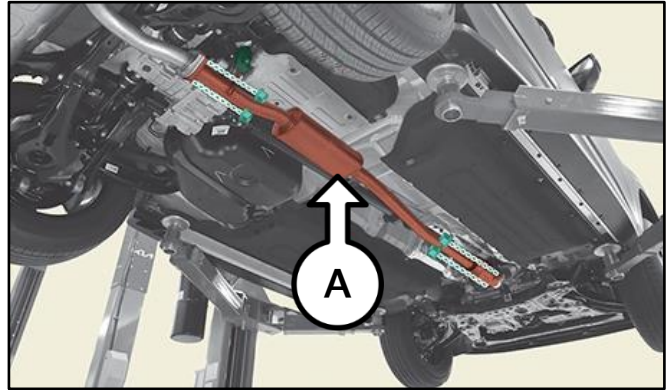
- 1a. Raise vehicle on lift.
- 1b. Locate the center muffler (A).

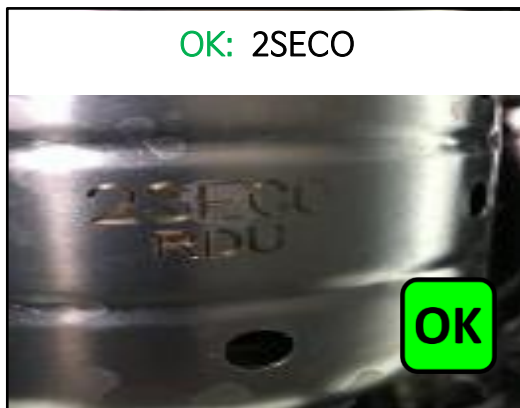
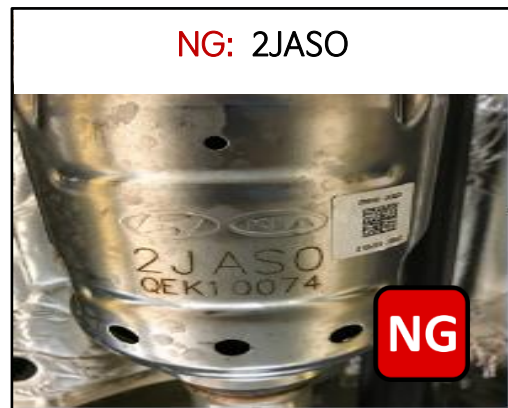
2. Inspect the number stamped on the surface of center muffler (A). Confirm if the vehicle is equipped with the correct center muffler:

- 3a. If the center muffler is the correct one (OK), no further action is required.
- 3b. If the center muffler is the incorrect one (NG), proceed to page 3 to the 'Replacement Procedure' to install the correct part for the vehicle.

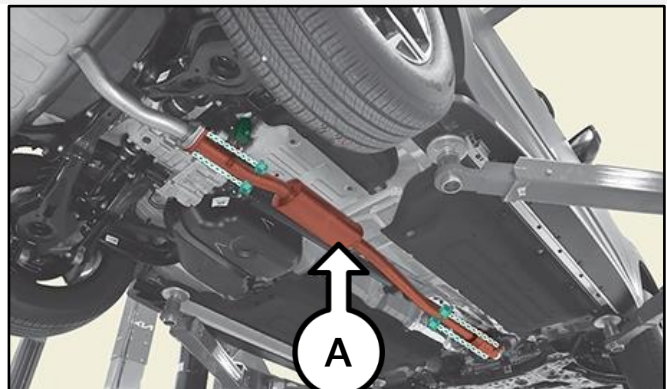
3. Replace the center muffler assembly by referring to "Engine Mechanical System → Intake and Exhaust System → Muffler → Removal and installation" in the applicable Shop Manual on KGIS.

Note: DO NOT reuse the center muffler rear gasket, install a new part.
