# Corrosion on the Back Door Steel Reinforcement Panel Around the Opener Switch and Rear Camera

YEAR(S)	MODEL(S)	ADDITIONAL INFORMATION
2017 - 2022	Prius Prime

Some 2017 – 2022 model year Prius Prime vehicles may exhibit corrosion on the back door steel reinforcement panel sub-assembly area visible below the opener switch and rear camera. Follow the Repair Procedure in this bulletin to address this condition.

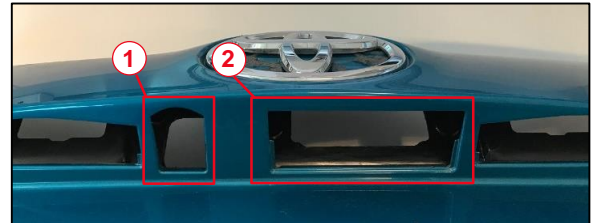
Figure 2.

1	Rear Camera Hole
2	Back Door Opener Switch Hole

3. Prepare the back door steel reinforcement panel for refinishing. Use 80 – 180 grit sandpaper to remove rust from surfaces surrounding the opener switch and rear camera hole locations (Figure 2).

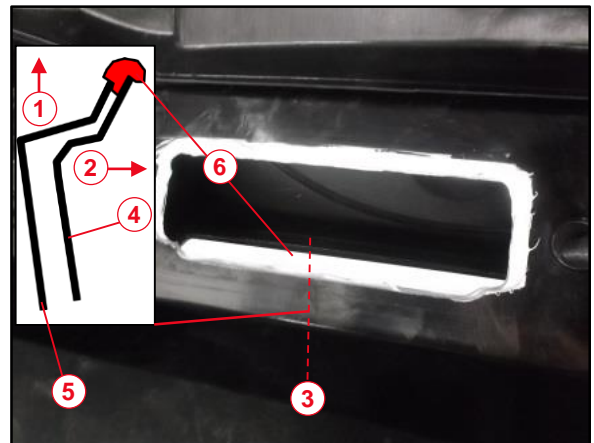
Figure 3.

1	Up
2	Rear
3	Cross-section
4	Steel Reinforcement Panel
5	Interior Panel
6	Sealer ≤ 1.5 mm Thick

5. Seal the gap between the back door interior panel and steel reinforcement panel.
  - A. Use urethane seam sealer to fill the edge gap between the interior CFRP panel and the steel reinforcement panel (Figure 3) to prevent water entry between the two panels.
  - B. Allow the sealer to dry per the manufacturer's recommendations.

To ensure proper fit of the back door opener switch and rear camera to the reinforcement panel when reassembling, the sealer should be no more than 1.5 mm thick.

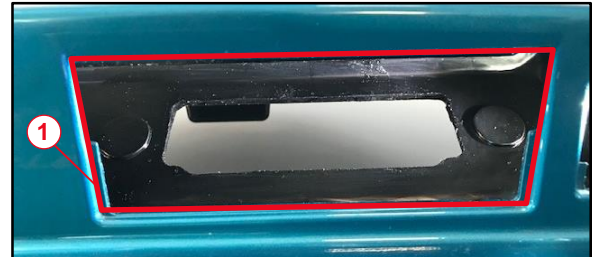
**Figure 4.**

<b>1</b>	<b>Visible Back Door Steel Reinforcement Panel</b>
----------	--

6. Apply two coats of black satin top coat to the visible area of the back door steel reinforcement panel surrounding the back door opener switch and rear camera holes and allow each coat to dry according to material manufacturer recommendation. The completed repair is illustrated in Figure 4 and Figure 5.

Coat the visible portions of the back door steel reinforcement panel surrounding both the door opener switch and the rear camera.

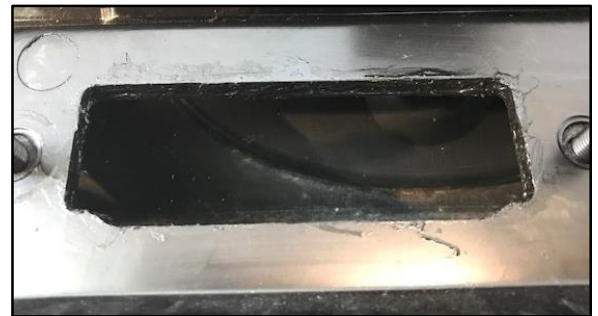
**Figure 5.**

<b>1</b>	<b>Rear View of the Gap Between Interior CFRP and Steel Reinforcement Panel Filled With Sealer</b>
----------	--

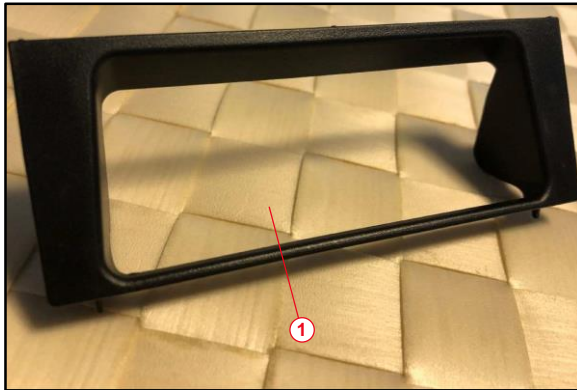
**Figure 6. Old Back Door Finish Panel Protector, No. 1**

<b>1</b>	<b>Original Cover-exposed Area of the Retainer Visible in This Area</b>
----------	---

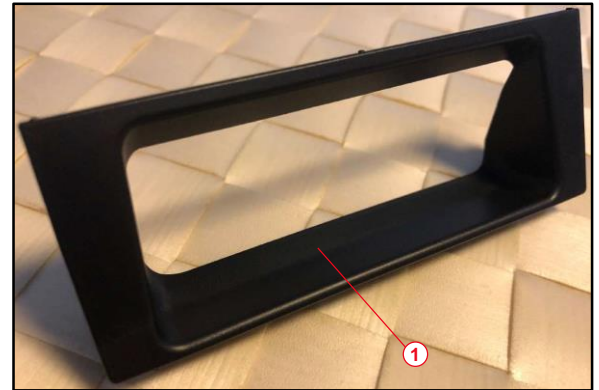
**Figure 7. New Back Door Finish Panel Protector, No. 1**

<b>1</b>	<b>New Cover Has Extension Which Covers The Currently Exposed Area of the Retainer</b>
----------	--

10. Ensure the NEW back door finish panel protector No. 1 has the extended portion as shown in Figure 7.
