Moon Roof Leaking During High-pressure Car Wash

Service Category Vehicle Exterior

Section Window/Glass

YEAR(S)	MODEL(S)	ADDITIONAL INFORMATION
2017 - 2022	RX350, RX450H	WMI(s): 2T2

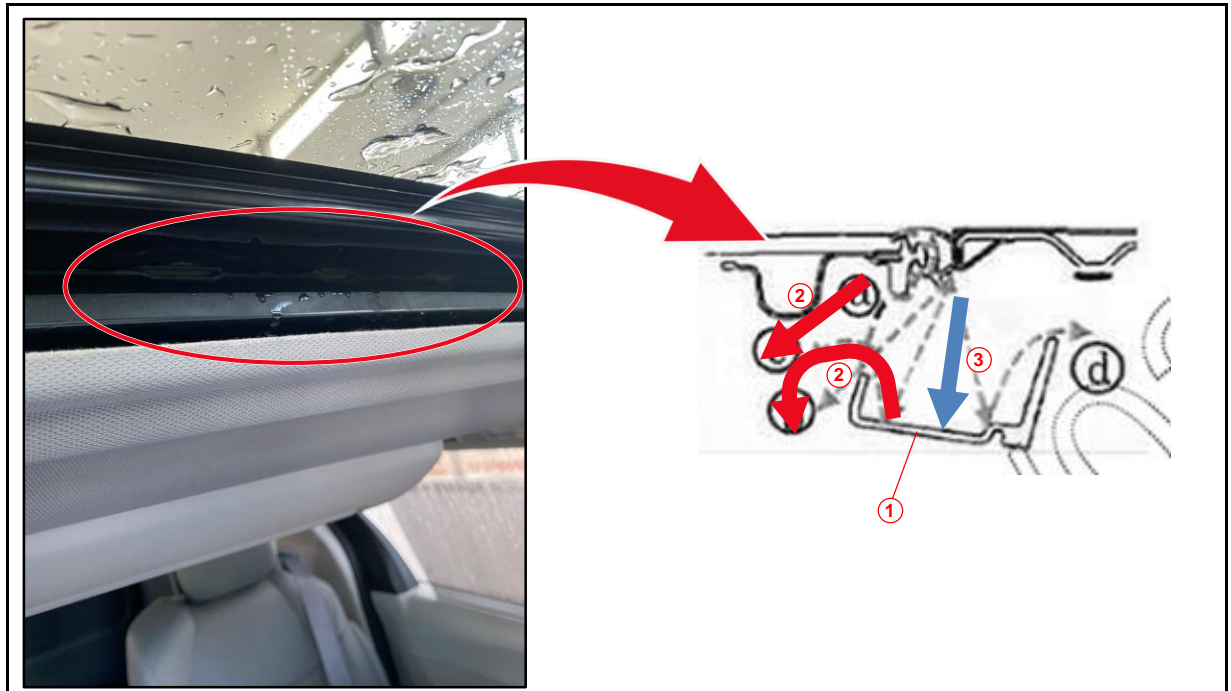
Figure 1.

If water drips but is contained inside the rain gutter, this condition is acceptable by design (blue arrow in Figure 1).

1	Rain Gutter
2	No Good Condition — Drips Outside Rain Gutter

3	OK Condition — Drips Inside Rain Gutter
----------	--

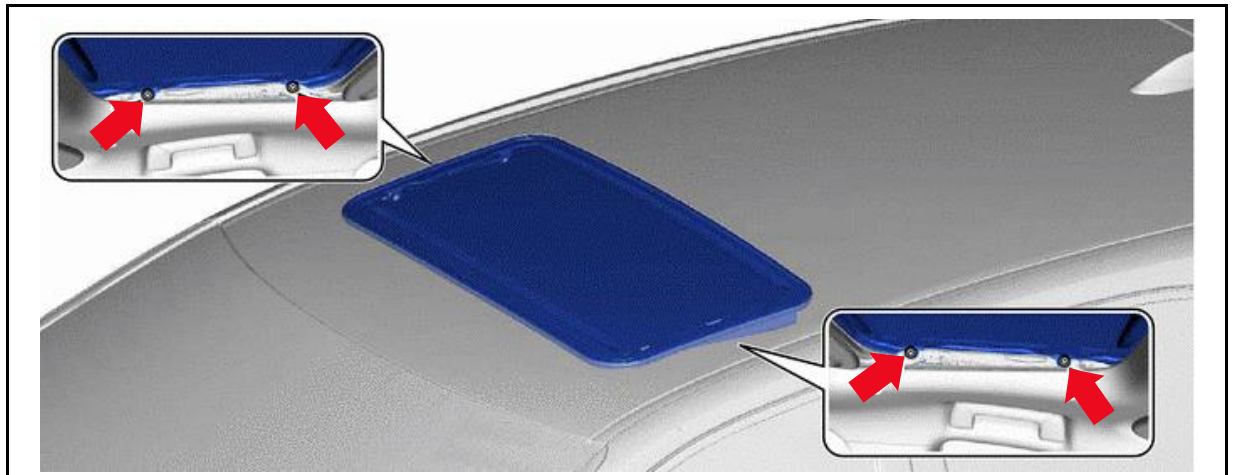
Figure 2.

2. Remove the sliding roof glass sub-assembly.

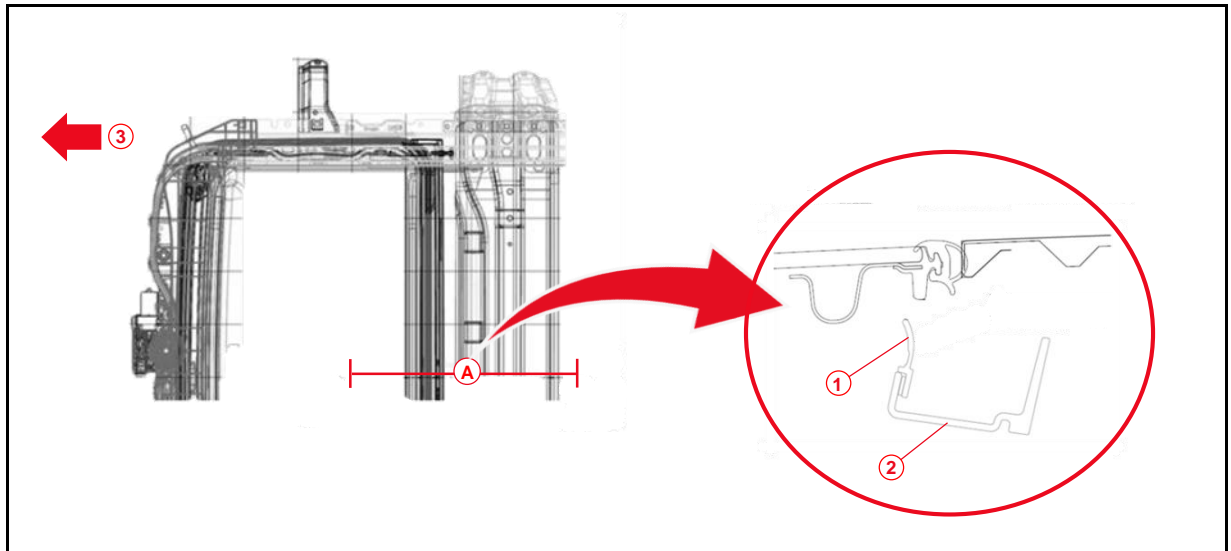
Figure 3.

3. Refer to the figure below for where the NEW Channel, Roof Drip Molding (63214-48040) will be attached to the moon roof assembly.

A	Cross Section of Moon Roof Assembly
1	New Channel, Roof Drip Molding (63214-48040)

2	Drip Tray Assembly
3	Front

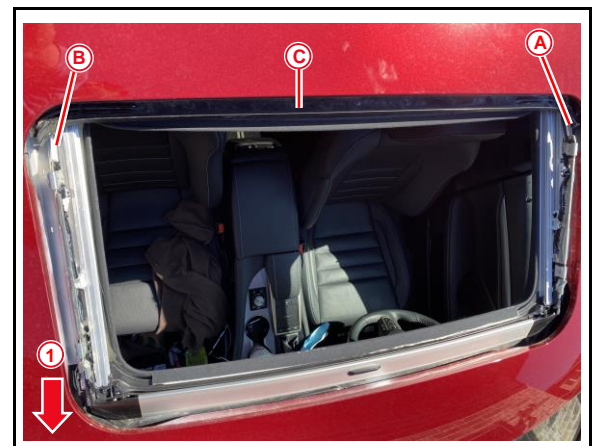
Figure 4.

4. Starting from the left-hand pivot arm (A) and working to the right-hand pivot arm (B), use an alcohol pad cleaner to wipe the front wall of the drip tray assembly (C) where the Channel, Roof Drip Molding (63214-48040) will be attached.

1	Front
A	Left-hand Pivot Arm
B	Right-hand Pivot Arm
C	Wipe Front Wall of Drip Tray

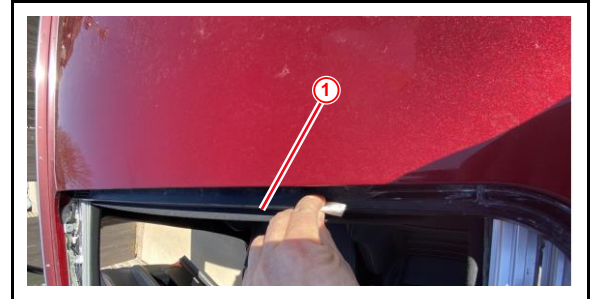
Figure 5.

5. Apply 3M™ PAC Primer K-500 to the front wall of the drip tray where the Channel, Roof Drip Molding (63214-48040) will be attached. Primer should be applied to the same cleaning area described in step 4.

1 Apply to Front Wall of Drip Tray

Allow the area to dry for AT LEAST two minutes and a MAXIMUM of four minutes. Ensure the primer is completely dry BEFORE continuing to the next step.

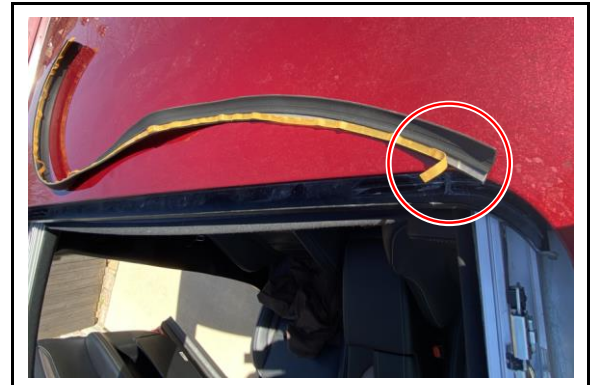
Figure 6.

6. Install the NEW Channel, Roof Drip Molding (63214-48040) to the drip tray wall.
 - A. Remove the backing cover from the double-sided adhesive tape.

Protect the tape adhesive from contaminants and sunlight exposure AFTER peeling the backing cover.

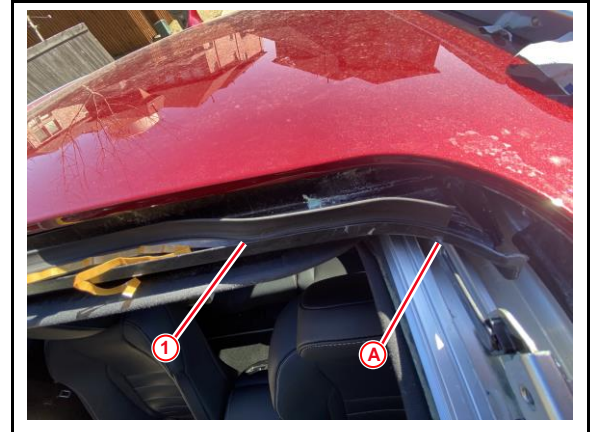
Figure 7.

- B. Attach the double-sided tape to the drip tray assembly. Starting from the left-hand pivot arm (A) and working to the right-hand pivot arm, carefully align the adhesion tape to fully engage and secure to the drip tray wall.

A	Left-hand Pivot Arm Starting Point
1	Align Adhesion Tape to Drip Tray Wall

Apply the force of 49N (min) (11.015 lbf) and press with two fingers across the entire length of the molding while installing to ensure good bonding of the double-sided tape adhesion to the drip tray assembly.
